# Fatality Investigation Report

OR2003-01-01

## **Roofer's family member helping at worksite dies after falling through skylight.**

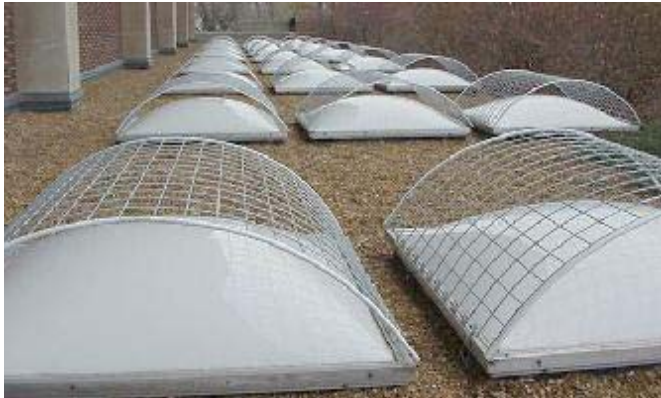
Photo. Skylight (typ.) with outer grids installed to prevent falls through them to the floor, below.

The 1997 version of the Uniformed Building Code, requires the installation of a steel grill with all acrylic plastic skylights, to prevent workers from falling through them. Polycarbonate or Lexan™, is more commonly used in the manufacturing of skylights today and is better at withstanding sudden changes of weight load and effects of weathering. Increasingly building permits for new construction (commercial buildings) are not being approved unless skylights are constructed with polycarbonate plastics, tempered or reinforced glass. Acrylic "plastics" can still be found and are being used in structures, especially on buildings, and homes, built before 1990. Acrylic domed skylights do provide advantages in that they provide explosion relief and will melt out during a fire creating a chimney effect (a desirable effect in an industrial fire). At minimum, all acrylic domed skylights, (those not incorporating tempered or reinforced glass) should have a steel grill installed

beneath them (or over them) to prevent workers from accidentally falling through them. This is an industry wide issue and must be addressed by building trades organizations, municipal code approval agencies, rental and leasing agencies, Fire inspectors, Safety Officers and housing authorities. Building owners need to decide how to best manage this risk for the older structures. Workers must adjust to the risk and take measures to prevent catastrophic incidents from occurring.
