## Worker struck by multi-piece rim during wheel installation

**FACE 03AK006**

**Released: December 12, 2003**

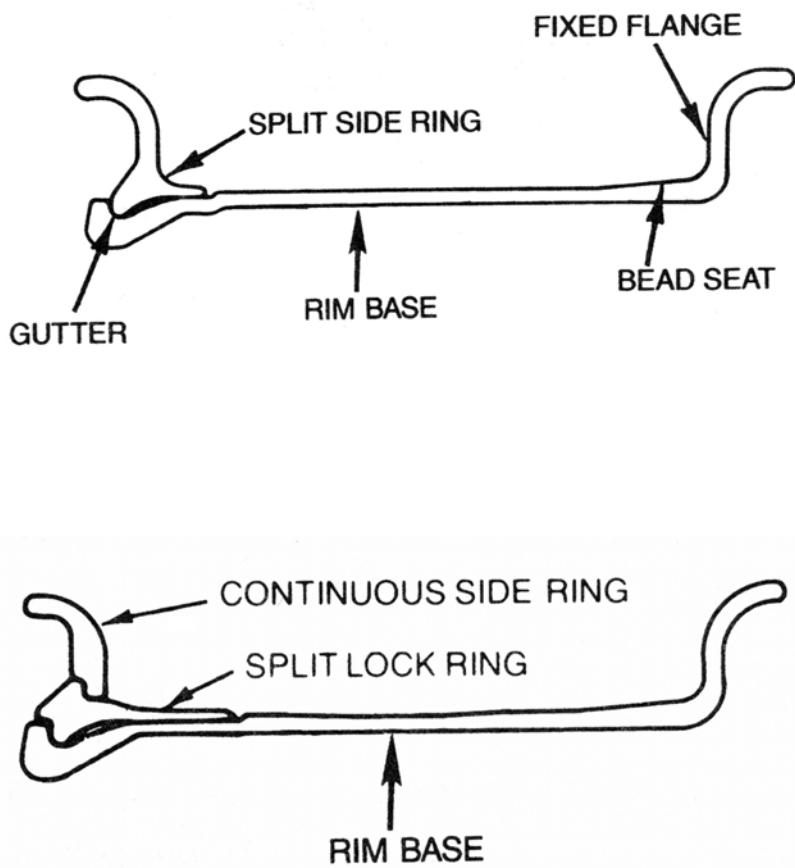
**Figure 1. Parts of a demountable two- and three-piece rim**

The wheel in this incident was a tube-type tire on a demountable rim (multi-piece). This rim had three pieces consisting of a rim base, a split locking ring, and a continuous side ring or flange

(Figure 1). The parts are designed to allow the locking ring to fit into a gutter on the base rim, “locking” the flange in place on the rim when the tire is inflated.

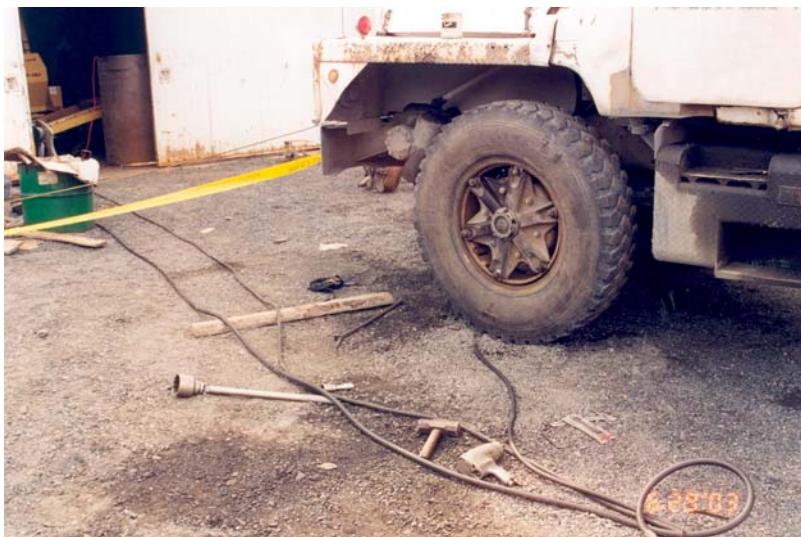
**Figure 2. View of wheel assembly**

A demountable rim does not have a center disc and is installed on a cast spoke wheel, the axle component to which the demountable rim is clamped. The spoke wheel in the case consisted of a hub and six spokes (Figure 3). Each manufacturer details a bolt pattern to be used to install the wheel, usually in a cross-cross pattern to allow the rim to set evenly against the wheel.

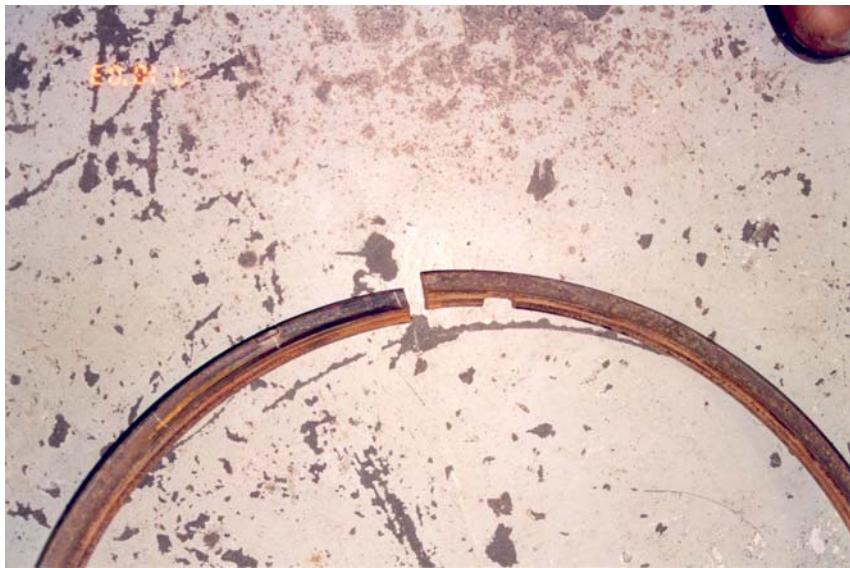
Post-incident inspection of the rim assembly by an AKDOLWD Occupational Safety and Health Enforcement Officer found that the parts were matched but severely pitted due to heavy corrosion. The locking ring was deformed or "sprung" (Figure 4), and the heavy corrosion obscured the identification stamping, indicating the parts were not cleaned and inspected prior to remounting. All of the aforementioned observations may have been contributing factors in this incident. In addition, post-incident inspection of the maintenance shop found Demounting and Mounting Procedures for Truck/Bus Tires and Multipiece Rim Matching charts (as required under 29 CFR 1910.177) were not posted in the service area. Since a pneumatic impact wrench equipped with a deep socket was used rather than a torque stick or torque wrench, the torque on the lug nut is unknown and could not be determined to be a factor in this incident.

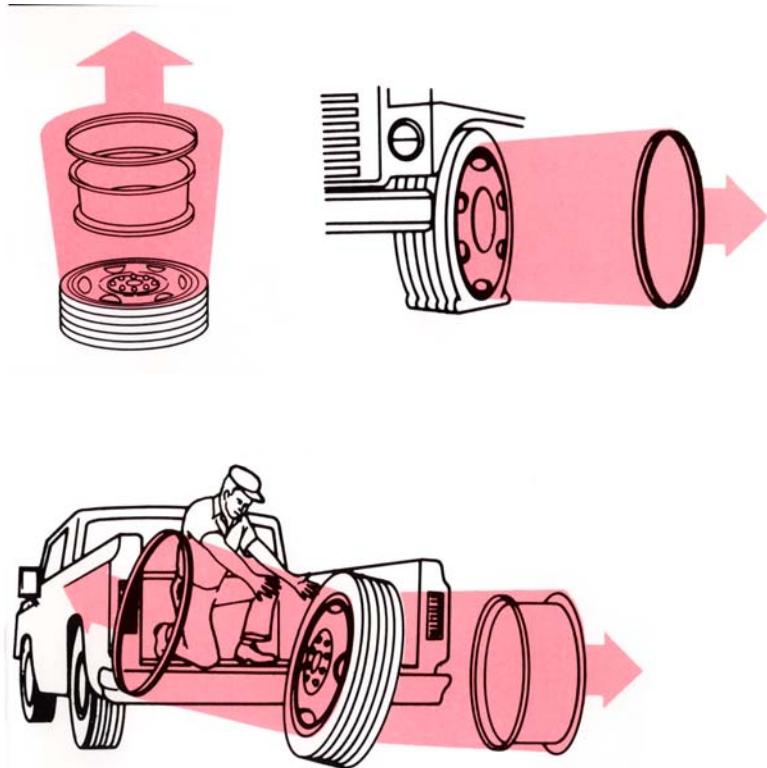
Figure 4. Trajectory of multi-piece rim parts

OSHA safety standards for the demounting, servicing, and remounting of single- and multi-piece rim wheels have significantly reduced worker injuries, but it does not eliminate injury that may occur from sudden release of rim parts during transport, movement and installation. Workers should also be trained on avoiding of any potential path that rim parts may travel (trajectory) and minimizing or eliminating activities within trajectory (Figure 5).
