## **A 14-year-old laborer crushed under 5-ton beam**

**FACE 01-AK-027**

**Release Date: June 21, 2002**

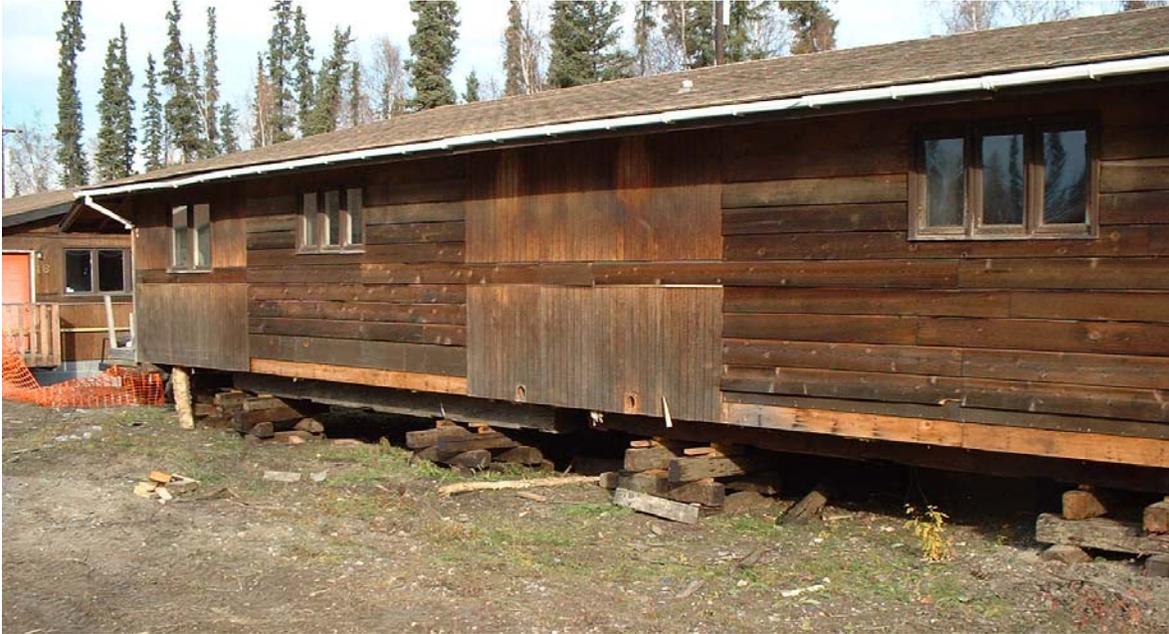
The incident site was in a residential lot with two multi-family residential buildings (four-plexes). Thirteen months prior to the incident, the two buildings were moved to the lot and left elevated approximately 3 feet above ground until a foundation could be built under each structure (Figure 1). The concrete block foundation of one building had been recently completed.

A second beam was beneath the adjacent building. The building was supported from underneath by several 12- by 12-inch wood support beams on top of stacks of 6- by 8-inch wood blocks or cross-supports (Figure 1). The supports were arranged in three rows, one on each side and one in the center. The beam appeared to have been dragged or rolled to its present location under the building. A chain was also on the ground under the house, parallel with the beam but on the opposite side of center supports. This was in preparation for moving the beam from under the first building (with the completed foundation) into position under the adjacent building.

Figure 1 Raised building supported by beams on wood blocks or cross supports

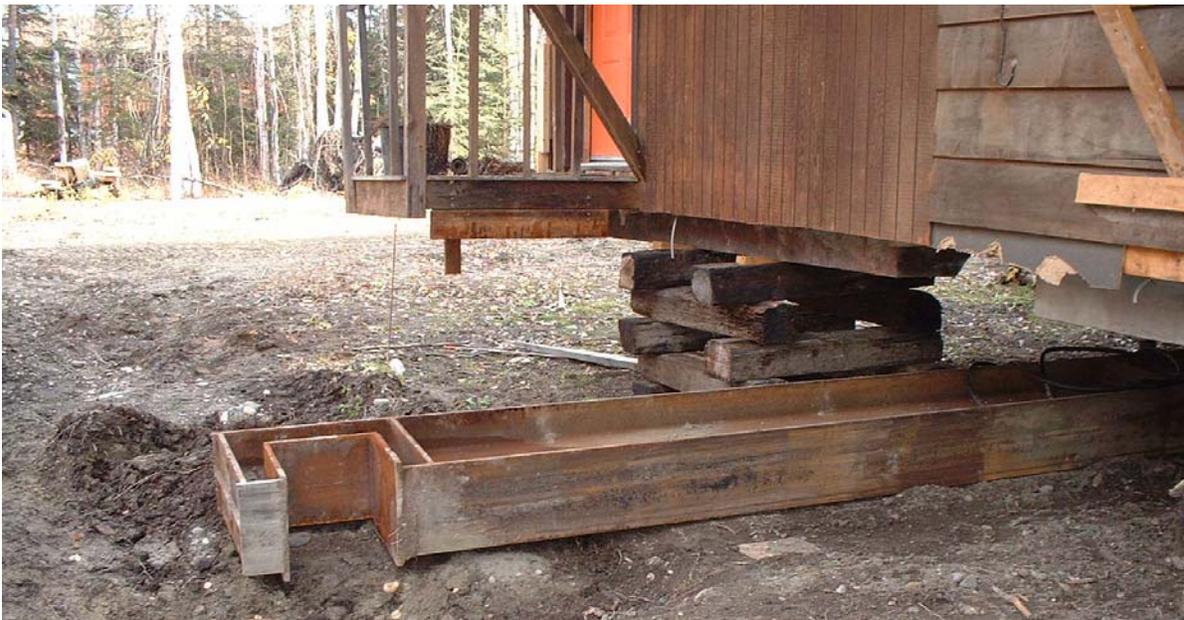
The company used two 79-foot metal beams to support the entire length of the structure when it was lifted and moved to its present location. The beams were 24½ inches tall with a central vertical support plate, and two 13 inches wide horizontal plates on the top and bottom (Figure 2). Each metal beam weighed approximately 5¼ tons. Prior to the incident, one building was lifted, supported, and then lowered for the necessary additional clearance to build a new concrete block foundation (Figure 3). A single metal beam remained under this building, extending past the foundation through openings in the foundation walls. Openings were left in the foundation walls so the beam could be pulled from underneath the building.

Figure 2. Beam position under raised building

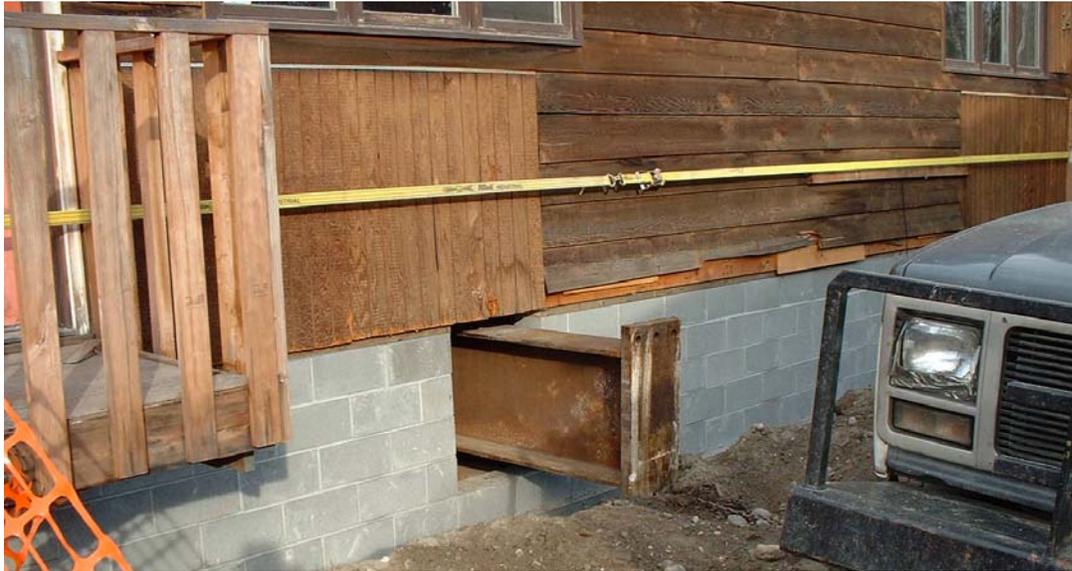
At the time of the incident, the victim was part of a three-man crew working beneath the second building; the company owner was working around the first building. The beam that had been relocated underneath the building had been pulled 3 feet past the building wall. Approximately 7½ feet of the beam remained on the opposite side (between the two buildings). The crew was working at this end of the beam; the victim was working on the opposite side of the beam from the other workers. His location was closest to the outside of the wall of the building; the other workers, on the opposite side of the beam, were near the center of the building. One worker was charged with setting, filling, and the deflating the airbag (Figure 4); the victim and the other worker placed wood blocking under the beam when lifted. They had successfully raised the beam 4 inches from the ground after the first lift and had begun the next lift.

Figure 3. Beam extending past concrete block foundation

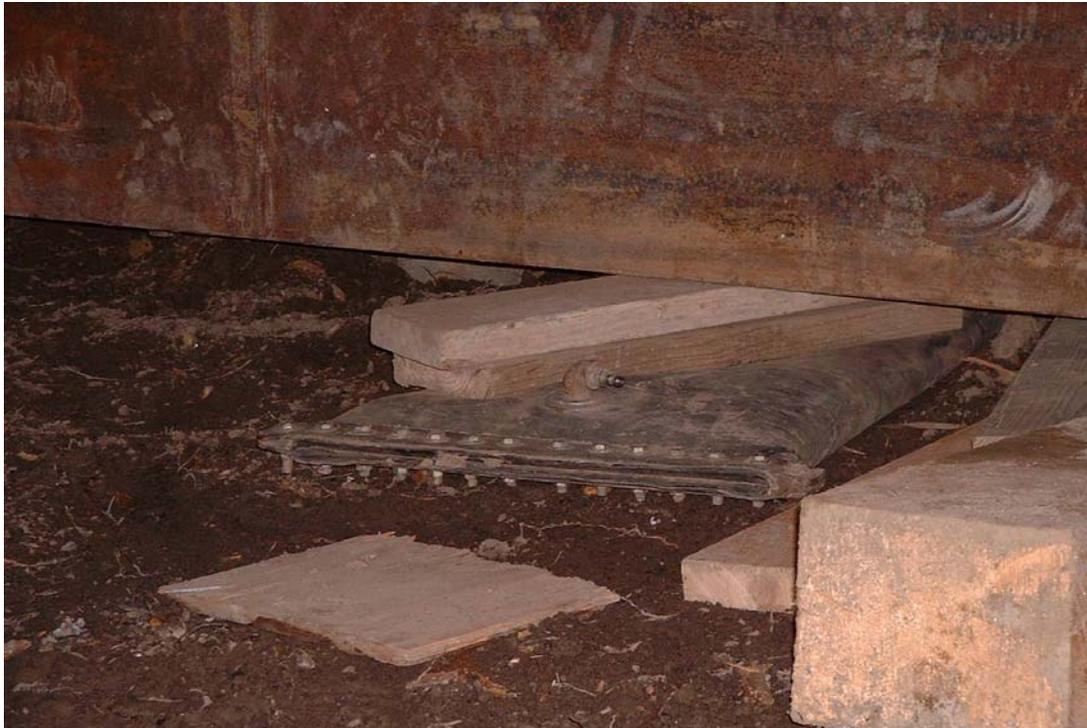
The lifting mechanism was a 2- by 3-foot airbag, used to initially raise the end of the beam. The use of airbags is an accepted standard industry practice and is considered less hazardous than hydraulic jacking. Each airbag can lift up to 100,000 pounds. Hydraulic jacks, used once the beam has been elevated into position to lift a structure, are considered a higher risk due to potential slippage and vertical instability of the jack (which is normally blocked as a preventive measure). Each airbag has the ability to provide 12 inches of lift; eight inches of lift was considered standard working height. The airbag filled and lifted the beam in approximately one minute. Once the beam is raised, a block of wood (6- by 8-inch or 8- by 8-inch) is slid beneath the beam from the side. (Only wood blocks are used, never concrete blocks, which can crumble.) The bag is deflated, placed on a block of wood, and re-inflated for the next lift. If the beam is raised more than six inches above the ground, then safety blocking is used. However,

The beam was lifted approximately eight inches above the first blocks of wood. The victim was kneeling next to the beam and was either reaching for a wood block or was attempting to push the block under the beam when the beam rolled off the airbag. The beam fell across the victim's back pinning him in a kneeling position against the ground. The other workers immediately called for help. As the worker in-charge of the airbag was attempting to deflate and reposition the bag, the second went to collect a hydraulic jack and a skid steer loader to lift the beam, if necessary. Hearing the cries for help, the company owner crawled under the building and

Figure 4. Airbag used to lift beam

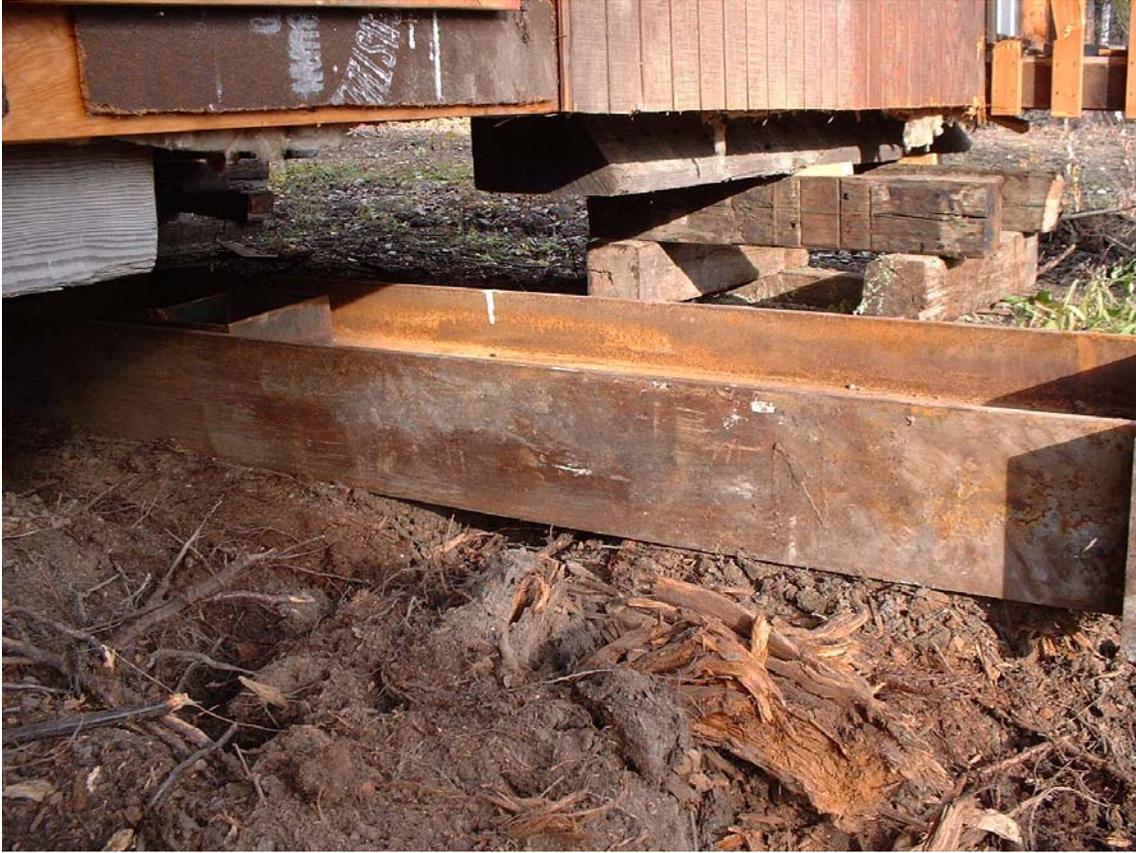
at the far end of the beam while it appeared to be level and upright where the crew was working. The injury prevention specialist for the Alaska Department of Health and Social Services, Section of Epidemiology, and an investigator for the Alaska Department of Labor and Workforce Development inspected the work area and the ground under the beam extending past the building. The far end of the beam was found adjacent to a buried stump (Figure 5). When upright, the beam would have been resting on the top of stump. It was surmised that the stump had been graded over during the excavation of the lot. Possibly the weight of the beam as it was tipped up during the lift crushed the remainder of the stump, causing the beam to become unstable and roll.

Figure 5. Stump and root material under beam

*Discussion:* Employers should conduct an initial inspection of the ground to identify potential hazards such as materials that may have been bladed over and not removed. In many

municipalities, all stumps and roots must be removed from the soil to a depth of at least 12 inches below the surface of the ground in the area to be occupied by the structure or building.
