Construction laborer/equipment operator crushed by skid-steer loader

FACE 01-AK-015

Release Date: May 17, 2002

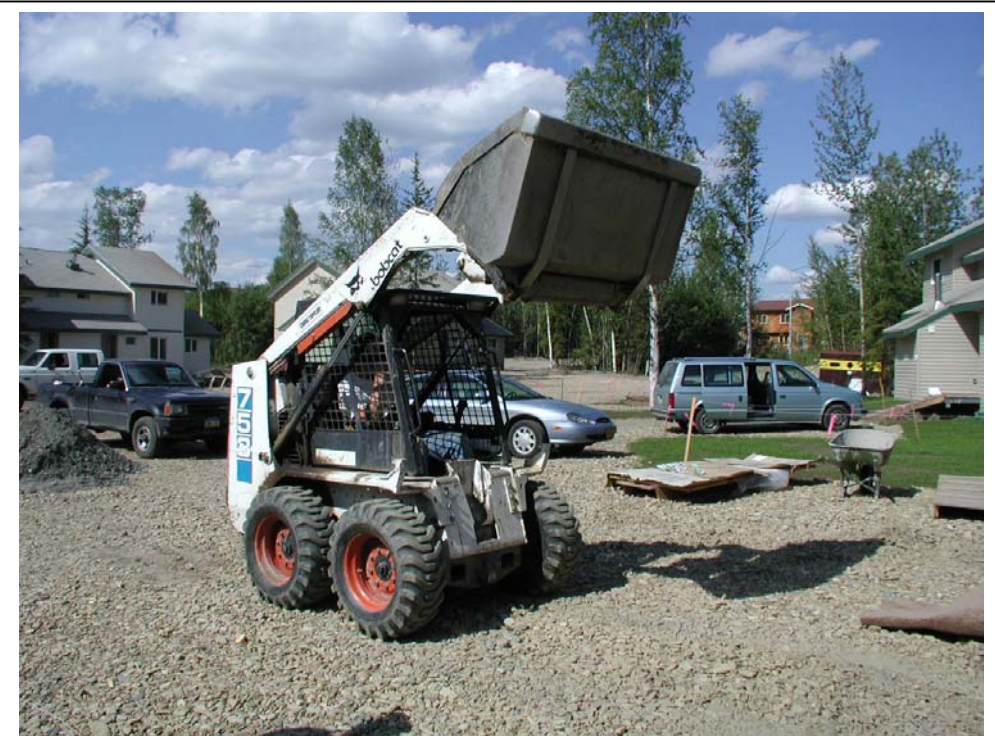
The machinery in this incident was a skid-steer loader (Figure 1). The four-wheeled unit weighs approximately 4700 pounds and has an operating capacity of 1300 pounds. It is equipped with hydraulic foot pedal-actuated lift and tilt cylinders for the bucket. Pushing forward on the lever handles to go forward or pulling back on the handles to reverse direction accomplishes movement. The unit is in a hydrostatic braking position when the handles are in neutral. It has one manual locking brake. The manufacturer published an operator's manual for this specific

Discussion: While containing a load, the bucket of the skid-steer loader was raised to approximately 6 feet above ground. With no load, the majority of the weight of the loader is on the rear axles. Weight shifts to the front axle when the bucket is loaded. Balance is the key to stability. With a loaded bucket elevated to allow an operator to see under the bucket, the center of gravity is shifted forward and stability is significantly jeopardized. Operators should be aware of load limits and check the load capacity rating for the loader. In addition, operators should always keep the loader's bucket as low as possible when traveling and turning and should lift the bucket only as high as necessary to dump a load.

Figure 1. Skid-steer loader with raised bucket

Recommendation #1: Employers should ensure that workers are knowledgeable of manufacturer recommended operating procedures and safety practices for equipment that they are assigned to operate.
