Mechanic struck-by backhoe while assisting with excavator disassembly

FACE 01-AK-008

Release Date: May 17, 2002

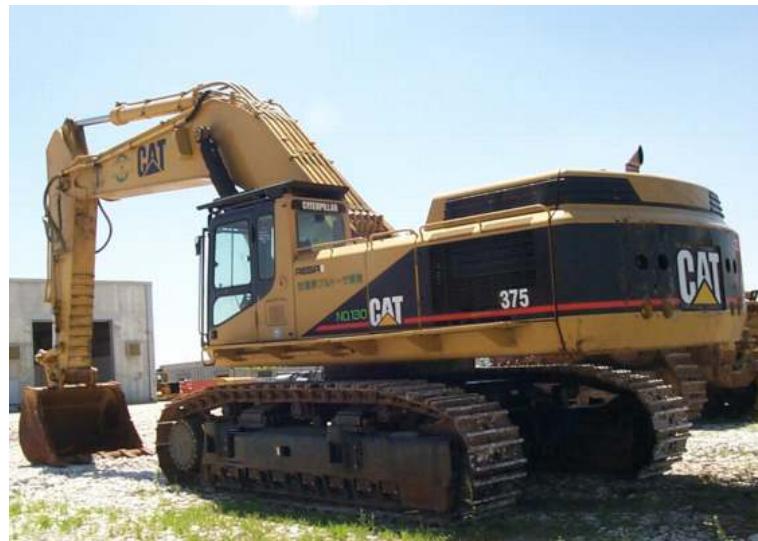
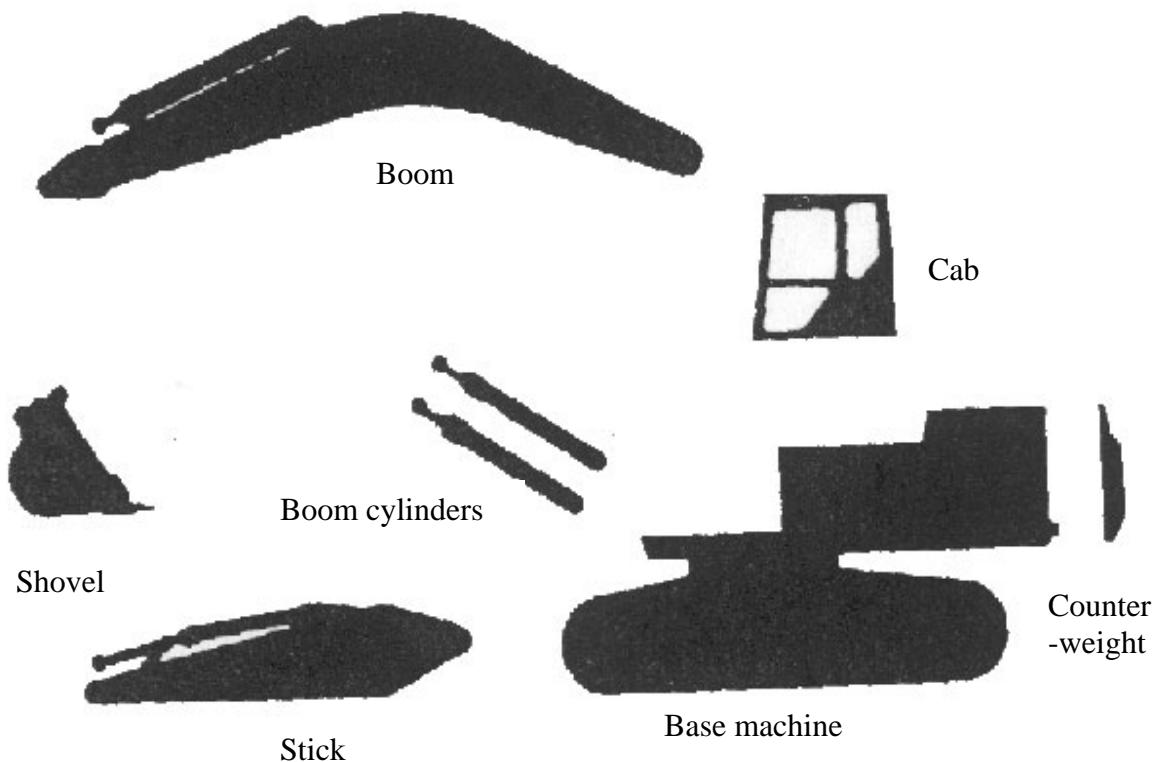
Figure 1. Excavator configuration for segment separation

The manufacturer recommended to segment the excavator into seven major portions for transportation: the base machine, counter weight, operator's cab, boom cylinders, boom, stick, and bucket (Figure 1). The boom, stick, and bucket sections (Figure 2) were attached by linkage pins that were inserted into two openings at the end of each section. (Thus, the pin would be inserted through a total of four bushings.)
