## Warehouseman Crushed While Unloading Pipe from a Trailer

Alaska FACE Investigation 99AK014

October 5, 1999

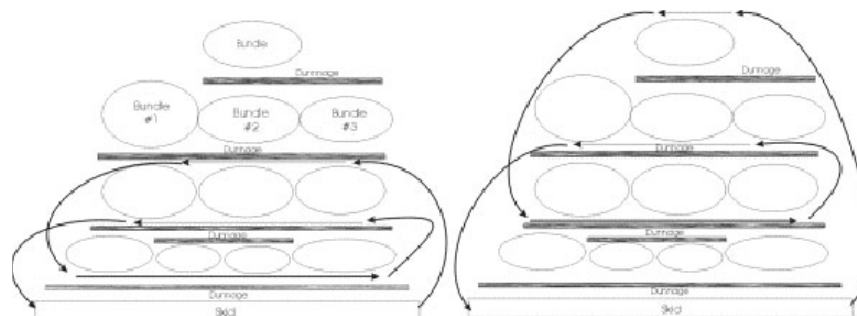
It was unknown how the dunnage for the single bundle on the fourth (highest) tier of the front pile was positioned before the incident. However, because bundle #1 on the third tier was larger than bundle #2 and #3 (Figure 2), it was surmised that dunnage was placed across bundle #2 and bundle #3. When bundles could not be matched to form a level surface, the dunnage would rest on top of the bundles at an angle. The bundles were then arranged in a manner that allowed the dunnage supporting an upper tier to compensate for the angle of the dunnage supporting a lower tier (Figure 3).

**Figure 2. Diagrams of straps used to secure front pile to the skid, viewed from the front of the trailer.**

Note: Straps as shown in Figure 2a. and 2b. were placed near each end of the piles.

When securing the load to the skid, tiers were normally tied down in pairs. In this case, the first and second tiers of the front pile were strapped as a single unit to the skid (Figure 2). Starting 1 to 2 feet from one end of the pile, the tiedown strap was looped over the second tier, under the first tier, and then back between the tiers. This process was repeated with a second strap placed 1 to 2 feet from the other end of the pile and then with two bands for the second and third tiers. Since the fourth tier consisted of a single bundle, it was included with the tier below it. The straps were  $\frac{1}{3}$ -inch wide metal bands. The entire load was then covered with a blue tarp that was attached to the front and back corners of the skid. Two metal bands were placed over the tarp to secure it.

The victim proceeded to cut bands securing the upper tiers of the front pile to the skid (leaving only the bands securing the lower tiers to the skid and the tarp in the center of the front bundles). Bundle #3 (Figure 2) from the third tier either-1) shifted and slid off the dunnage or 2) was pushed off when the top bundle collapsed between bundles #1 and #2 on the third tier. The front end of the bundle slid down as the front band was cut. It then slid out from under the band securing the tarp and fell approximately 10 feet to the ground. The victim was struck-by the bundle as it fell, trapping him under the pipes.
