## Drill Operator Crushed Between Drill Rig and Transport Vehicle

## **Fatality Assessment and Control Evaluation (FACE) Project**

**FACE 99AK012**

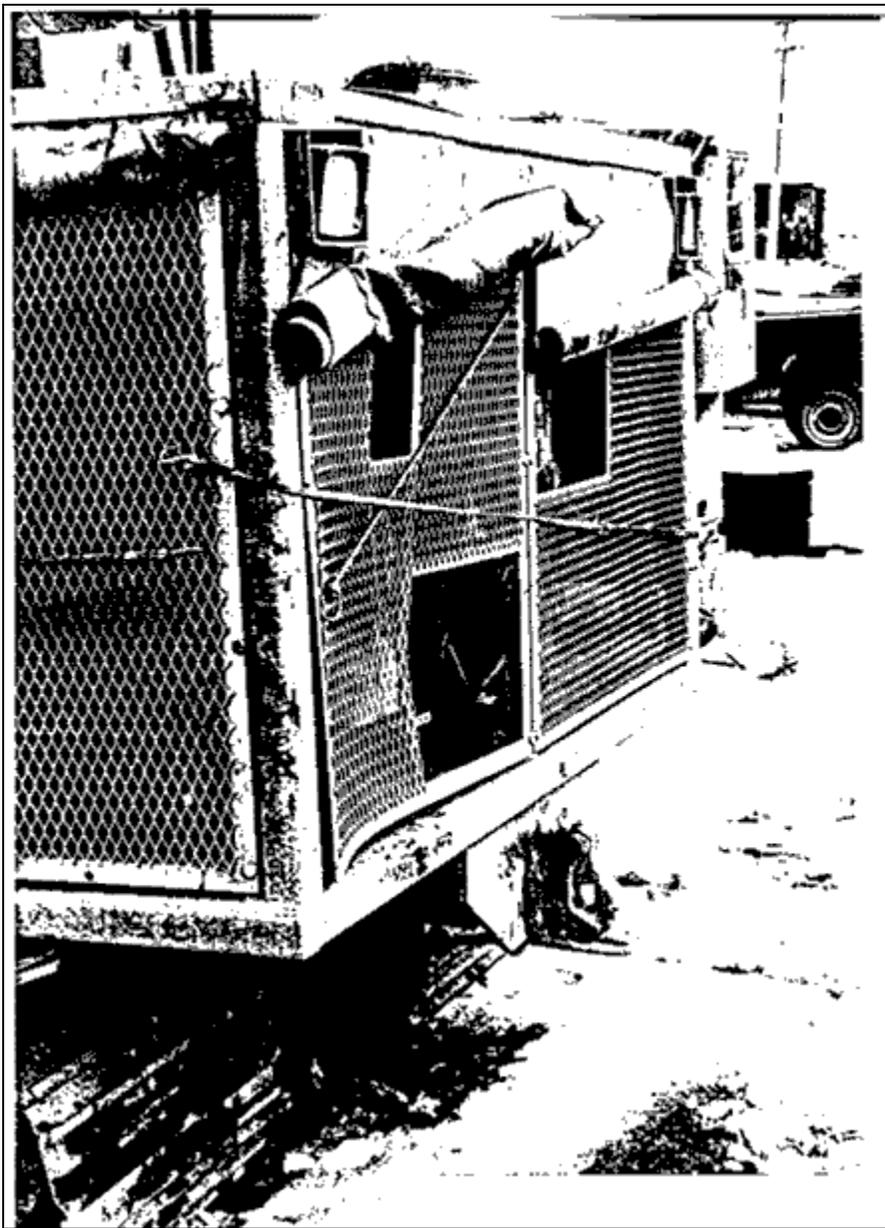
The drill rig and the rear transport vehicle were owned by the company, however the middle vehicle was leased by the contractor from a local mineral exploration company. The three vehicles were two-tracked (having body-length track on both sides). Deck height (from the ground) was approximately 40 inches. The drill rig had a front operator's compartment and an engine in the rear of the unit. The housing around the engine compartment consisted of a steel frame with steel mesh panels. A pintle hook was attached to the rear of the frame rail (Figure 1).

**Figure 1. Impact area on engine compartment door of drill rig, viewed from rear left side.**

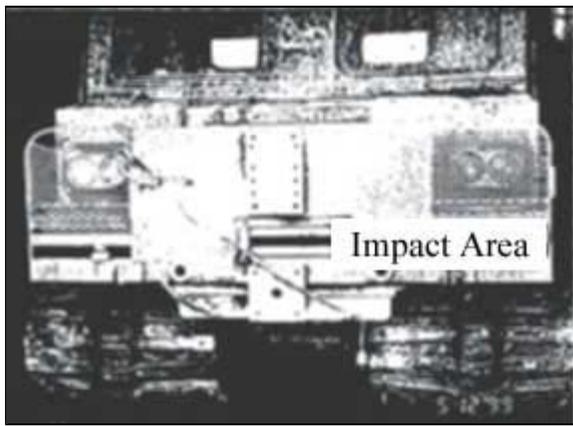
**Figure 2a. Impact area on debris guard transport vehicle.**

The victim was standing between the vehicles directing the witness and trying to attach the D-ring to the pintle hook. On the first attempt, the witness moved the transport vehicle close to the rear of the drill rig and put on the brakes. The victim tried to attach the cable to the drill rig but was unable to connect the vehicles. Due to a slight slope and slackness of the tracks when the transport vehicle was stopped it rolled away from the drill rig. A second attempt was made; this time the victim instructed the witness to place the vehicle in neutral when stopping. The second attempt was unsuccessful. During both the first and second attempts, the victim jumped from between the vehicles towards the center of the road to avoid being crushed. On the third attempt, the victim again positioned himself between the two vehicles as the witness inched the transport vehicle forward. The victim was crushed between the two vehicles.

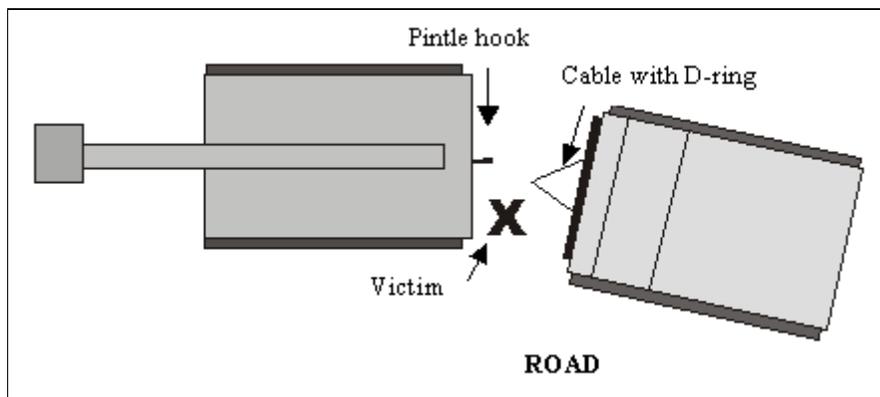
**Figure 3. Aerial view of drill rig and transport vehicle (Not to scale)**

The two vehicles were oriented at an approximate 10° angle and aligned with the left front of the transport vehicle behind and slightly to the left of the left rear corner of the rig (Figure 3). As the witness moved the transport vehicle forward, the right side of the transport rig was behind the left side of the drill rig.
