## **Laborer/rigger electrocuted during an aerial lift of equipment**

**FACE 99-AK-011**

**Release Date: January 24, 2000**

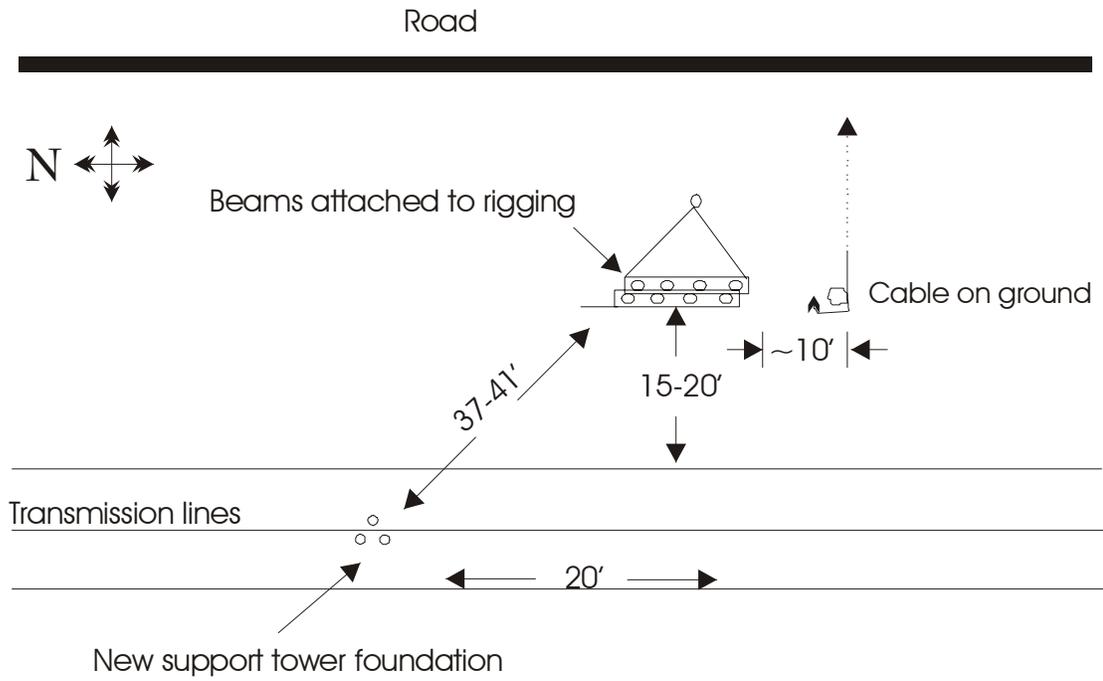
Figure 1. Diagram of staging area (Not to scale)

On the day of the incident, hotline orders were in use. The victim and his co-worker (the witness) had completed the tests and were ready to transport the beams to the next site. Each beam weighed approximately 250 pounds and could be moved short distances by the crew. The staging area for the aerial lift was located approximately 37-41 feet southeast of the new foundation; this was approximately 15-20 feet east of the nearest transmission line (Figure 1). Using a two-way radio located in a truck parked on the road near the new foundation site, the

*Discussion:* In this incident, an aerial lift was being conducted 15 to 20 feet away from energized transmission lines. While the company had a policy regarding aerial lifts inside of the 20-foot safety zone, workers were unsure of the exact distance from the lines. Before aerial lifts are performed, staging areas should be clearly marked on the ground for reference by the air and ground crews. Employers should ensure that workers understand and follow established safe work procedures. When a 20-foot zone cannot be maintained during an aerial lift due to wind or other factors, ground crews should notify their supervisor so that the site can be reassessed to ensure that work is performed without any undue risk to the helicopter crew or ground crew.

**Recommendation #1: Employers should ensure that all aerial lift staging areas are located outside of a 20-foot safety zone around overhead power lines and are clearly marked.**

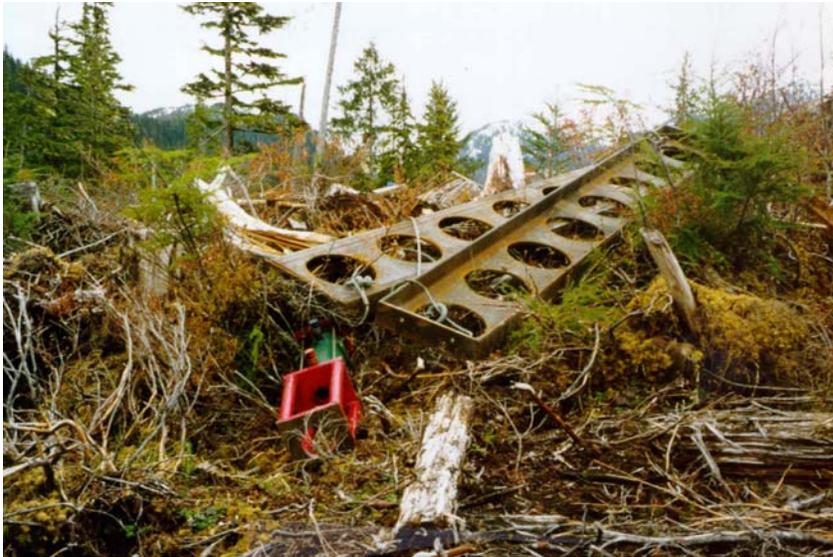
Figure 3. Steel beams with attached rigging

The test crew was responsible for conducting load tests on guy anchors and tripod legs at new support tower sites. Test equipment included two 1½-foot by 12-foot steel beams (Figure 3). During the load test, the beams were used as the equipment base as the reinforcing bar (rebar) anchor was pull-tested. The beams were airlifted by helicopter to each newly completed foundation site.

a series of cracks, turned, and saw sparks coming from the beams. The victim stepped either off of or away from the beams, staggered, and collapsed to the ground. The witness waited until the helicopter moved away with the load before going to assist the victim. Getting no response, the witness ran to the truck to radio for help. Emergency medical services were notified at 2:53 p.m.

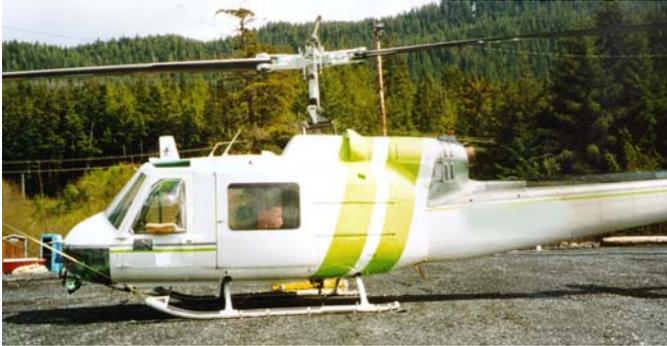
Figure 3a. Bell UH-1B helicopter with cargo hook

A non-retractable cable was attached to a cargo hook on the belly of the helicopter. The cable was 111 feet long and composed of steel wire with a protective cover. Upon arrival at the test site, the pilot hovered the helicopter near the staging area, nose into the wind. The pilot estimated a wind direction to be at approximately 45° angle to the transmission lines, from the southeast. This position enabled the pilot to view the activity on the ground through the bubble window on the left door of the helicopter and the transmission lines in front of the helicopter through the front windshield. The pilot then lowered the helicopter to place the load hook and 5-7 feet of cable on the ground, approximately 10 feet south of the load (Figure 1). The industry practice was to ground the cable, by placing several feet of cable on the ground, prior to it being touched by the ground crew.

Simultaneously, the pilot saw a flash of light and the co-pilot heard a crack. (During post-incident examination of the cable, four melt/burn points were found between 38 and 41 feet from the load hook end of the cable.) Since the pilot had not actually begun to lift the load, there was slack in the cable. (The amount of slack was unknown. However, if the helicopter was 90 feet above the ground, the cable could have had 21 feet of slack.) The pilot pulled away from the transmission lines, lifting the beams. He dropped the beams approximately 20 feet north of the staging area, and then landed the helicopter. The pilot exited the helicopter and went to check the victim's condition. The co-pilot took command of the helicopter and went to get an emergency medical technician (EMT) employed by the company.

**Recommendation #7: Employers should consider using non-conductive cables when airlifting loads near overhead power lines.**

*Discussion:* Employers should investigate use of non-conductive synthetic cable instead of wire cable when conducting lifts near energized transmission lines. This type of cable can be used for heavy-duty work and significantly lowers the risk of electrical shock to workers.

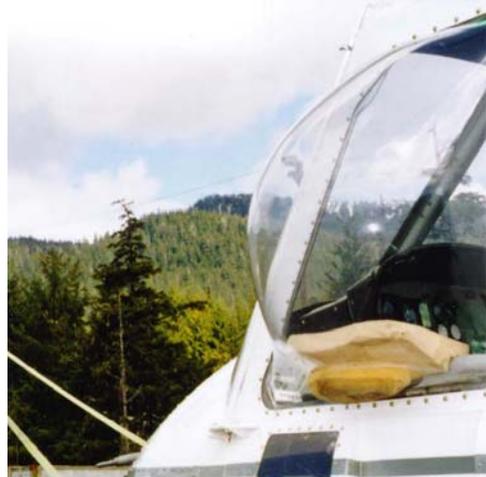
Figure 3b. Bubble window on left door

The pilot estimated his altitude at approximately 90 feet above the staging area. Although the pilot was able to view the cable grounding area and the witness picking up the hook, neither the pilot nor the co-pilot could see the load or the victim who was holding the rigging cables. After the hook was attached to the rigging, the witness turned away from the victim and moved away from the load and the area underneath the helicopter. He had taken several steps when he heard
