## **Logger and logging supervisor killed by uprooted tree**

**FACE 00-AK-024**

**Release Date: November 1, 2001**

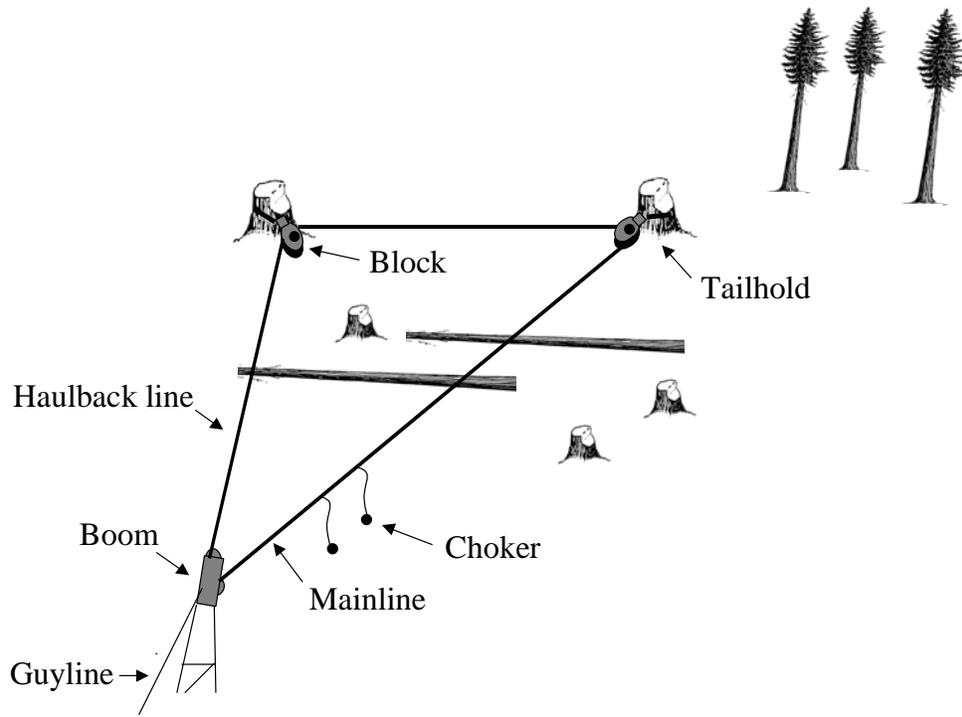
Figure 1. Schematic of cable yarding system (Not to scale)

The company used a cable yarding system to partially lift and/or drag (skid) logs from their felled location to a landing area. The system was made up of a single cable that was drawn from a crane, through two blocks, and back to the crane. The layout was usually triangular in shape, with the crane as the apex, and the mainline and haulback line composing the sides of the triangle (Figure 1). These lines were of relatively equal length to equalize the stress placed on them. The base of these triangular logging systems was typically shorter than the sides. The system required a minimum of three anchors: two for the lines and one for the yarder. Stumps used for anchorage were selected for their ability to withstand stresses or pull of the yarding lines. Secure anchors are essential in any arrangement to ensure that the stresses on the lines and boom are shared. In this arrangement, the boom of the crane was supported by a single guyline. This line also needed to be positioned to counter the force from the mainline and haulback line.

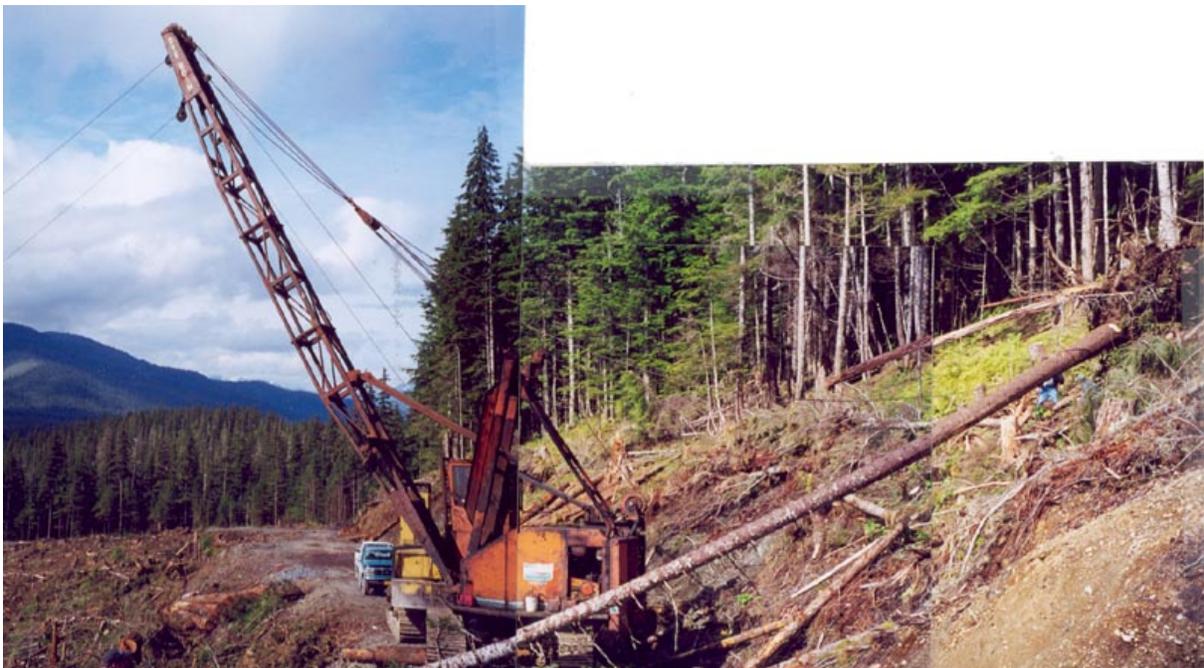
Figure 2. View of swing yarder on access road

The company used a mobile swing yarder (Figure 2). The unit has two sections. The bottom section is a crawler (tracked) base. The upper section of the yarder consists of an operator compartment, a lattice boom crane, and a counterweight on a turntable mount (verses a fixed mount), which allows the upper section to pivot or "swing" 360 degrees on its base. The yarder had been in-service for 6-8 weeks before the incident. While the yarder was not used
