Pipefitter dies from 40-foot fall

**Alaska Occupational Injury Prevention Program
Section of Epidemiology
PO Box 240249
Anchorage, AK 99524-0249
Phone (907) 269-8000
FACE 98AK027**

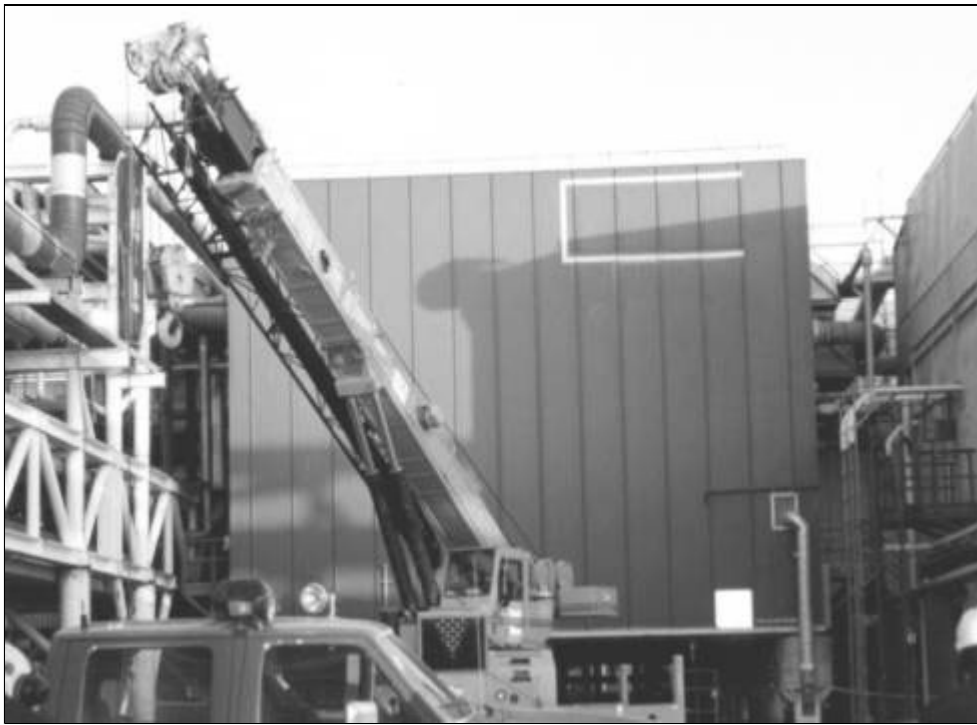
Figure 1. View of building and surrounding structures.

The building involved in the incident was 42 feet wide, 24 feet long, and 32 feet tall. The building was set on top of 8-foot pilings. The roof had a 4½ x 12 pitch. Total height from the roof to the ground was 40 feet at the edge and nearly 45 feet at the peak. Exterior surfaces including the roof were covered with overlapping metal sheets that were bolted in place. The 5/8 inch bolt heads were not flush with the metal surface and extended approximately ¼ to 3/8 inch above the surface (Figures 1 and 2).

Caption: The scaffold was located on the opposite side of the building. The lower section of the building that includes the 8-foot pilings is not in view.

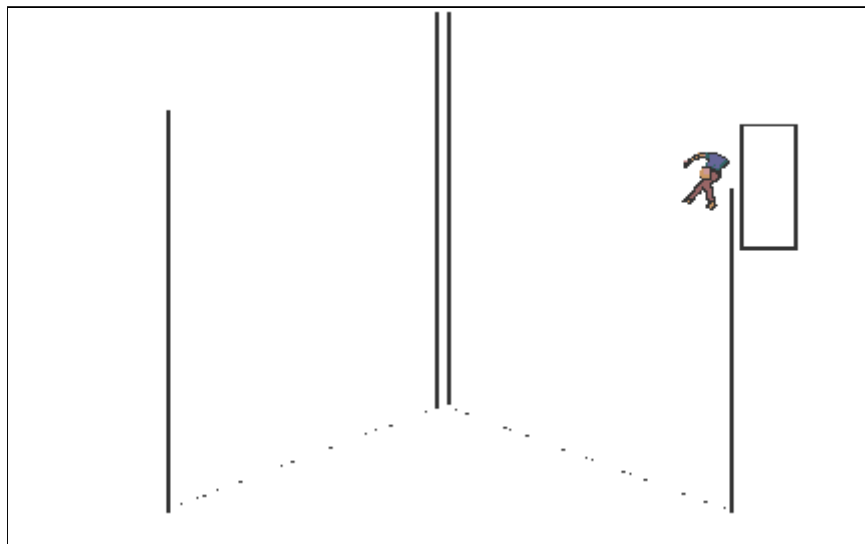
Figure 4. Diagram of roof and scaffold (not to scale)

The lift began without complication. As the tri-tool case neared the scaffold, the victim instructed the crane operator to stop. The case was suspended approximately 10 feet in the air above the scaffold. The victim instructed the crane operator to move left. When the operator did not respond, the victim repeated his instruction and then attempted to check the radio function by adjusting the controls. At 11:05 AM, the crewmembers observed the victim climbing the roof. They assumed that the victim was going to attempt to visually signal the crane operator from the peak. As the victim neared the peak, one crewmember (the witness) saw him pitch forward and fall over the peak. The witness could not tell if the victim lost his footing due to a slip or if the victim tripped, possibly on a bolt head. The victim appeared to try to twist around to grab the roof cap and then slid down the opposite side of the roof, falling 40 feet from the roof edge to the ground (Figure 4).
