Scrap metal cutter dies from injuries sustained in storage tank explosion

FACE 98-AK-021

Release Date: January 11, 1999

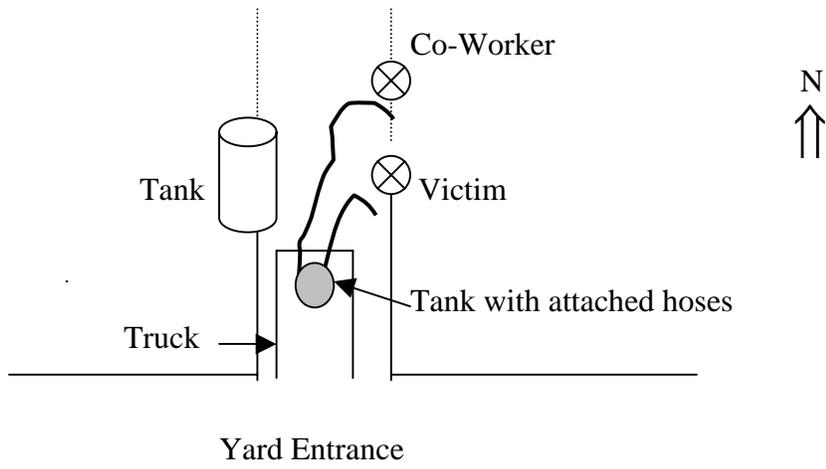
On the third morning, the victim and his co-worker (the witness) were told by their foreman to unload the flatbed truck. The foreman cautioned them to unload the tank an "adequate distance" from the hot work areas and not to cut the tank. After the victim and the witness determined that the tank was empty, they manually rolled the tank off the truck. They did not notice any fumes while unloading the truck. The tank was located 20 to 30 feet from the yard entrance on the west side of the driveway (Figure 1). Its exact orientation was unknown. Although it was on its side, the evidence suggested that the openings, a port and a vent, were near the ground.

Figure 1. Diagram of yard area before the explosion (not to scale)

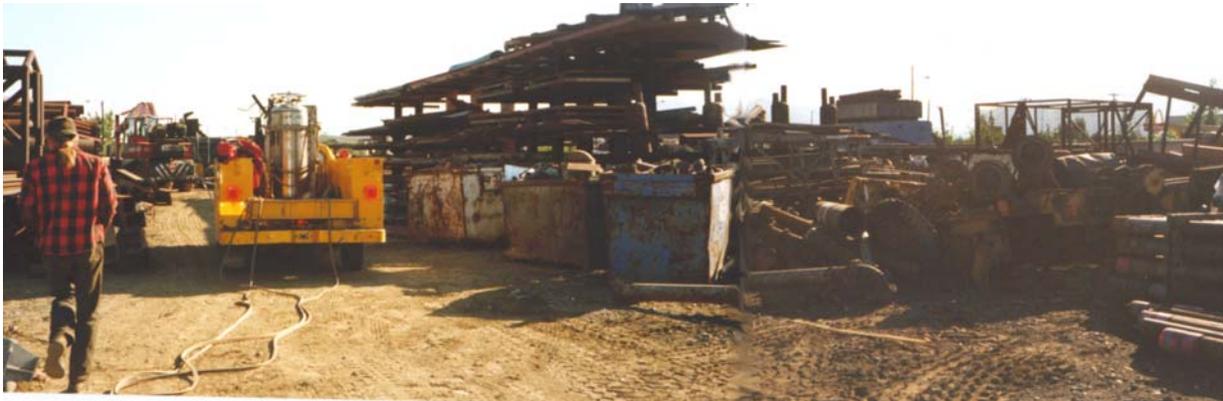
Figure 2. Work area, looking to the north
