Laborer dies from crush injuries when he was struck-by a suspended overhaul ball

FACE 97-AK-033

Release Date: December 15, 1997

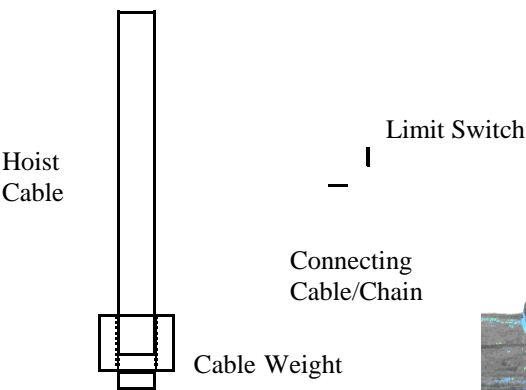
Figure 2. Anti-Two-Blocking Device

the trailers to or worked at the dock. The crane operator had 20 years experience in crane operation including approximately 6 months with mobile hydraulic cranes. Prior to beginning lifting, the operator had completed a “walkaround” visual inspection of the crane. A written inspection worksheet was not used at that time. Anti-two-blocking devices were installed on the crane, however they were not required for operation of this particular unit and had not been inspected during the walkaround. During inspection after the incident, the devices were found to be missing parts and not capable of functioning as designed.

“Two-blocking” is a term used to describe contact between the hook block (or overhaul ball) and the boom nose. Two-blocking will occur if the hook block or overhaul ball is pulled into the boom nose by the operating hoist. Alternatively, two-blocking can be caused by either extending the boom or lowering the boom if the hook block or overhaul ball is already close to the boom nose and cable is not simultaneously let out. An anti-two-blocking device is an “operational aid” to help prevent contact between these components. The devices on this unit were closed circuit sensors consisting of weights and limit switches. Typically, the devices consist of weights fastened around each cable below the boom nose and suspended from the limit switch by a cable or chain. While the weight remained suspended, allowing the cable to pass freely through the weight, it maintained a closed circuit (Figure 2). The circuit opened when the block or ball rose to a position to support the weight, activating an audible alarm and warning light. Crane actions of hoist up, boom extension, and boom lowering are also halted. A bypass switch enabled the operator to override the automatic shutoff.

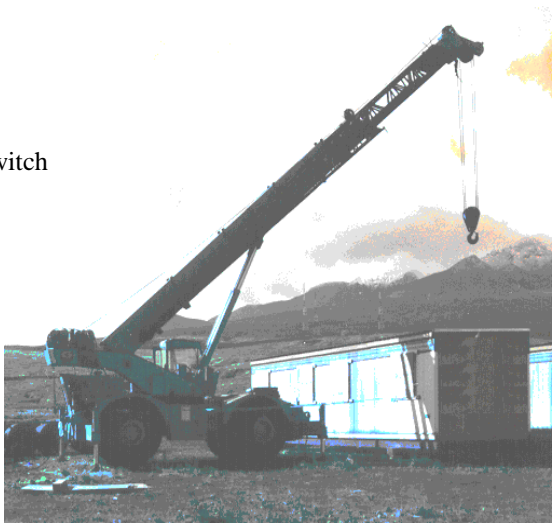
Figure 3. Height and Angle of Boom

Prior to the incident the victim and the crane operator had completed lifting and loading one trailer and had disconnected the rigging from the hook block. The crane was repositioned for lifting the next trailer. Outriggers were extended and the crane was checked to be level. The rigging, a four-point cable assembly attached to a spreader bar, remained on the ground and would later be attached to the hook block in order to lift and suspend the unit properly. The boom was raised to an approximate 40 degree angle. The boom nose was approximately 30 feet

from the ground (Figure 3). The hook block was positioned several inches from the ground and approximately 6 inches short of the “O” ring connecting the four-point cable assembly of the spreader bar. It was surmised the overhaul ball was near or in contact with the boom nose at this time. The operator extended the boom to correct the hook block position. As the hook block position was adjusted, the boom simultaneously extended under the stationary auxiliary hoist cable. The overhaul ball and cable were pulled towards the boom nose, contacting the whipline sheave (Figure 4). The cable was severed just above the cable connector for the overhaul ball.
