Logger killed while attempting to dislodge a previously felled tree with another tree

FACE 97-AK-027

Release Date: October 30, 1997

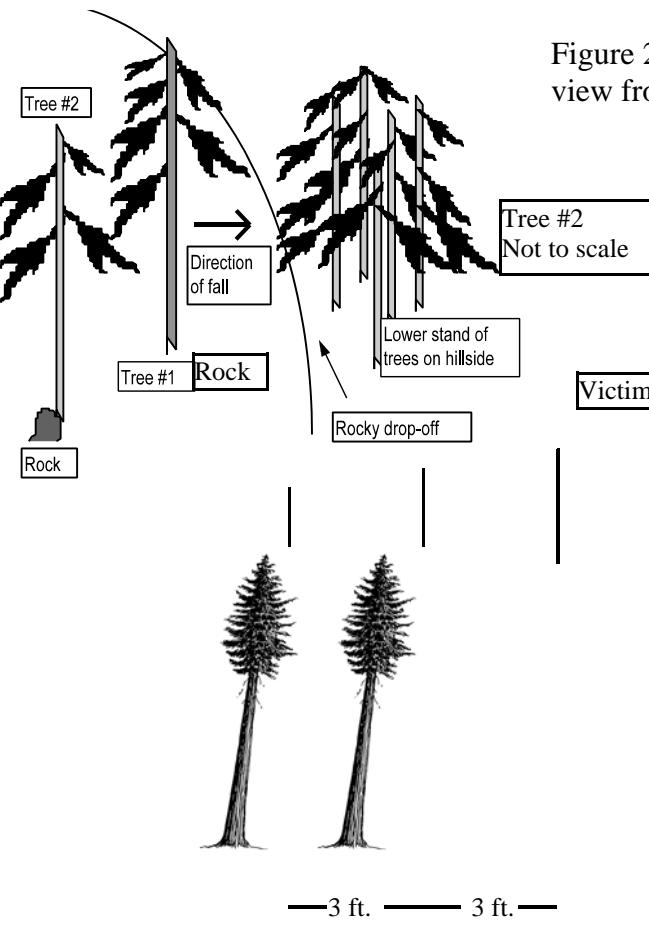
Since the incident was not witnessed, it was surmised from the evidence that the victim decided to fell trees as he descended the hillside from his original drop-off point to the planned pick-up location at the bottom of the hillside. The victim had felled Tree #1 from the top of a rocky drop-off in the direction of a lower stand of timber (Figure 1a). The tree became lodged as the branches arrested its fall through the stand. Now having a hazardous condition in his planned route, the victim then went to Tree #2 approximately 30 feet away and slightly below Tree #1.

Figure 1a. Aerial view of tree positions on hillside

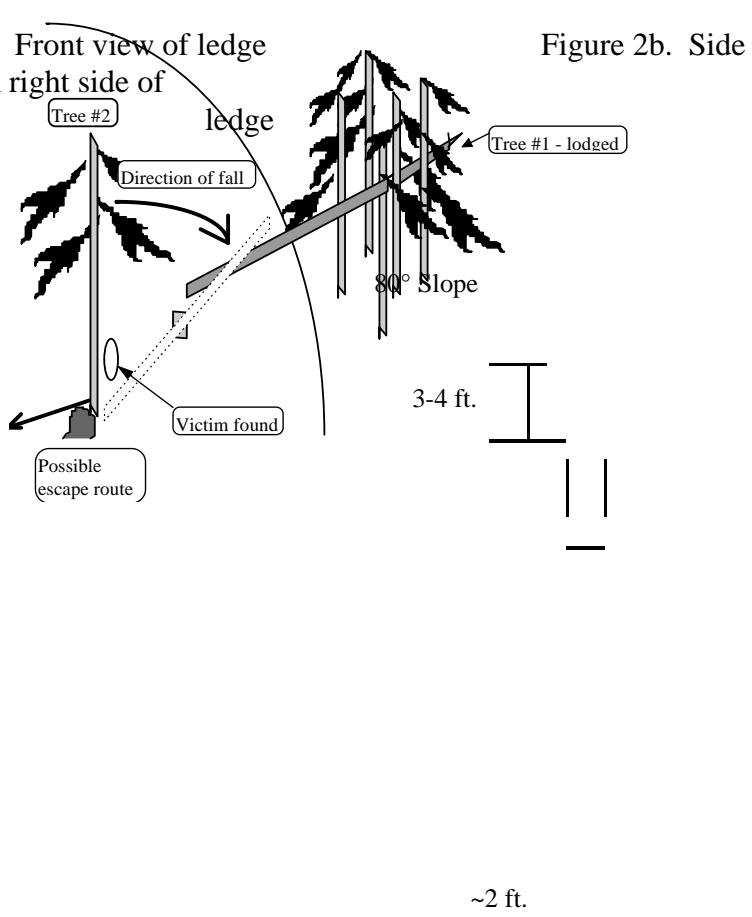
Upon completion of the cuts, Tree #2 fell and struck the lodged tree. However, the impact did not dislodge the tree. The trunk of Tree #1 acted as a pivot, allowing the butt of Tree #2 to rebound. The victim was struck as the butt descended and swung toward him as it continued to slide down the trunk of the lodged tree.

At approximately 2:30 PM, the victim had not yet arrived at the designated helicopter staging area for transport back to camp and was not responding to his radio. Co-workers, hiking back to the last spotted position, found the victim approximately 3 feet from the stump, pinned under the newly fallen log against the hillside. No pulse or signs of breathing were apparent. Emergency medical services were notified, and a medivac flight was dispatched from Ketchikan. The log was lifted by helicopter, at which time the victim slid down the slope. He was recovered, placed in a Stokes litter, and transported by helicopter to the main staging area where it was met by emergency medical technicians (EMTs). At 4:24 PM, the victim, having remained unresponsive and not exhibiting any vital signs, was pronounced dead at the scene.

Secondly, the victim did not clear an accessible escape route. However, the victim's position following the incident (Figure 1b) suggested the victim may have intended to escape from the ledge by climbing up the 3- to 4-foot, near-vertical incline. 29 CFR 1910.266(h)(2)(i) states "Before felling is started, the feller shall plan and clear a retreat path. The retreat path shall extend diagonally away from the expected felling line unless the employer demonstrates that such a retreat path poses a greater hazard than an alternative path. Once the backcut has been made the feller shall immediately move a safe distance away from the tree on the retreat path." Employers should ensure all cutters properly plan and clear an accessible route for escape opposite the direction of fall before initiating the cut.

Figure 1b. Position of victim relative to Trees #1 and #2

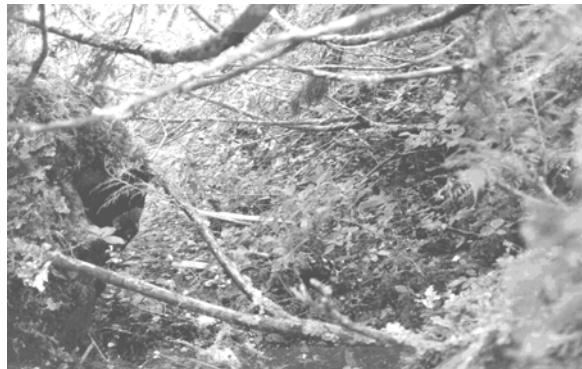
The location of Tree #2 was on the brink of a ledge, located 3 to 4 feet below a near-vertical incline (Figures 2a and 2b). As viewed from the front of the ledge, the ledge extended back approximately 2 feet and approximately 3 feet along the hillside to the right of Tree #2, tapering into the hillside. The ledge also extended to the left, approximately 3 feet, behind an adjacent rock and ended by merging into the natural slope. This area was wide enough to allow passage between the hillside and the rock but was partially obstructed by branches (Figure 3).

The victim made two standard cuts to fell Tree #2, a Humbolt undercut (a notch cut in the direction of the intended fall) and a backcut (the final cut on the opposing side) (Figure 4). Due to the close proximity of the rock, the victim positioned himself to the right of the tree to make the cuts (Figure 2a). This position placed the victim in the direction he intended the tree to fall (Figure 1b). An escape route was not apparent. Brush and branches in the immediate area had not been cleared (Figure 3).

Figure 3. View of unbrushed ledge
