FACE 97-AK-019

To: Ted Pettit, NIOSH, Division of Safety Research
From: Deborah Choromanski
Occupational Injury Prevention Program
Subject: A low bed trailer operator was crushed during a surface compactor tipover --
Alaska

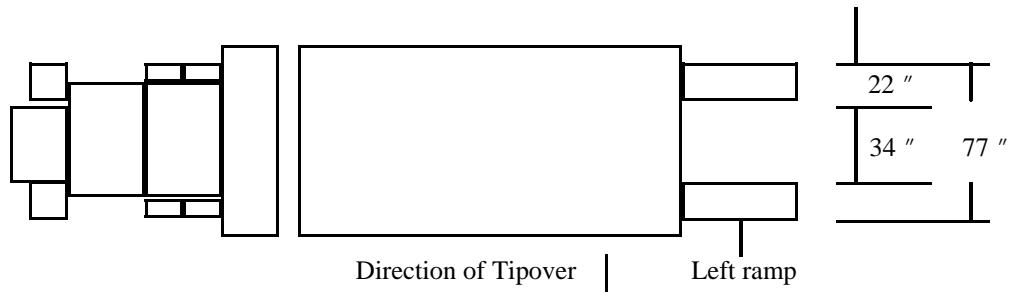
Figure 1. Aerial view of tilted trailer and ramps.

The terrain at the incident site was relatively level and had been graded in preparation for paving. The weather was cloudy without any noticeable precipitation. The trailer was a Dynaweld low bed trailer with adjustable ramps. In addition, the front of the trailer bed can be lifted to provide an extended, flat loading surface for equipment with minimal ground clearance (e.g., scrapers and pavers). The trailer length was approximately 25 feet. Each ramp was 22 inches wide and could be positioned to provide a minimum gap of approximately 34 inches between the ramps (Figure 1). Ramp height for the bed when tilted was 18 inches. The surfaces

Discussion: Although the trailer was equipped with horizontally adjustable ramps to accommodate various axle lengths, the maximum adjustment to narrow the gap between the ramps could not have provided adequate support to safely load and unload the compactor. However, the procedure used by the victim required him to maintain nearly a 9-inch overlap of the drum on each side of the single ramp. The drum width in this incident was 17.4 inches or 44% wider than the width of the ramp, increasing the risk of slippage off either side of the ramp as the compactor proceeded down the ramp. A trailer with adequate ramp surface should have been used for the transportation of this machine. In addition, the use of a spotter may have also provided additional assurance that positioning on the trailer ramps was maintained during loading and unloading of machinery.

Recommendation #2: Employers should ensure ramps used for loading and unloading equipment are an adequate width and trailers are appropriately positioned and level to minimize risk of rollover (tipover).

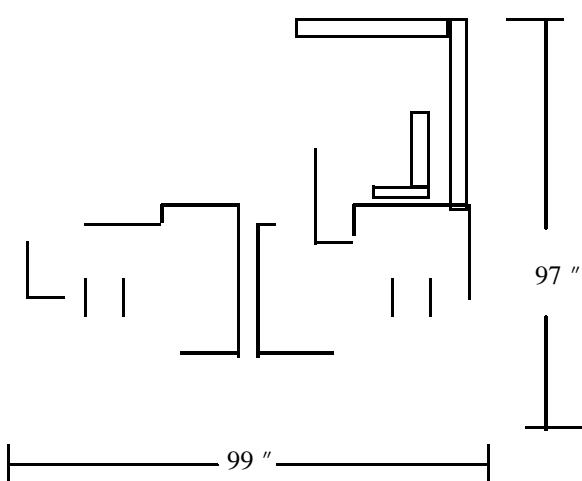
Figure 2a. Side view of compactor

The surface compactor involved in this incident was an Ingersoll-Rand vibrating compactor, model DD-22. The compactor was equipped with a manufacturer-installed ROPS. Total weight of the compactor with ROPS was 8630 pounds. The height from the ground to the top of the ROPS was 97 inches (Figure 2a). The drum width was 39 inches (Figure 2b).

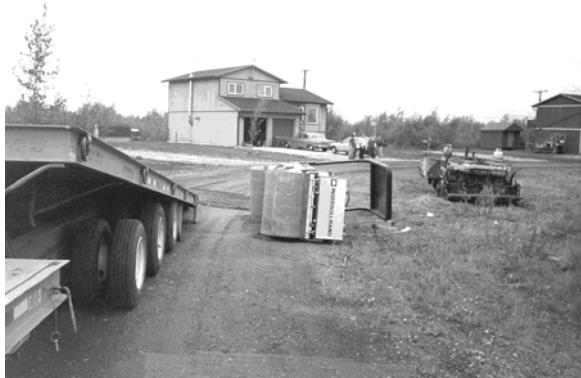
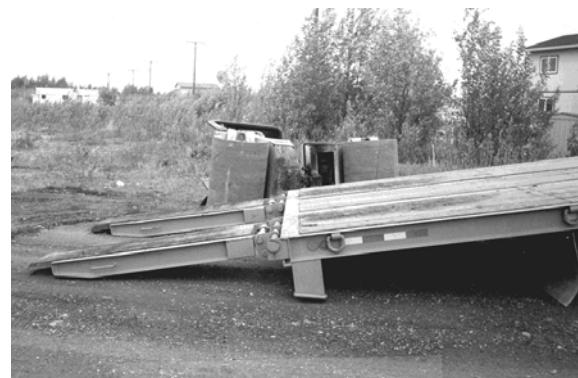
Figure 3. Position of compactor after tipover.

On the day of the incident, the compactor along with a paver were transported simultaneously to the work site via the low bed trailer. The victim, working alone as he normally did during the performance of his assignments, intended to unload the paver first, followed by the compactor. Having successfully unloaded the paver, the victim had begun to back the compactor down the left ramp (Figure 1). The rear drum proceeded down the ramp approximately 12 inches when the compactor became unstable and began to slide off the left edge of the ramp and tip. According to a neighborhood resident (the witness), the victim jumped from the compactor and trailer. After taking several steps away from the trailer, the victim turned to face the trailer and was struck by the ROPS as the compactor settled onto its side (Figure 3). The victim remained pinned between the ground and the ROPS. The witness immediately called 911. At 2:14 PM fire department and ambulance personnel arrived on the scene and began to extricate the victim. The victim was transported by ambulance to the nearest medical center and was listed in critical condition. The victim died later that evening from his injuries.

Recommendation #1: Employers should reinforce safe operation techniques including the function of the rollover protection structure.

Discussion: The General Duty Clause of the Occupational Safety and Health Act of 1970 states employees must comply with all occupational safety and health standards, rules, regulations and orders that apply to their own actions and conduct on the job. Although the victim was an experienced low bed operator and reportedly familiar with the safe operation of the compactor, he did not observe safety procedures which would likely have prevented this fatality. The surface compactor in this incident was well-marked with safety labels stating the hazards of rollover, the need to “BUCKLE UP” and stay belted while operating the machine, and “DO NOT JUMP IF THE MACHINE TIPS.” Employers may consider implementing a spot inspection program to ensure compliance with safety requirements and positive incentives for safe work practices by employees.
