**FACE AK-95-18**

**SUBJECT: Independent Contractor Dies in Boom Truck Roll-Over -- Alaska**

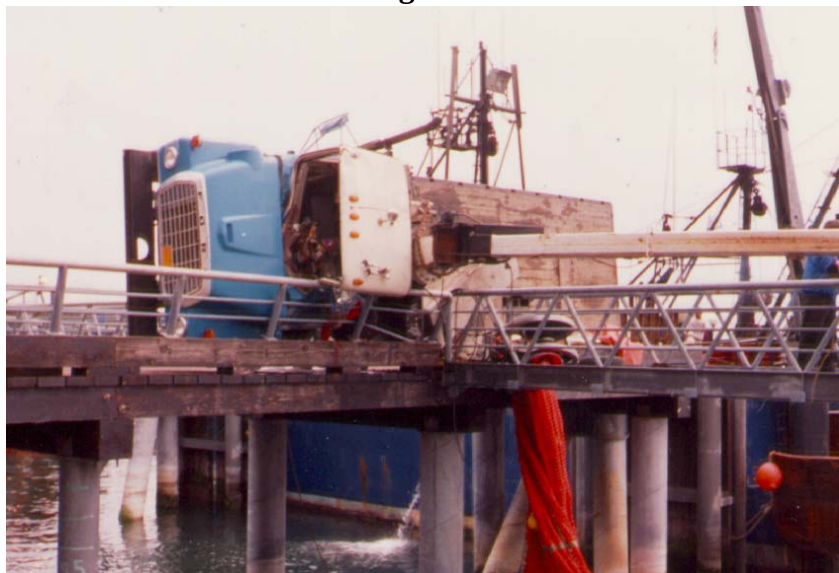
**Figure 1**

question was clear. This is significant in that the north end of the dock was more suitable for the operation being attempted. A larger area on this section of the dock was available that would have allowed full use of the boom truck stabilizing equipment. None-the-less, the operation was attempted without use of the vehicle's side outriggers. This resulted in dramatically reduced transverse stability.

Immediately before the incident, the operator moved the net from the dock toward the water to the right of the "finger pier". At this time the crane hook from the fishing vessel was attached to the net, but no tension had been applied by the ship's crane. The intent of the operation was to remove the net from the dock with the boom truck, and then move the net toward the vessel. When the vessel crew applied tension to the net from the ship's crane, the net was to be brought on board the vessel by the ship's crane and detached from the boom truck. The boom was at a steep angle and boomed out to full length at the time of the incident. A member of the vessel crew was standing on the rear of the truck bed, guiding the boom operator with hand signals. A witness indicated that the victim moved the boom toward the left instead of the right, and at that time the vehicle became unstable. The witness believed that the victim attempted to correct the boom movement, which resulted in the load beginning a pendulum motion. Another witness indicated that the victim, apparently realizing the truck was going to roll, attempted to get through the pier's metal railing as the truck rolled. Whether he fell from the truck or abandoned the truck is unknown. However, the victim was caught between the truck's left cab door and the steel railing. He received massive head injuries. Rescuers on the scene determined that the injuries were not survivable and emergency medical services were not instituted. See figure 1 below:

Recommendation #1: Employers and independent contractors should ensure that all crane or boom truck operators fully deploy outriggers and other stability-enhancing devices.

*Discussion:* The operator did not extend the side outriggers of the boom truck prior to attempting to move a 2-2.5 ton load. This resulted in decreased transverse stability and a highly enhanced tendency to roll under lateral loading. He was reportedly familiar with safe operation of boom trucks, but chose to operate the vehicle in this manner because of the pier’s narrow width. The boom truck had a boom loading chart in clear view of the operator. However, the maximum loads, boom extensions, and boom angles indicated on the chart would be of no value if the outriggers were not extended. The boom loading chart values are based on a vehicle set-up for correct operation.

Recommendation #2: Employers and independent contractors should ensure that all crane or boom truck operators use equipment on environmental surfaces conducive to proper operation, such as full extension of outriggers.

*Discussion:* The site chosen for this operation did not allow for the extension of the boom truck’s side outriggers. The “finger pier” was of an inadequate width to allow such extension. This operation should not have been attempted in this environmental setting. The north end of the dock was suitable for the operation, because the physical area of this section of the dock would have allowed full outrigger extension. Space was available to moor the vessel at this part of the dock. Dock policies should be re-evaluated and rewritten to allow flexibility in berthing assignments. No unloading or loading operation requiring the use of cranes or boom trucks should be authorized on the “finger pier” of the dock.
