## MIFACE Investigation #01MI064

**Subject: Restaurant Maintenance Worker Wedged between Sump Pump Pipe Support Bar and Sump Pump Crock Rim**

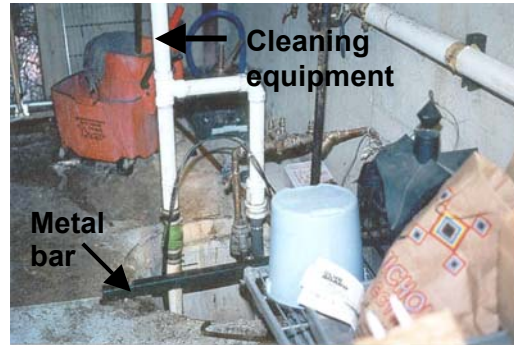
On March 18, 2001, a 54-year old restaurant maintenance worker died of asphyxiation when he became wedged between a metal support bar for sump pump piping and the rim of the sump pump crock. The uncovered sump pump was located in a storage area behind a row of refrigerators in the restaurant basement. The victim used the storage area as an area to hang his coat. After punching out, the victim went downstairs to retrieve his coat. The victim's coat pocket may have contained several pieces of jewelry. The owner thinks that some jewelry may have fallen out of his coat pocket while he was putting on his coat and/or getting car keys. The victim may have thought that some jewelry fell into the open sump pump crock and he attempted to retrieve the jewelry. During the retrieval process, the victim became pinned between the metal support pipe and the sump pump well rim. Another restaurant employee found the victim and called the restaurant co-owner. The co-owner called 911. The victim was found bent at the waist, headfirst in the sump crock with his head in the water. Rescue workers used a reciprocating saw to cut the metal support to free the victim. The victim was pronounced dead at the scene.

The sump pump was located in a 12'x5' storage area behind a row of refrigerators in the basement. The sump pump handles effluent from the refrigerators as well as any peripheral building drainage; the design was a standard basement commercial sump pump. The sump was approximately 6" away from the wall. The crock diameter was approximately 23". The crock had a "lip" of approximately 4 1/2"; the total crock diameter was 28". The crock was approximately 3 1/2 feet deep. The sump pump had one PVC pipe and one copper pipe that carried condensation from the downstairs storage area refrigeration units. Also across the opening of the sump pump was a singular 2 1/4" plastic pipe. The sump pump piping was stabilized by an 1 1/2" metal bar bolted to the cement floor. The sump pump has a high water sensor that signals an alarm when the water rises above the sensor. The restaurant has a keypad at the top of the basement stairs that beeps when the sensor is activated and an external alarm monitoring company is alerted. The sump pump back up system is not electrical.

On the day of the MIFACE investigation, standing water in the crock was approximately 1 foot deep, which according to the owner, was a normal level. On the day of the site visit, the sump crock was uncovered and cleaning equipment was stored in the storage area. The co-owner stated that sometimes a metal grate was placed over the front of the sump crock, but it was not there on the day of the incident.

- Employers should evaluate the workplace to identify any confined spaces and develop and enforce written work procedures for entry into these areas.
- Employers should cover sump crock openings with a solid cover to prevent items and/or people from falling into the sump pump area.
- Employers should develop and enforce written work procedures, including general electrical safety-related work practices.
