## **MIFACE INVESTIGATION: #03MI202**

### **SUBJECT: Farmer Died When Crushed Between Tractor Steering Wheel and Enclosed Feed Auger**

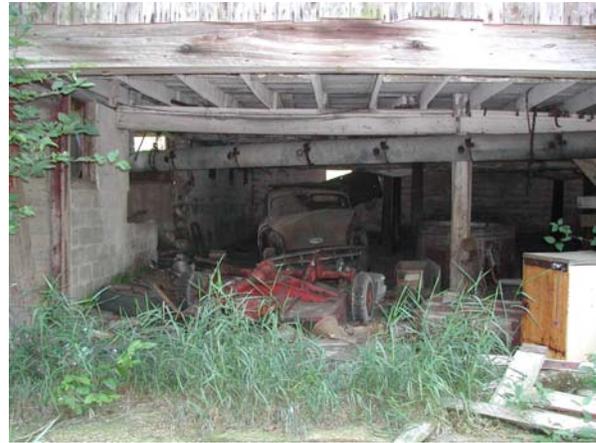
Figure 1. Storage area in barn for rotary mower

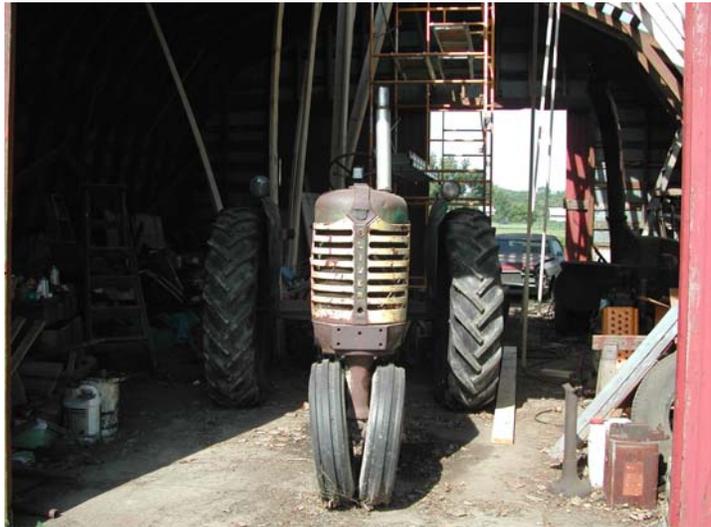
The victim had purchased the diesel Oliver Super 77 tricycle tractor in 1954. (See Figure 2) The victim took care of the everyday tractor maintenance and took the tractor to a local business for major work, such as engine problems. According to his son, the brakes and clutch were working properly at the time of the incident. The victim was very familiar with the tractor's operation, as this had been the tractor utilized for all of the farm work. It appears the tractor clutch pedal was worn smooth from over 49 years of use. The victim's son said the top forward speed for the tractor was 12 mph and that it had two reverse speeds. The distance from the ground to the top of the muffler was 87 inches. The height of the tractor seat was 63 inches from the ground.

Figure 2. Oliver Super 77 tractor involved in incident

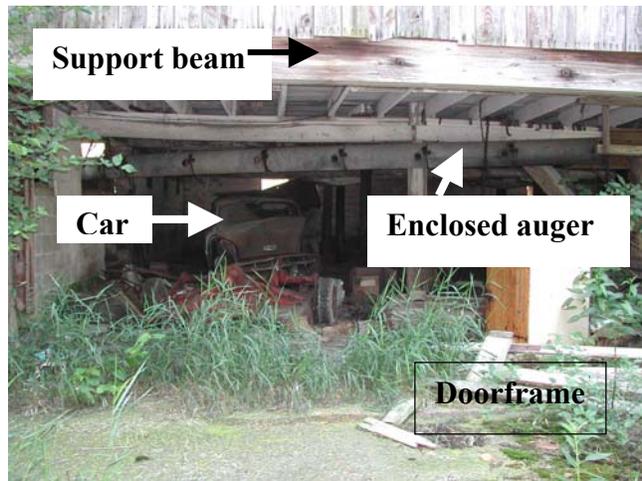
The barn where the victim stored the rotary mower was previously used for his dairy cows and beef cattle. The barn was located on the north side of his residence. The victim stored the rotary mower on the lower level of the barn. The lower level was open the length of the barn. The victim used only one area to store the mower. (See Figure 3) The barn's support beam was 82.5 inches from the ground to the bottom of the beam. Approximately 12-15 feet inside the barn was a round feed auger within in steel enclosure, running along the ceiling of the lower level. The auger enclosure was 71 inches above the ground at its lowest point. Behind the auger enclosure was an old car. On the ground under the barn's support beam was an old, broken doorframe that limited the victim's maneuvering room to a nine foot wide opening to back the rotary mower into the barn's lower level. The grassy area in Figure 3 is the location of a slight incline to enter the barn.

Figure 3. Enclosed auger, doorframe, car, support beam

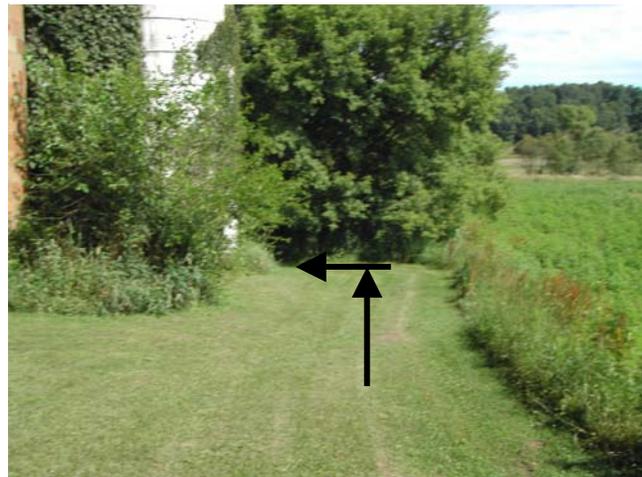
The victim appeared to follow his normal procedure to park the mower in the barn's lower level. The victim drove the tractor/rotary mower down a hill located on the east side of the barn and made a 90-degree turn to the west. (See Figure 4) The entrance to the lower level is on the victim's left. To be able to back the rotary mower into the barn, the victim turned the tractor 90-degrees to the north to an open area so the tractor/rotary mower was oriented in a north-south direction. This open area was approximately 30 feet long from edge of the open area to the barn entrance. (See Figure 5) The tractor was too tall to enter the barn (muffler was approximately 87 inches from the ground, the barn beam was approximately 82 inches from the ground). Therefore, the victim drove in reverse until only the rotary mower was in the barn. His son thought that the victim used visual cues to determine when the mower was within the barn. It is

Figure 4. Path down to barn entrance

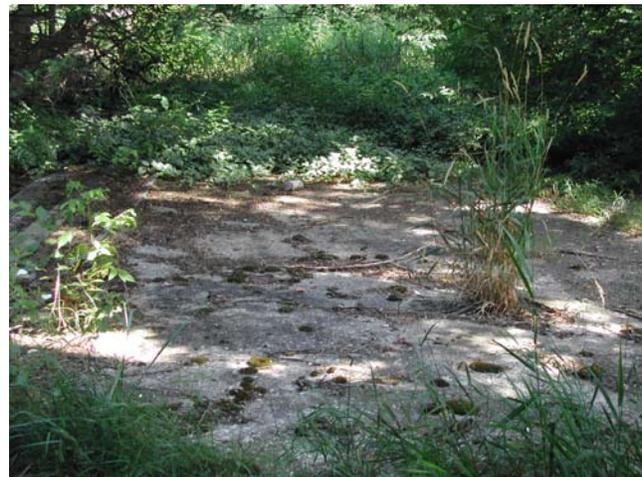
Figure 5. Open area in front of barn entrance

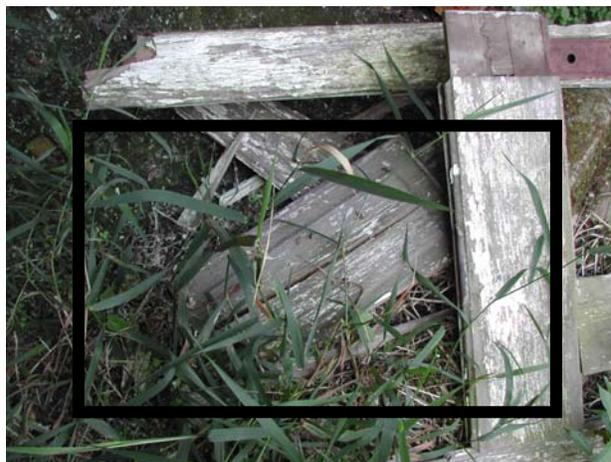
Figure 6. Cracked doorframe

The event was unwitnessed. The victim's son discussed with the MIFACE researchers what he thought had happened. The victim had successfully traveled to the lower level and oriented the tractor and rotary mower so that it could be put into storage in the barn. It's possible that the victim may not have oriented the tractor/mower in a "true" north/south position; he may have been backing in on an angle. Another scenario is that the victim was "too far west" in the open area when he positioned the tractor to back the mower into the barn. Either position caused him to run over the doorframe with the left rear tractor wheel, causing the tractor to elevate slightly.

The victim's son pointed out a cracked piece of the doorframe to support this scenario. (See Figure 6) Because this was unexpected, he lost track of his position. His foot may have been on the clutch at this time, since he was near the entrance. Unable to react quickly enough, the victim traveled too close to the barn beam and either was able to duck under the beam or he struck his head against the beam. His foot slipped off of the clutch and the tractor continued in reverse. The tractor muffler scraped the beam as the tractor went under it. (See Figure 7) As the tractor continued in reverse, the mower struck the car parked in the barn causing the mower to jackknife. The tractor continued moving in reverse, and the victim was pinned between the steering wheel and the auger casing. The mower was against the east wall. The tractor eventually stalled.

The broken doorframe limited the maneuvering room the victim had to park the cutter. Keeping storage areas clean, entrances and exits clear, properly storing tools, other items and equipment or materials in their proper storage area, and discarding broken containers and damaged materials are work practices that eliminates clutter and ultimately can reduce the risk of accidents, both to an individual and equipment.

- Keep floor areas where equipment is stored clear of objects that might impede the positioning of stored equipment.

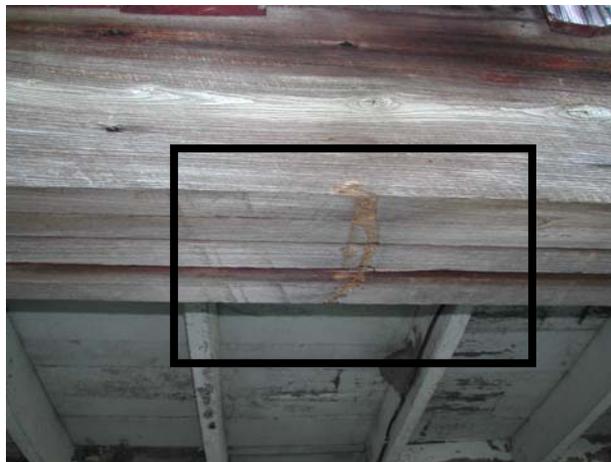
Figure 7. Mark on beam made by muffler

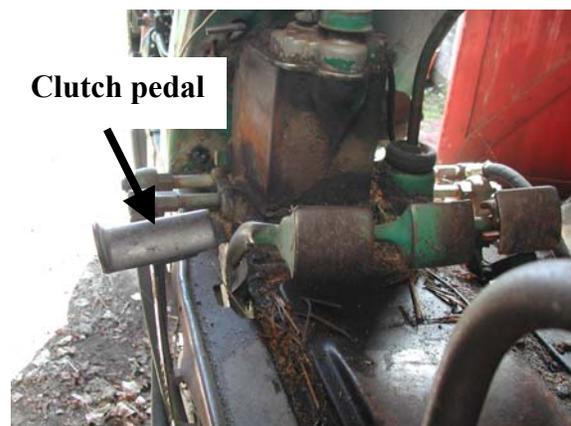
The operation of the Oliver Super 77 tractor clutch makes backing up potentially difficult because of the clutch pedal's relationship to the operator's seat and its lack of aggressive surface. (See Figure 8) A tractor operator's left foot may slip off of the clutch pedal while turning their body when traveling in reverse due to the lack of aggressive tread on the pedal. The tractor's clutch pedal was smooth and may have been a contributing factor in this fatal incident. Newer tractors have incorporated an aggressive surface and, over the years, modified the foot pedal design and placement to increase the operator's ability under routine and/or non-routine working conditions to initiate and maintain contact with the pedal. On older tractors, a possible solution to increase and maintain contact with the foot pedals is to "rough up" (i.e. crosshatch design) the pedal contact surface with a 4-inch portable grinder (See Figure 9). Addition of a non-slip surface, or a rubber pedal cover to the foot pedal surface is another option.

Figure 8. Oliver Super 77 clutch pedal

- Consider adding roughness to smooth clutch or brake pedals by using a 4-inch portable grinder or welding a bead of metal, or cover the pedal with a non-slip surface for added foot pedal control.

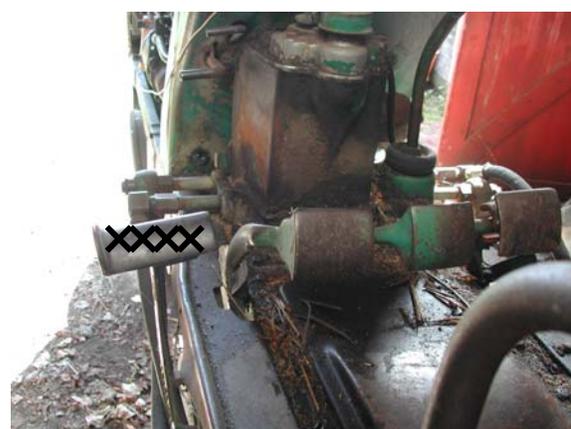
Figure 9. Crosshatch design on clutch pedal
