## **MIFACE INVESTIGATION: #03MI103**

### **SUBJECT: Farmer Dies When Tractor With Front-End Loader Overturns In Ditch and Pins Him**

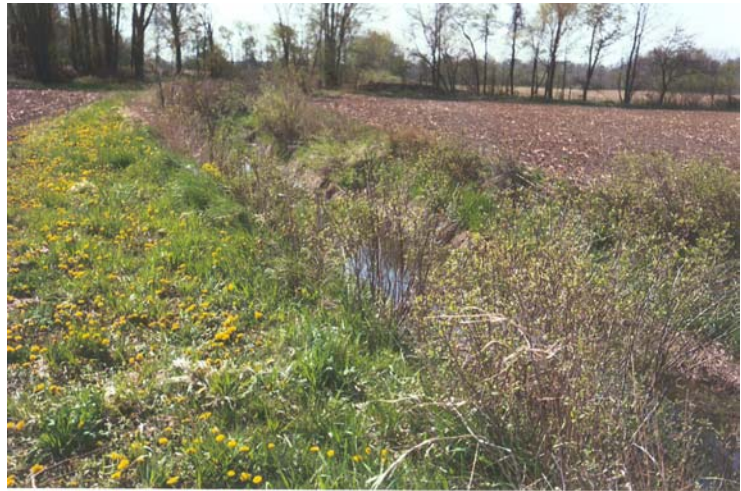
On July 28, 2003, a 77-year-old male farmer was driving a 1954 77 Oliver tractor equipped with a front-end loader with 12-inch bucket tines to a woodlot on his property. He was carrying a salvage flail mower chained to the loader. The tractor was not equipped with a roll-over protection structure (ROPS). He traveled east along a lane between his cornfields to the back of his property and made a right turn (south) around a 10-foot deep by 15-foot wide drainage ditch. There was a variable width path to the wood area on the east side of the ditch (See Figure 1). It

Figure 1. Access path/ditch leading to woodlot

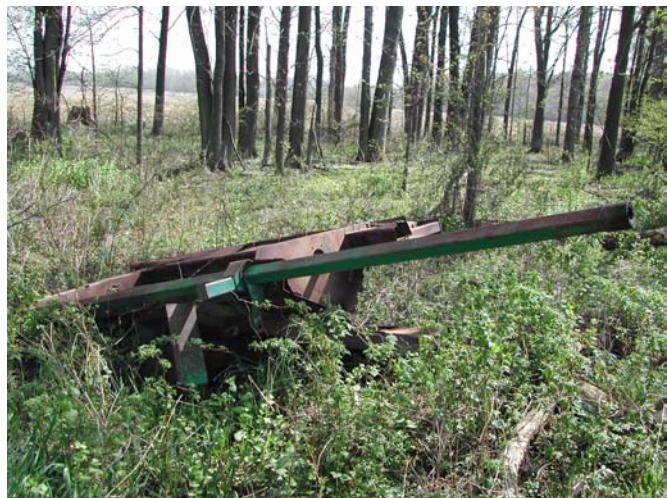
The victim had two flail choppers, one that he had salvaged for parts and one for use. Because of a fire on his property, he had lost the storage building for the choppers, and they were currently being stored where they could be seen behind the house. The victim wanted to move the salvage flail chopper to a remote location so that it would be out of sight. Therefore, he decided to take the salvage chopper to a woodlot at the rear of his property. MIFACE researchers measured the flail chopper dimensions during the visit; the chopper measured 17 feet 10 inches from front-to-back and seven feet wide.

Figure 2. Salvage flail mower in woodlot

MIFACE estimated the salvage flail mower to exceed 700 pounds (See Figure 2).

- Use equipment properly – front-end loader bucket isn't designed to carry a flail chopper.

Front-end loader buckets are not designed for carrying the large and heavy pieces of equipment, such as the flail chopper. Although a manual for the flail chopper was unavailable, the chopper's size and weight was close to exceeding the capacity of the tractor and made the tractor unstable even though the victim was driving slowly. It is unknown if the victim set the tractor wheels at the widest recommended setting, since a manual was also not available for the tractor and MIFACE was not able to see the tractor. The victim's wife indicated she did not think that extra ballast was added to the rear of the tractor to give the tractor extra stability. The ballast would counterbalance the extra weight on the front of the tractor and help prevent an overturn. Additionally, overloading a front-end loader on a tractor can cause instability and steering difficulty.

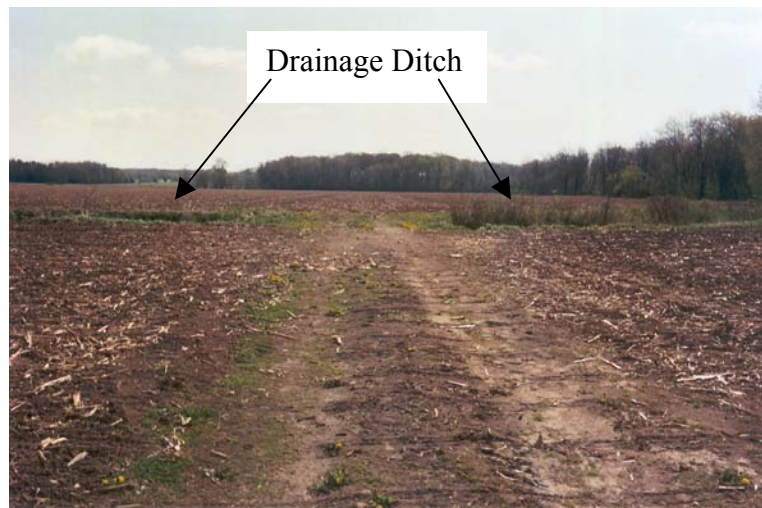
Figures 3-5 show the path he drove to the woodlot. Before transporting the flail chopper to the woodlot, he chained the chopper to the front-end loader/tines. He traveled down a wide lane between cornfields. This lane terminated into a cornfield and the woodlot was to the operator's right. The drainage ditch was to the victim's right and left.

Figure 3. Access lane between cornfields

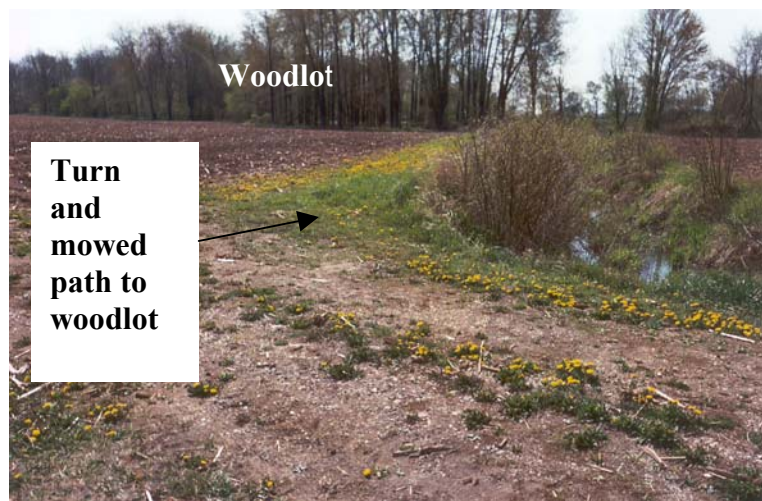
Figure 4. Lane ending at cornfield and turn to woodlot

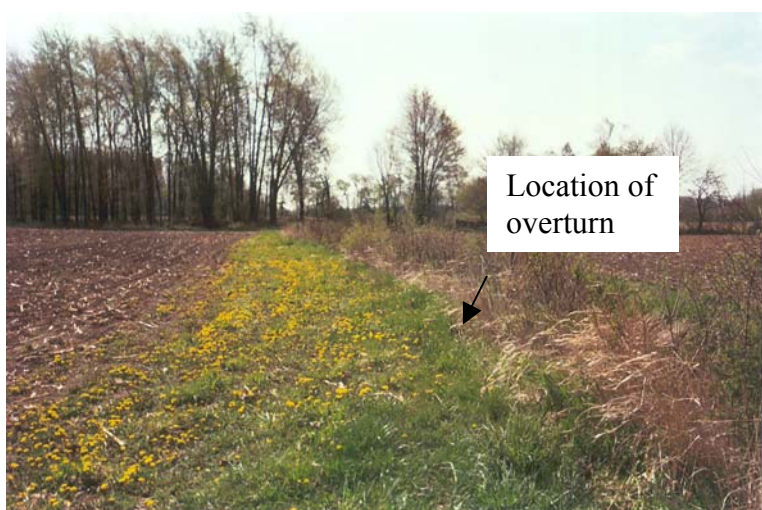
There was a mowed path that directly abutted another cornfield. This mowed path led to the woodlot. This path narrowed as it approached the woods. It was approximately 6-7 feet wide as it entered the woodlot. The distance from the planting row to the edge of the mowed path was approximately seven inches. The victim's wife thought that this was similarly planted at the time of her husband's death.

The victim successfully completed the turn to take the path to the woodlot. After traveling approximately 150 feet, it appears that he was too close to the edge of the ditch. The path was approximately 12-feet wide at this point. The police report stated that tire tracks in the grass showed that shortly after the victim made the turn south on the lane he slowly

Figure 5. Mowed path to woodlot

drove the tractor closer and closer to the edge of the ditch until the tractor slipped down the embankment and rolled over landing on top of the victim at the bottom of the ditch.

- Establish crop- planting limits/boundaries to maintain farm machine access roads to other fields/areas.

the maneuvering room the victim had to travel to the woodlot due to the presence of the growing corn plants along the outside planting row. A planting boundary should be established so that the outside planting row does not impinge on an access road to other fields/areas.
