# **MIFACE INVESTIGATION: #03MI098**

## **SUBJECT: Farmer Dies When Pinned by Flail Mower**

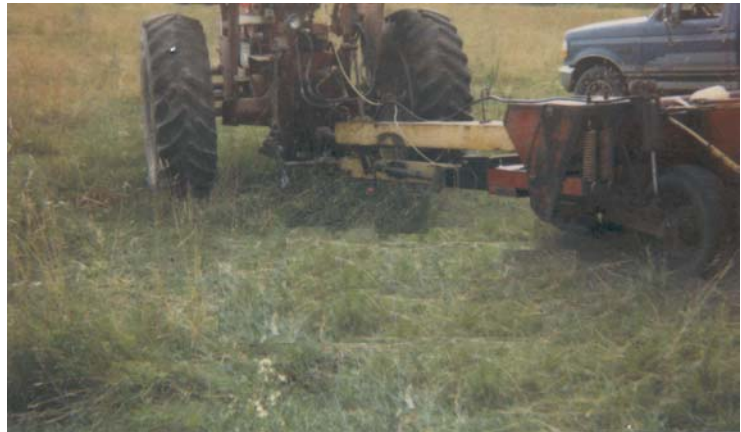
Figure 1. Incident scene

It appears from pictures taken at the scene of the accident that the flail mower is off to one side of the tractor. He was found face down with the mower on top of him. The victim was pinned by the steel roller that was approximately 4" off of the ground. Emergency responders found the victim pinned face down underneath the wheel and mower frame.

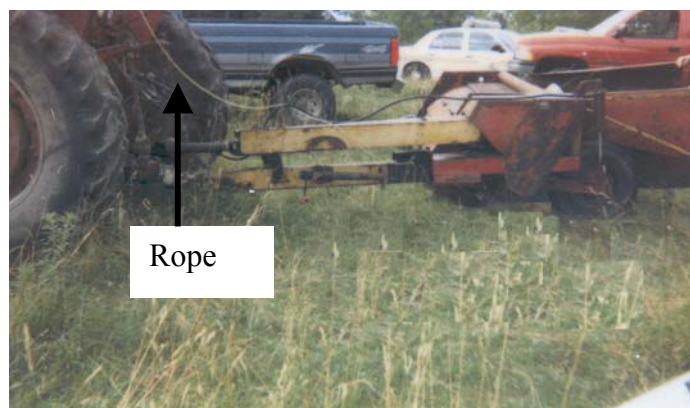
Figure 2. Rope attached to pin for flail mower

The rope was a part of the mower, not an aftermarket addition. The rope was attached to the tractor, according to his son, to allow the pin to be released directly from the tractor instead of having to dismount/mount the tractor. This pin was difficult to remove. (See Figure 2)

The son indicated that the mower was old and rusty, and that it was possibly not used for two years. The equipment was stored outside. He stated that it was hard to pull out the pin. All machine components should be checked periodically to ensure that they are in proper working order. Maintenance and servicing equipment is a prerequisite to a properly working, functional machine.

- Owner/operators should maintain equipment in good operating condition.
