## MIFACE INVESTIGATION: #03MI079

SUBJECT: Department of Public Works Employee Electrocuted Attempting to Read a Water Meter Located Behind an Apartment Boiler

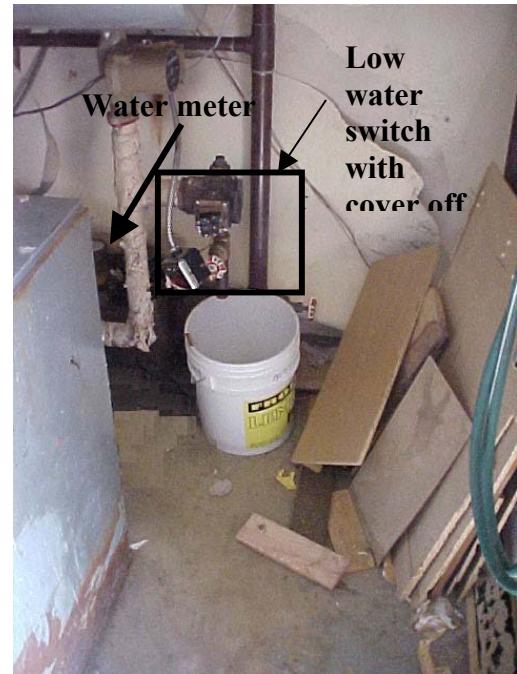
On June 30, 2003, a 37-year-old male Department of Public Works (DPW) employee was electrocuted while attempting to read a water meter that was located behind an apartment boiler. The boiler room was lit by one overhead 40-watt light bulb. The meter was located near ground level. There was approximately a two-foot gap between the boiler and the back wall. He placed his water meter logbook on top of the boiler. Bracketed on a water pipe near the boiler was the boiler's low water cutoff switch. It is unknown if the switch cover was on the switch when the victim tried to maneuver between the water pipes and the boiler to read the water meter. During his attempt to read the water meter, he contacted exposed, 120-volt energized low water cut-off switch terminals with his right chest. Following contact with the terminals, he collapsed and became wedged between vertical pipes coming from the boiler. The low water cutoff switch cover was found hanging under the victim's chest. A cigarette lighter was found on the floor under the body. A screwdriver, not the type used by DPW employees, and a small metal screw was found near the victim's body. He was found by an apartment complex resident who alerted an apartment complex employee. The apartment complex employee contacted 911. The power company was notified and turned the power off to the boiler room. The victim was declared dead at the scene.

Figure 1. View of area near boiler

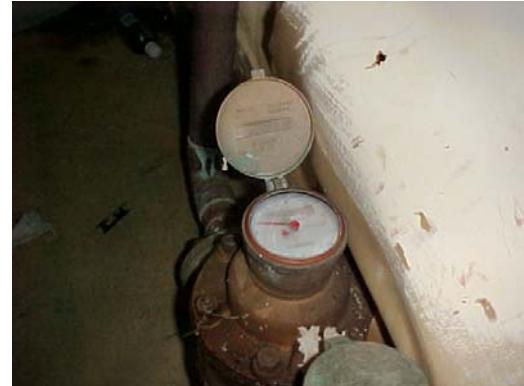
The water meter involved had been installed at the apartment complex in 1972. The water meter is located behind the boiler near the wall at floor level. (See Figure 2) Current building codes would not permit the water meter location to be behind the boiler, however installation in that location was permitted in 1972. The meter was read one time per month.

There was approximately 13 inches of clearance between the piping behind the boiler and the water meter. It is unknown if the switch cover was on the switch at the time of the incident or whether the cover was inadequately secured on the switch housing, and the victim knocked the cover off of the boiler's 120-volt low water cutoff switch as he was positioning himself to read the water meter. The victim was a large man, over 250 pounds and over 6 feet tall, which could have made it difficult for him to enter the space behind the boiler to read the meter.

Figure 2. Water meter at floor level

- **Additionally, city officials should consider a phase-in conversion of direct reading water meters to remote reading meters.**

Many businesses and homes have water meters that are in hard-to-reach areas and may be difficult to read. Traditionally, the water meter in the building is usually located on the lower level where the water service pipe enters the building. To read the meter requires access be provided to the meter reader.

Remote water meters provide digital readings of water usage that can be gathered (a) visually and manually recorded, (b) with a handheld scanning device at the meter itself, or (c) by reading radio signals from the meter. The remote reader is installed on the outside of the building to facilitate reading. The meter reading is transmitted by wire to the remote readout.

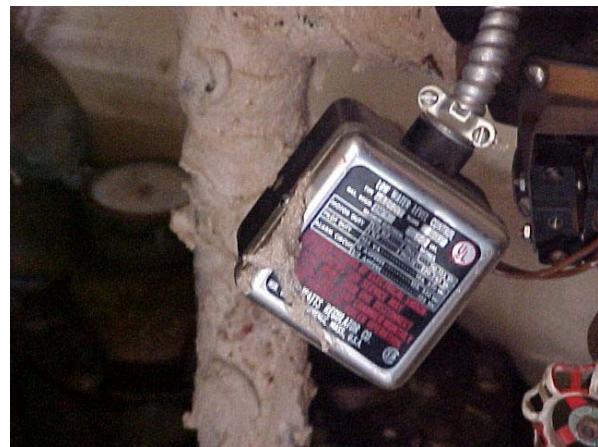
The boiler involved was a Hydrotherm model from 1975. It had received a boiler inspection, and passed, in 2002. This model heats an incoming water supply and supplies heated water to the apartment complex heating units. Eight apartments received their hot water from this boiler unit. The boiler has a 120-volt low-water level cut-off switch located behind and to the side of the boiler on a water pipe. The low water switch will turn off the boiler when water is lost through the system. The 120-volt low water cut-off switch had two terminals and was not properly

The police report stated that the apartment complex maintenance person had worked on this boiler unit approximately one month prior to the fatal incident, because no heat was being provided to the apartments serviced by the boiler. While performing the required maintenance, the police report states that the maintenance worker removed the cover to the low water shut-off switch to assure it was operating. While working on the switch, the maintenance worker was distracted by a resident and left the boiler area. The maintenance worker could not remember if the cover was properly secured.

Fellow workers thought it unlikely that the victim would have entered the space behind the boiler to read the meter if the cover was off of the exposed terminals. Whether the cover was on the switch when the victim arrived or whether he placed the cover on the switch is unknown. A screwdriver, not the type used by DPW employees, and a small metal screw were found near the victim's body. Due to the lighting in the room, fellow workers thought it was unlikely that the victim saw the screw and screwdriver lying on the floor. It is unknown if this screw fell out at the time of the incident or whether the maintenance person left it on the floor when he left to assist the resident and never returned.

Although exactly what occurred is not known, MIFACE proposes the following scenario based upon the interviews of fellow employees, law enforcement and review of other documents. The low water cut-off switch cover was on the switch but was not properly secured. The victim used the small cigarette lighter that was found under his body to see the water meter face, holding the lighter in his left hand. His back was to the boiler and his chest area was facing the back wall. He may have been using his right hand on the water pipes as support. He attempted to crawl in between the pipes and boiler to read the meter. As he was attempting to enter the space behind the boiler, he knocked the cover off of the low water switch, due to the location of the cover under the victim's left chest when he was found. (If he had knocked the cover off as he was exiting the space, it is thought that the cover would be more towards the right shoulder). (See Figure 3) When he attempted to exit the space, his right chest contacted the exposed terminals, "bending" one terminal into the energized terminal. (See Figure 4) He was apparently touching either the water pipes or the boiler with his body as he provided a path to ground. After collapsing, he became wedged between the vertical pipes behind the boiler.

Figure 3. Low water switch box cover hanging from bracket

- Employers should establish electrical safety work practices and identify and train those employees who, under normal working conditions, are exposed to electrical hazards and have little or no electrical training in these safe work practices.

To prevent electric shock or other injuries resulting from either direct or indirect electrical contact, an employer must develop safety-related work practices. Specific work practices must be consistent with the nature and extent of the associated electrical hazard. No one knows the location of the low water switch cover or any victim action relating to this cover. Because he had read this meter without incident in the past, and with the dimly lit work area, if the cover was placed on the switch housing, it is easy to presume that he thought that the cover would be secure and that he would not be exposed to an electrical hazard. If the switch cover was left hanging and/or he reattached the cover, an electrical hazard would have been present and he was not properly trained to assess this hazard and take appropriate precautionary measures.

To develop the safety-related electrical work practices, a hazard assessment of the varied work areas the DPW employees enter should be conducted. The hazard assessment would gather information about potential electrical shock sources so specific safety-related work practices, consistent with the nature and extent of the associated electrical hazards can be developed as required under the MIOSHA standard. The work practice of using a cigarette lighter as a light source to read a meter should be discouraged. DPW employees stated that they are issued flashlights. A flashlight, with high-intensity adjustable spot-to-flood beam better illuminates a “hard-to-read” meter than does a cigarette lighter.

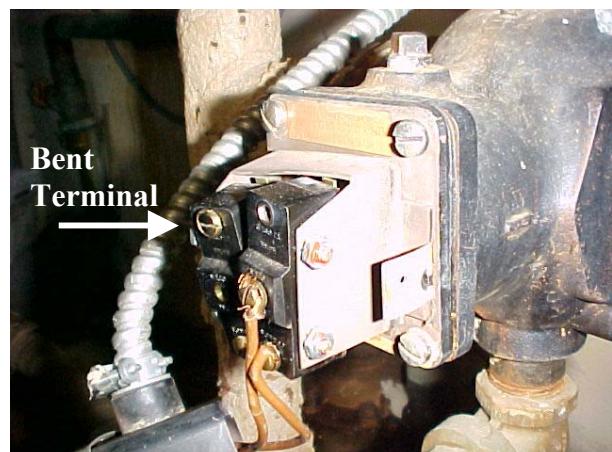
A resident of the apartment complex saw the open boiler room door, and upon walking through, noticed boots near the boiler. The resident went to get the apartment complex manager and the manager went to investigate. Upon seeing the victim, the manager called 911. Emergency response arrived. Police found the victim in a kneeling position, with one leg extended. His head was resting on a hot water pipe from the boiler. His left hand was under his body, his right hand by his hip. His back was against the boiler. The low-water level cut-off switch cover was hanging under his body. There was a burn mark on his shirt and a corresponding burn mark on his chest below the right nipple, nearly the size of the terminals from the cut-off switch. No exit area for the electricity was noted.

Figure 4. Low water switch terminals after victim contact
