## MIFACE INVESTIGATION: #03MI029

### SUBJECT: Co-Owner of Metal Forge Shop Dies When an Ejected Piece of Steel Used as a Stop Block in a Full Revolution Press Strikes Him in the Chest

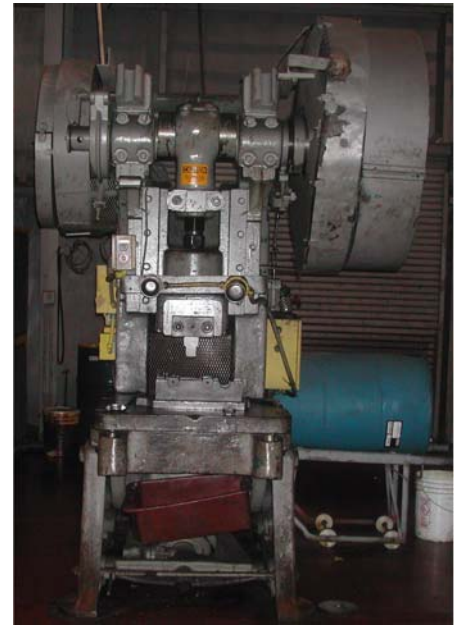
Figure 1 – “Bender” press

The company did not have any manuals for the “bender” press. The “bender” did not have a serial number or other identifying information. The company co-owner estimated that the press was manufactured sometime between 1940 and 1950, and was an approximately 8-ton press. The “bender” was normally used to bend metal, specifically press drag links. The “bender” was a full revolution press. It consisted of a moving slide (ram) guided in a definite path by the press frame and a stationary bed. The lower die was attached to the press’s base plate, the plate attached to the top of the stationary bed having drilled holes to T-slots; the upper die attached to the ram. The “bender” did not have an interlocked press barrier guard attached to the press frame or bolster. There was a metal mesh guard at the rear of the press. (See Figure 1 on page 1) The press did have a barrier guard when used as a “bender”; the barrier guard was impractical for the boot cutting operation and was not installed on the press for this job.

- Install an electrically integrated safety block and barrier guard to permit safe work operations.

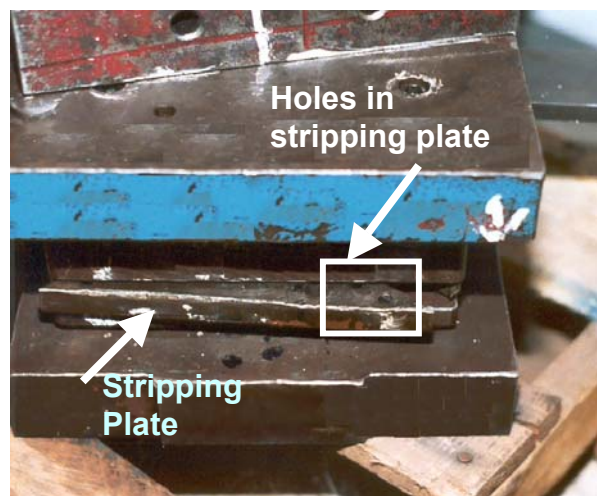
The victim installed the upper and lower dies on the “bender” press to trim the rubber boot. Figure 2 shows the die set used in the rubber boot trim operation. Attached to the bottom die was the stripping plate. The stripping plate was attached by four springs to the bottom die. When the press is activated and the upper ram moves downward and comes into contact with the stripping plate, the stripping plate goes down with the ram, but doesn’t touch the bottom die. In this way, excess boot material can be stripped without damaging the product and die.

Figure 2- Die set for rubber boot

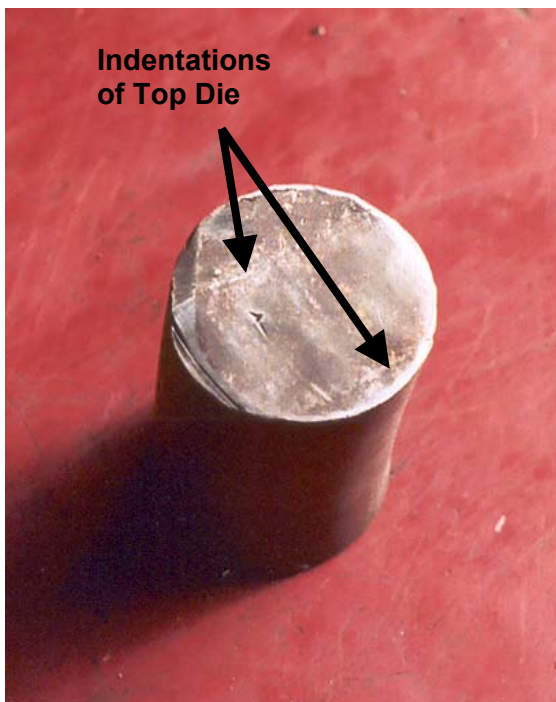
installed the sharpened dies. It appears the victim had placed a cylindrical piece of solid steel 17/8" in diameter and 4" long on the top edge of the stripping plate, nearest to him (See Figure 3). He was using the steel as both a measurement tool for the die and as a stop block to ensure that the top ram would not go down too far (bottom out) on the lower die pins.

A stool was located in front of the press. The victim activated the press with the piece of steel on the stripping plate. It is unknown if the victim was seated on a stool in front of the press when the incident occurred; if seated on the stool facing the press, he had a good view of the ram movement. He may have noticed the steel on the stripping plate and tried to remove it (there were cuts on his right hand). Under normal operation, when the ram comes down, the stripping plate will depress evenly. At the time of the incident, when the ram came down and contacted the piece of steel on the front side of the stripping plate causing the stripping plate to depress unevenly - the front side was lower than the back side of the stripping plate. Figure 3 and Figure 4 show the force of the dies on the stop block. Figure 3 shows the mark on the chunk of steel where it was contacted by the upper die. Figure 4 shows the pinch mark where the steel was placed on the edge of the stripping plate and indentations on the steel that matched the holes on the stripping plate.

Figure 3. Indentations from top die on steel used by victim

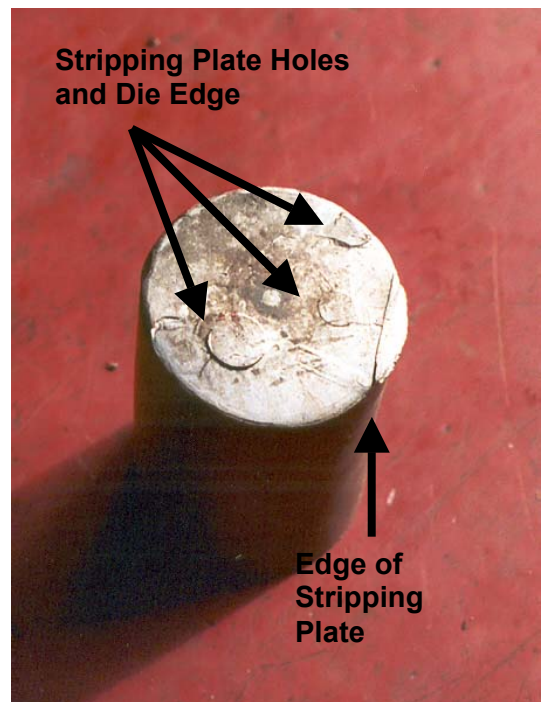
Figure 4. Indentations from stripping plate on steel used by victim

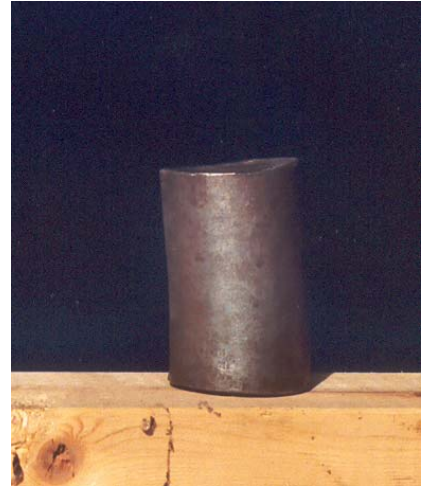
Because of the location of the piece of steel on the stripping plate and the downward force of the ram, the chunk of steel was propelled from its position on the stripping plate at a high velocity away from the press, toward the victim. Figure 5 shows the deformation of the cylindrical piece of steel caused by the force of the press. The piece of steel struck him in the chest. The co-owner was working approximately 20 feet away. He heard two bangs; heard the victim yell and looked over to see the victim on the ground. The co-owner provided CPR while the office worker called 911. Emergency response arrived and transported the victim to the hospital, where he died of his injuries.

Figure 5. Side view of cylindrical steel piece used by victim as stop block

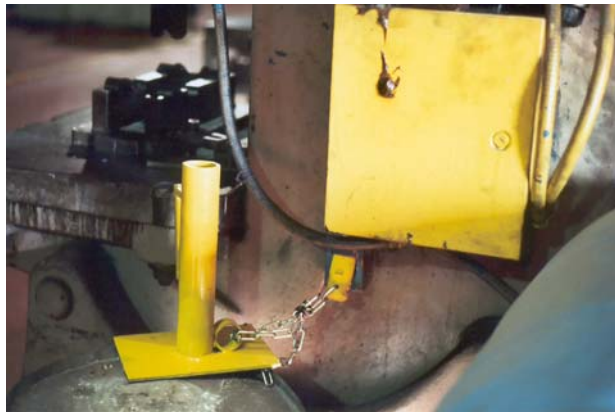
Figure 6. Company-designed safety block

After the death the company designed and installed a MIOSHA compliant electrically integrated safety block for the press. A safety block is defined as a prop that is inserted between the upper and lower dies or between the bolster plate and the face of the slide that prevents the slide from falling of its own deadweight. Figure 6 shows the safety block and its electrical interlock. A chain is permanently connected to the safety block and the female plug is connected to the male end of the interlock plug. By design, the chain is too short in length and cannot be used as a safety block when the press is in operation by the press operator unless the chain is unplugged from the male end. When the chain is unplugged from the male end, all power is cut from the press and the safety block may be used.

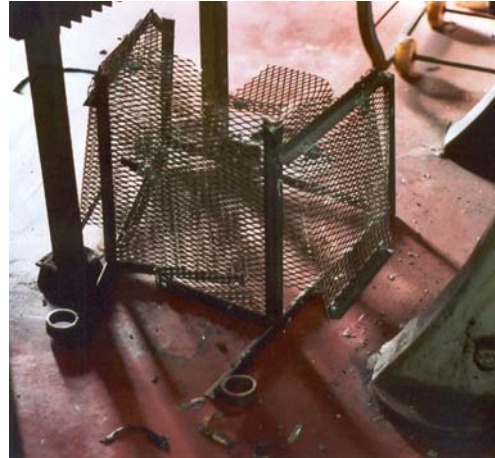
Figure 7. Barrier Guard

Also after the incident, a barrier guard was designed and installed on the press to prevent operator injury from flying objects when the press is in use. Figure 7 shows the company-designed barrier. The barrier can be attached to the front of the press. The “doors” on either side of the barrier allows the operator to load and unload the part.
