## MIFACE INVESTIGATION: #03MI025

**SUBJECT:** DPW Worker Run Over by Pickup Truck Exiting the Vehicle to Open an Overhead Garage Door

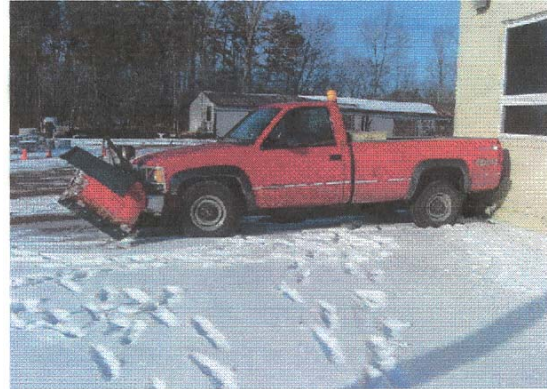
Figure 1. Final resting place of truck

snow are thought to be efforts he made to climb back into the truck, presumably to stop the truck. The imprints are repeated three times. He placed the front half of the right foot on the ground. The impression in the snow indicated his foot slid to the right and back. It appears that he lost his footing, fell, and was run over by the driver's side front truck tire, rolled by the truck undercarriage, and then struck by the plow. The truck continued in reverse in a smooth, symmetrical, circular arc (approximately a 270-degree arc) from the point where the victim may have driven the truck onto the apron to the resting point at the northwest corner of the garage wall. Figure 5 shows the area behind the garage where the footprints were visible. The orange cones mark the path of the truck as it traveled in reverse before coming to rest against the west wall of the garage. The truck finally came to rest against the west wall, the truck cab facing to the west with its wheels spinning. (See Figure 1 on Page 1 of this report)

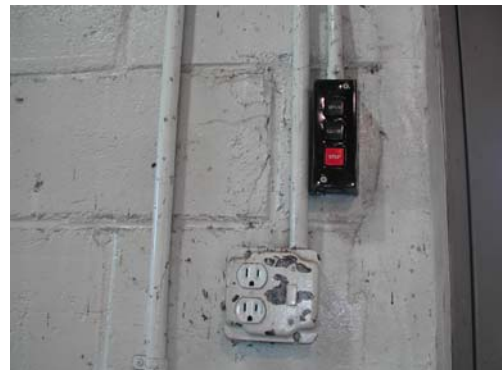
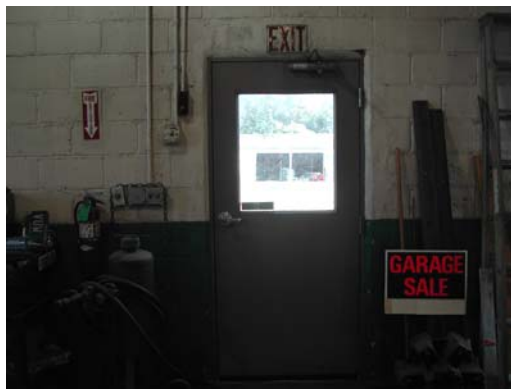
Figure 2. Remote garage door opener by pedestrian door

by a garage door opener mounted on the wall approximately 6-inches from the frame of the pedestrian door located adjacent to the overhead door. On the day of the incident, the pedestrian door was left unlocked; the victim did not need to remove his keys from the ignition to unlock the door. See Figures 2 and 3.

Figure 3. Remote control garage door opener by pedestrian door

- The DPW should explore assigning each operator or equip each vehicle with a remote garage door opener for the overhead door.

The DPW had installed a remote control overhead door operating system near the pedestrian door to assist operators in opening and closing the overhead door. MIFACE recommends that the DPW explore the possibility of having a remote control garage door opener assigned to each

operator or equip each vehicle that is driven and stored in the garage with a garage door opener. This would allow an operator to stay in the vehicle to open as well as close the overhead door when coming out of the garage if he/she is the only individual present. This would eliminate the need for the operator to exit the vehicle and provide for operator safety, not only in inclement weather but also at night.

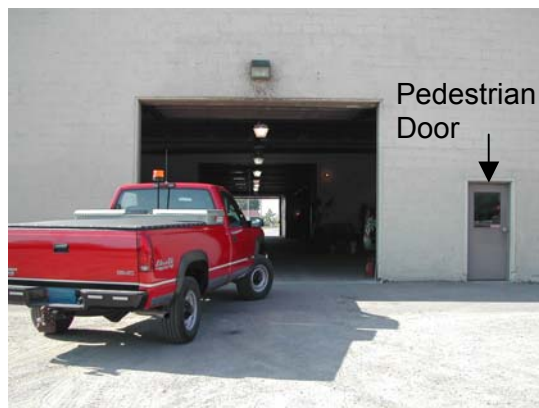
During the MIFACE visit, a DPW worker positioned the truck to the location where the victim might have driven the truck to prior to exiting. (See Figure 4) The plow was raised approximately 10-inches from the ground. There is a slight incline at the entrance to the overhead door. The truck's front wheels would have probably been turned at an angle as a result of making a circle to enter the overhead door and to position the truck so it could be parked. Vehicles were parked in the DPW garage at an angle. Figure 4 shows the truck orientation at the garage and location of the pedestrian door. Note that the front wheels are turned as a result of driving to this location through the back lot and positioning the truck to drive at an angle into the garage.

Figure 4. Possible location of truck when pulled onto asphalt apron

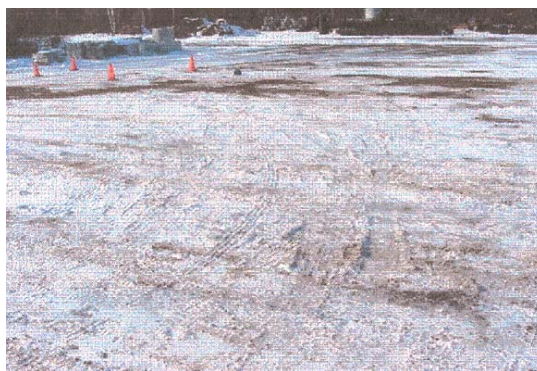
Figure 5. Area behind truck where victim tried to reenter truck

- Employees should be instructed never to try to stop a moving vehicle.

Operators should be instructed that they are not to attempt to remount a moving vehicle. Although the truck was moving at idle speed, his best safety action would have been to let the truck come to rest naturally instead of trying to get back into the cab to stop its movement. It should have been let go and retrieved once it came to rest.
