## MIFACE INVESTIGATION: #03MI022

**SUBJECT:** Indoor amusement manager killed when struck by a moving roller coaster

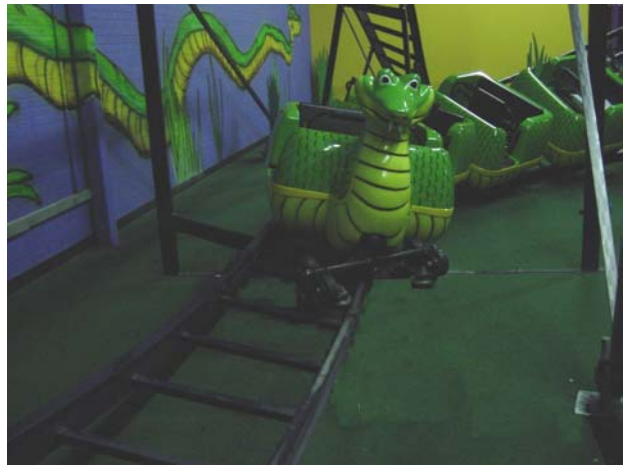
On March 1, 2003, a 43-year old male amusement manager of an indoor restaurant and game room facility was killed when he was struck from behind by a moving 5-car roller coaster. The victim entered the fenced roller coaster area near the end of the ride circuit. The ride operator had completely loaded the cars and the ride was approximately half way through one track circuit. It is thought that he was looking at a structural area previously identified by a building inspector as needing a support plate on the floor. The roller coaster operator did not see the victim enter the area or see the coaster strike the victim. When the roller coaster came around the track curve, it either struck him or a piece of the front roller coaster car caught on a piece of his clothing and dragged him on the track. (See Figure 1). The coaster ran over the back of the victim's neck and derailed. 911 was called and emergency response arrived. The victim was declared dead at the scene.

Figure 1. Derailed roller coaster

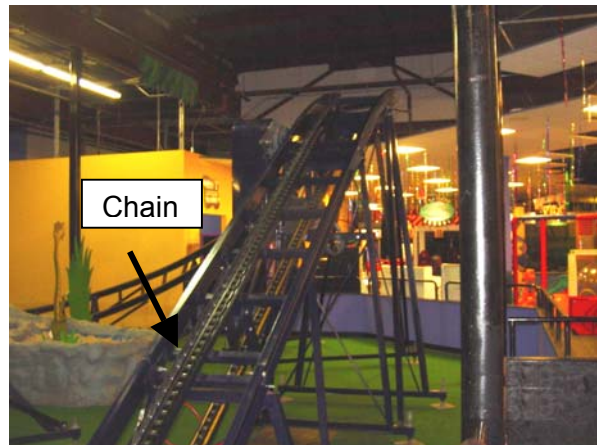
Figure 2. First Hill of Roller Coaster

The company leases this 5-car roller coaster from the manufacturer. The coaster is designated as a free-fall coaster. The coaster is pulled up the lift hill (the first hill), using a chain wound around gears at both the top of the hill and bottom of the lift hill. (See Figure 2) A motor powers the chain loop and it turns the loop of chain so that the coaster can be raised up the lift hill. The chain is grabbed by 2 sturdy hinged hooks (chain dogs) under the track at the bottom of the lift hill. When the ride starts, the motor powers the chain and the chain/chain dogs pull the cars up the lift hill. At the top of the hill, the chain dogs are released and the roller coaster begins its descent down the hill. Once at the top of the lift hill, the coaster travels by its own power along the tracks and cannot be stopped until the coaster enters the chain area again, where brakes can be applied, and the chain dogs hook onto the chain. The chain area begins before the operator's position. An emergency stop is present and was functional at the time of the researchers visit.

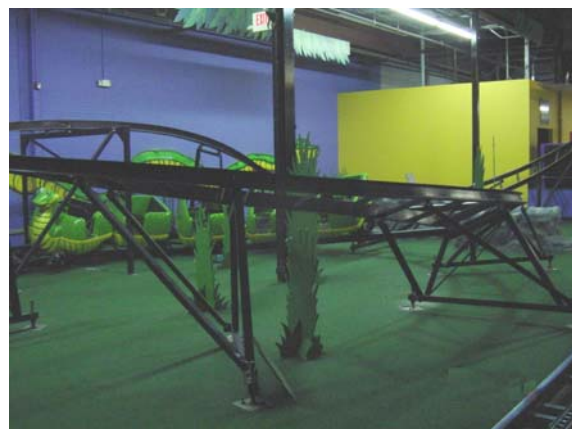
Figure 3. Overview of Ride

The lead car of the roller coaster has a “python” head design; the other 4 cars follow that theme. The roller coaster runs along a 2-inch dual rail track. The track width is 28 inches, with 24 inches between the rails. At the point where it is believed that the victim was hit by the car, the track was 18 inches off of the floor. The python head is approximately 30 inches tall. The coaster's speed is approximately 10-12 miles per hour, or approximately 24-28 feet per second. The ride circuit begins at the operator station where passengers are seated and secured in the coaster cars. A track circuit begins and ends at the operator's station. The normal ride is three times around the track circuit. (See Figure 3)

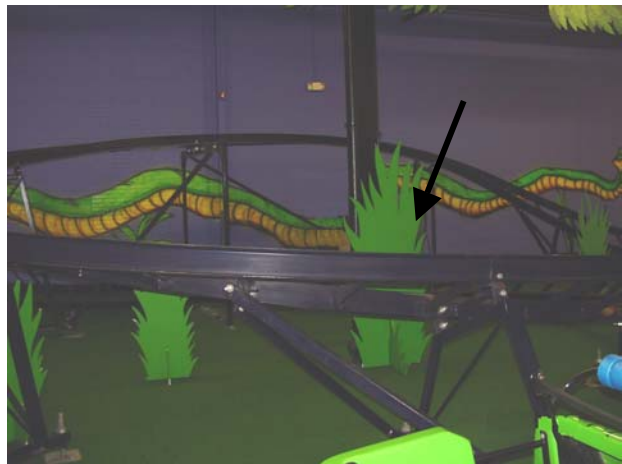
Figure 4. Approximate Location of Victim

The victim entered the ride area while the ride was running without the knowledge of the ride operator. The ride operator was at the operator station. It is believed that the victim entered through the tunnel area from the back portion of the ride. When the MIFACE researcher stood at the operator's control panel, the location where the victim was struck is hidden by a plant decoration.

It is unknown if the ride operator stopped the coaster at the end of the 3<sup>rd</sup> circuit, or if the operator let the coaster continue around the track for a 4<sup>th</sup> time. Patrons on the ride witnessed the death. The location where the victim was stuck was at a descent from a hill that curves toward the tunnel area. This location is also the location where the building inspectors indicated the track required the metal floor support plate. Witness statements do not concur concerning the location of the victim. It is thought that the victim was inside of the tracks when he was struck, but he may have been standing along side of the track. It is unknown if the victim was facing toward the approaching coaster or if his back was facing the coaster. As the roller coaster came to the position of the victim, the "Python" head on the first car of the roller coaster either struck the victim or caught on a piece of his clothing. A part of the victim's pant leg near the cuff was ripped. The victim was struck from behind by the first car in the right neck/shoulder area. The victim was run over by the car and dragged approximately 5 feet before the car derailed. The right front wheel assembly of the first car derailed after breaking a 6 inch section of track. The victim's screwdriver was on the floor near the track and a type of screw identical to those found on the roller coaster was found near his shoe.

The warning sign should be placed at each entrance point to the ride operation area.

Mirrors positioned strategically in the ride area would help to eliminate blind spots in the ride area for the operator. The blind spots created by the use of decorations used to enhance the ride experience are unavoidable. The ride operator is responsible for ensuring the ride is operated safely; mirrors would allow the operator to have a view of the ride areas that he/she can't see from the operator's station.
