## MIFACE INVESTIGATION: #02MI208

### **SUBJECT: Laborer Electrocuted When Antenna on Top of Steel Pole Building Contacts 14400-Volt Energized Line**

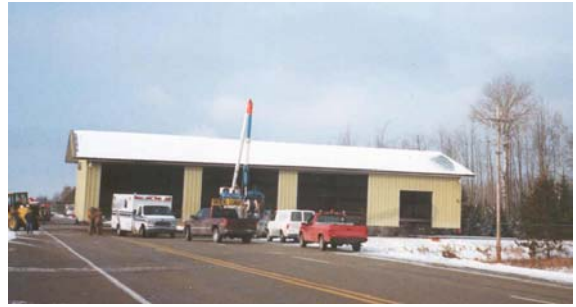
Figure 1. Incident Scene

On December 5, 2002, a 48-year-old male laborer was electrocuted when a county road commission steel pole-building antenna contacted an energized 14,400-volt overhead power line while the building was being relocated via a state highway. An electric company lineman, a cable company employee, road commission employees and a police escort were on site. The building was positioned on three dollies, two steer dollies at the “rear” of the building and one dolly at the “front” of the building that hooked to the tow vehicle. The lineman dropped the neutral wire

from the pole and left the 14,400-volt electrical lines energized. The lineman was present in an aerial bucket positioned on the road shoulder to observe building clearance while the building was being moved. Approximately 75 feet of the building had proceeded under the lines when two employees assigned to the “rear” steer dollies went under the building and began to ratchet each dolly chain to steer the rear of the building onto the road. (See Figure 1). Near the front of the building a “bolt of lightning” was observed as the building antenna contacted the line. The two employees at the “rear” steer dollies received electrical shocks and fell to the ground. Bystander CPR was initiated and emergency response was called. One of the workers was taken to the hospital and survived, the other worker was pronounced dead at the scene.

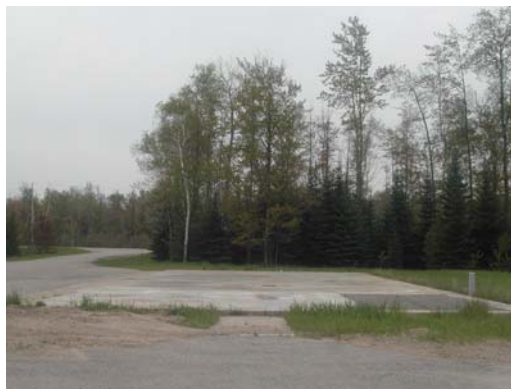
Figure 2. Original building location

The company was contracted by the county road commission to move a steel pole building (40-feet-wide by 100-feet-long) that acted as its maintenance garage, from one location to another location along a 2-lane state paved highway. The original location of the building was approximately 50-100 feet away from the state road. The building was located on a concrete slab. A compacted dirt driveway led to the pole building location. There was an estimated elevation change of approximately 4-6 feet from the building location to the state road. (See Figure 2)

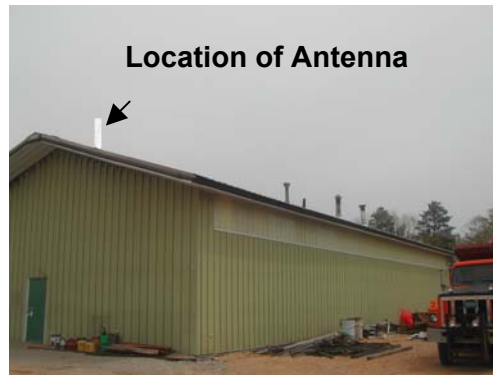
Figure 3. Pole building

The building had 4 ventilation stacks on the roof that

did not extend beyond the roof peak. An antenna with a rubber tip used for 2-way radio communication was also present on the building roof. The estimated height of the antenna was 30-36 inches. (See Figures 3 and 4).

MIFACE recommends that a standard operating procedure be developed to guide the assessment of hazards that may be presented by a building before a building move. This procedure should be implemented regardless of the height of the building. At the time of the MIFACE researcher visit, the company only accessed the roof of the building was less than 18 ½ feet when raised. If the owners had accessed the roof of the building involved in the incident, they may have seen the building antenna and taken steps to remove it or build a skip board to protect personnel and the building from potential electrical contact. A standard operating procedure that incorporates a full perimeter building assessment regardless of the height could detect additional building projection hazards that may alter the height or width of the building and identify additional measures that may be required to safely move the building.

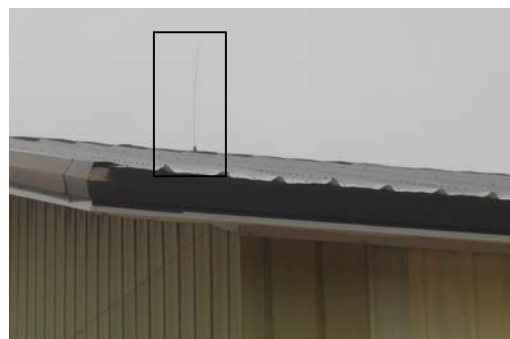
Figure 4. Antenna on building roof

This highlights and emphasizes the role of effectively communicating hazards to all individuals involved in operations around energized electrical power lines. It is unknown if the utility lineman observed the antenna on the building roof until it contacted the overhead wire. A communication protocol between the utility company and moving company owner directing his employees was not established and may have played a role in this incident. MIFACE recommends that utility companies review company policy for communicating with individuals prior to work that will be performed within the vicinity of an energized overhead power line and the documentation procedures of this communication. Documentation of the communication

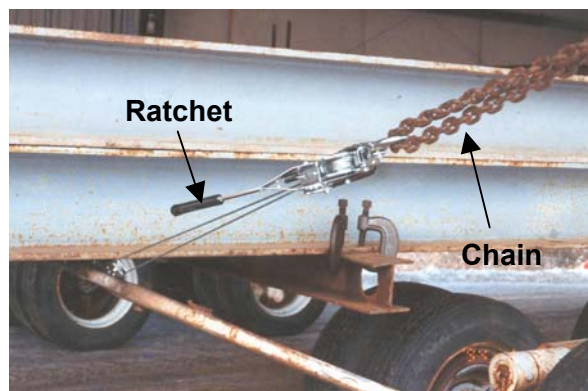
Figure 6. Rear steering dollies ratchet and chain

The victim and coworker had worked together in the past and for this move, had practiced using the two rear steering dollies in tandem. They had to simultaneously ratchet the chains on the rear steering dollies to turn the dolly wheels to successfully turn the rear of the building. (See Figure 6). The company owner stood near the end of the building that was attached to the front-end loader and was responsible for telling the victim and coworker at what point they needed to begin turning the rear of the building.

The tow dollies used may be operated in areas both with and without an overhead electrical hazard. The ratchet handles should have an insulating material such as fiberglass or rubber placed on them to provide additional operator protection.

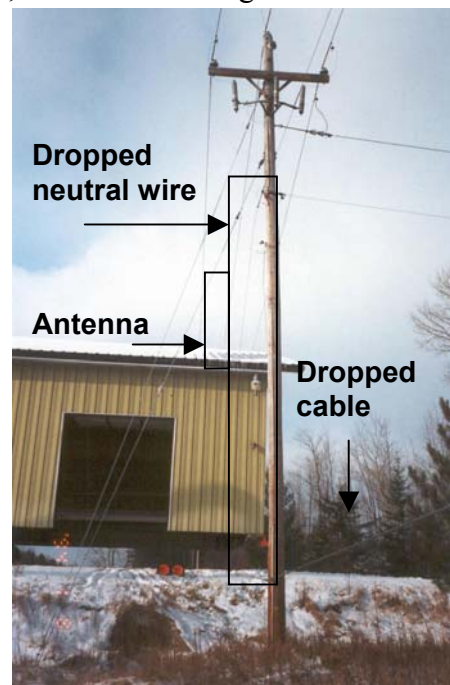
Figure 7. Building position and dropped utility lines

After dropping the neutral and cable lines, the building move continued. Approximately 75 feet of the building had passed under the energized overhead line. (See Figure 7) The owner, by 2-way radio, instructed his employees to go under the building to adjust the steering mechanism on the rear steering dollies with approximately  $\frac{1}{4}$  of the building still under the power lines. As they adjusted the steering, the building continued to move and the rear steer dollies went over cable's plywood crib. The 30-36 inch antenna protruding up from the peak made contact with the energized 14,400-volt line. The owner saw a flash of light near the front tandem axle dolly. Both the victim and his coworker under the building adjusting the rear steering

dollies provided a path to ground for the voltage. It is unknown if the workers were holding onto the ratchets or in contact with the building when they became a path to ground. Both workers broke contact by falling to the ground.

- Employers should verify that a minimum of 10 feet is maintained by employees when working near an energized electrical line, gear or equipment exposed to contact with an energized overhead power line.

dollies. A safe distance could not be maintained due to the height of the building. The company must train their personnel and enforce a policy that no one must be within 10 feet of a structure when under an energized overhead power line.
