## MIFACE INVESTIGATION: #02MI151

### SUBJECT: Farm Laborer Killed When He Became Entangled in an Unguarded PTO Shaft

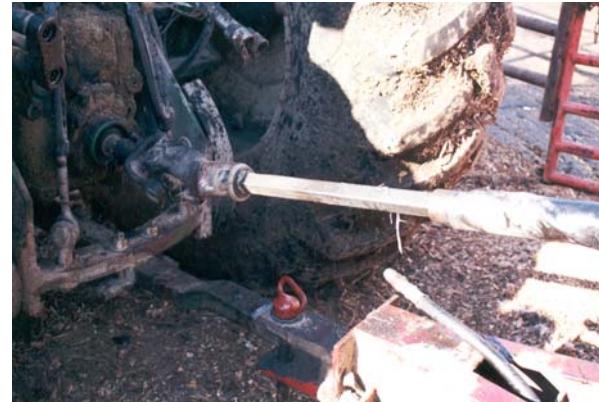
On November 11, 2002, a 45-year old male farm worker was killed when he became entangled in an unguarded rotating power take off (PTO) shaft at the tractor connection (See Figure 1). The mixer had undergone repair and its u-joint and PTO shaft were unguarded. The tractor PTO lever was located on the operator's right side while seated in the tractor. The mixer had a moveable scale that was attached to a stationary arm that could be moved to face either side of the mixer. The victim loaded the mixer with supplements and then had driven the tractor/mixer to the bunker silo area to add haylage to the supplements. He drove the tractor into the bunker area from a north to south direction instead of his usual approach, which is in a south to north direction. He had dismounted from the tractor and left the tractor running; it is unknown if the PTO was engaged or disengaged when he dismounted. He was working alone and the event was unwitnessed. His left hand/arm became entangled in the rotating PTO. His clothing was ripped off and his left arm severed at the shoulder. Another employee found the victim with his head by the driver side rear tractor wheel and his feet facing the mixer. This employee turned off the tractor and contacted another employee for help. The second employee ran to assist the victim; when the second employee determined there was nothing he could do, he called the farm owner to obtain the exact farm location address and then called 911 with this information. Emergency response arrived and the victim was declared dead at the scene.

Figure 1 – Unguarded PTO Shaft

- All rotating shafts, including PTO drivelines, should be covered by shields/guards in good condition to prevent worker contact with rotating parts

It is not known exactly how the victim became caught in the PTO shaft. The master shield should be kept in place at all times. A master shield should be removed only when required for hooking up special equipment with equivalent shielding. The PTO tractor stub shaft guard should be placed back on the tractor whenever PTO driven equipment is not being used. A guard covering the PTO may have prevented the victim from becoming entangled in the moving shaft.

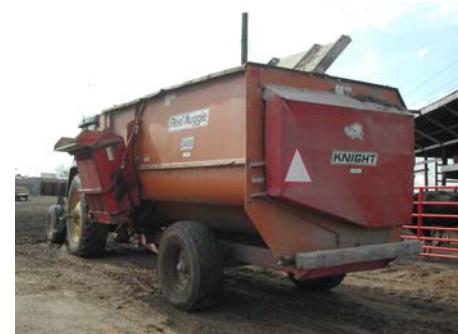
Figure 2 – Knight Brand of Auger-Mixer Wagon

The Knight brand of Auger-Mixer wagon used by the farm operation was a Reel Auggie 3450 tow type feed mixer. It was purchased new in 1996 and was used to mix feed for the dairy cows (See Figure 2). All safety decals were present and readable on the mixer. The mixer had 2 hatches that could be opened to load the mixer from the top with feed. The top of the mixer on the auger side (low side) was 7'3". The top of the mixer reel side (high side) 8'6". The mixer is equipped with a scale mounted on a stationary arm. The scale is capable of pivoting side-to-side to measure feed weights (See Figure 3). The scale is approximately 6 feet off of the ground. The operator's manual stated that when loading hay, it is helpful to have the PTO engaged and the mixer knives running during the loading procedure when hay is added to the mixer. The manual also recommends that the hay be loaded on the auger side (the low side of the mixer) to facilitate mixing of the hay. When loading hay, the manual also recommends that the mixer should be running at least at  $\frac{2}{3}$  to  $\frac{3}{4}$  rated speed.

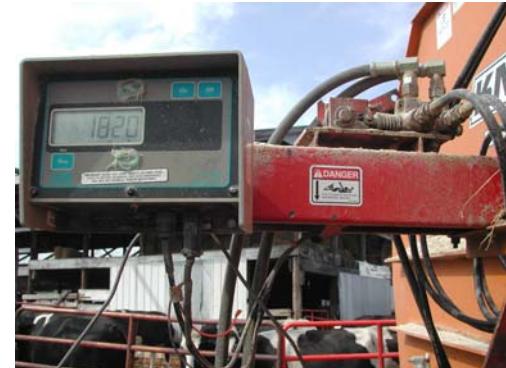
Figure 3 – Mixer Scale

The normal mixer loading procedure was to first add feed supplements at another location on the farm site. To add the feed supplements, the mixer is backed up to the unloading chute at the supplement building with the auger side next to the building. The scale is directed to the auger side (the scale face is in the same direction as the low side of the mixer and faces the supplement building) to determine the supplement weight entering the mixer. After loading the supplements, the tractor and mixer is driven to the bunker silo area on the farm, to continue loading the mixer. Traveling from the supplement location, the tractor would normally enter the bunker silo area from the south; the tractor/mixer faces north. Positioning the tractor/mixer so it faces north places the reel side (high side) of the mixer toward the feeding/milking area and the auger side (low side) of the mixer (with visible scale face) toward the bunkers to allow for easier loading of corn/hay into the auger side of the mixer. The tractor would also be oriented so the operator, if standing on the ground, would not have to reach across the PTO drive shaft to "push" the PTO lever forward to engage the PTO. As told to the MIFACE researchers, the owner said that the operator, if necessary, while standing on the ground would reach around the tractor fender to engage the PTO.

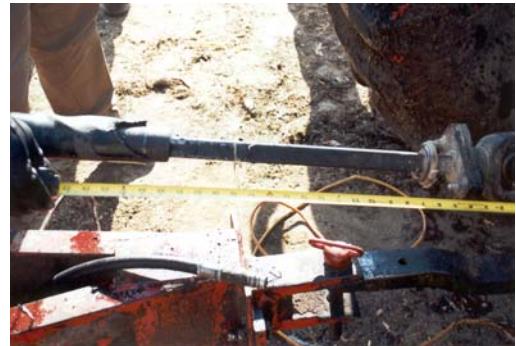
PTO shielding. The police report of this incident indicated that the alternate PTO shaft was 50 inches in total length. The PTO drive shaft closest to the tractor to 20 inches back to the feed mixer was not shielded (See Figure 4). The mixer's universal joint that connected to the drive shaft housing was also not covered with a protective housing.

Figure 4 – Unguarded PTO shaft

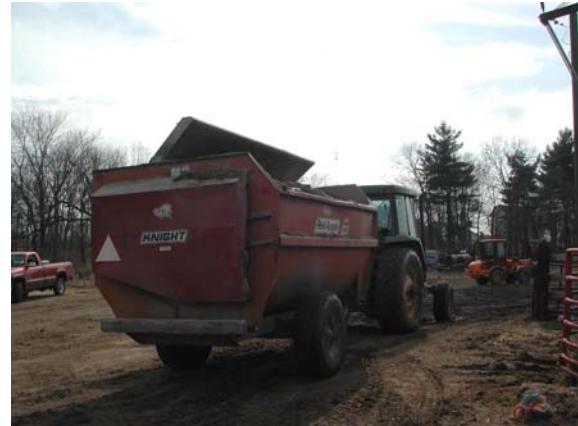
Figure 5 – Tractor/mixer facing south instead of north

On the day of the incident, the victim drove the tractor so it entered the bunker area from the north instead of his usual approach, which is from the south. The farm owner stated that other employees said that they had seen the victim enter the bunker area from the north prior to this incident as a "change of pace". This positioning of the tractor/mixer had several work practice implications: (1) the auger side of the mixer and the scale face were directed to the feeding/milking area rather than facing the bunker silos, (2) the scale face would need repositioning in order to be seen from the bunker silo side, (3) if standing on the ground, access to the PTO lever was by reaching across the unguarded PTO shaft instead of around the tractor bumper. (See Figure 5 for a re-enactment of the position of the mixer/tractor). Pictures taken at the incident site by the sheriff department showed the hatch open as reenacted in Figure 5. Sheriff photographs taken at the time of the incident showed that the mixer was very close to the milking/feed lot fencing and that it would be difficult to load the feed with the tractor loader on the auger side. It is unknown if the victim was attempting to load the mixer from the reel side facing the bunker or the auger side facing the milking/feed lot. The pictures also showed two pitchforks leaning against the fencing. It is unknown if these pitchforks were being used by the victim.

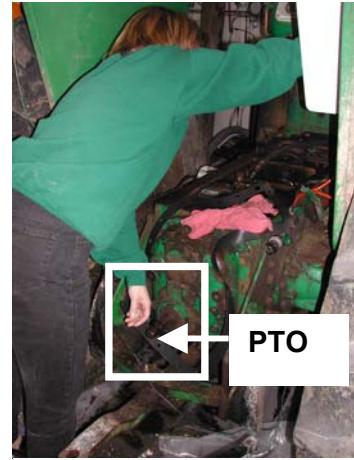
Figure 6- Reaching for PTO lever

1. The victim did not engage the PTO prior to dismounting from the tractor. While standing on the ground, he reached across the unguarded PTO and attempted to engage the PTO with his right hand. A possible position of the victim is illustrated in Figure 6. To push the PTO lever forward from this position may have caused him to be off-balance once the PTO engaged. After engaging the PTO, he may have lost his balance and while trying to recover, his hand and/or a piece of his clothing became caught in the unguarded, rotating PTO. A similar scenario is that he successfully activated the PTO and while moving away, the position of his left arm and/or piece of clothing may have been near the PTO and became entangled in the unguarded shaft. Figure 6 shows the protective shield on the tractor, behind the PTO lever that was installed at the repair shop. At the time of the incident, the shield was not present.

- Tractor operators should engage/disengage the PTO while seated in the tractor operator seat.

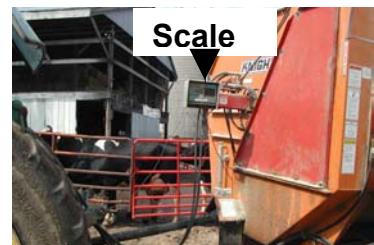
Figure 7 – Scale moved into position

2. The victim left the tractor running and the PTO engaged. Because the scale was facing the feedlot instead of the bunker silos, he needed to pivot the face of the scale so he could see it while loading. He may have leaned forward slightly to

take hold of the scale, in doing so; his sleeve and/or other piece of clothing became entangled in the unguarded PTO shaft. See Figure 7. Figure 7 shows the mixer PTO shield in place; it was not present at the time of the incident.

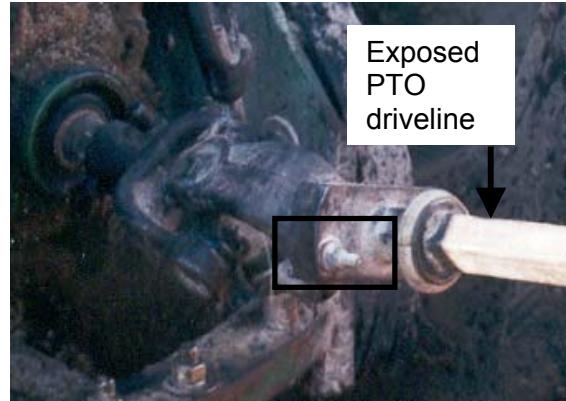
A total shielding system for a PTO driveline includes a tractor master shield, the PTO driveline shield and an implement shield. Exposed rotating shafts are hazardous situations that can cause serious injury or death to workers. Properly designed guards and/or shields should cover any rotating shafts that a worker may be exposed to. In this incident, the PTO shaft was unguarded from the point where it was connected to the tractor to the mid-point of the shaft. As a result, one half of the rotating horizontal shaft between the tractor and the mixer was exposed (See Figure 8).

Figure 8 – Exposed Bolts and driveline of PTO shaft
