## **MIFACE INVESTIGATION: #02MI121**

### **SUBJECT: Electrocution of Family Member When Welding on Rotary Disc Mower on Farm**

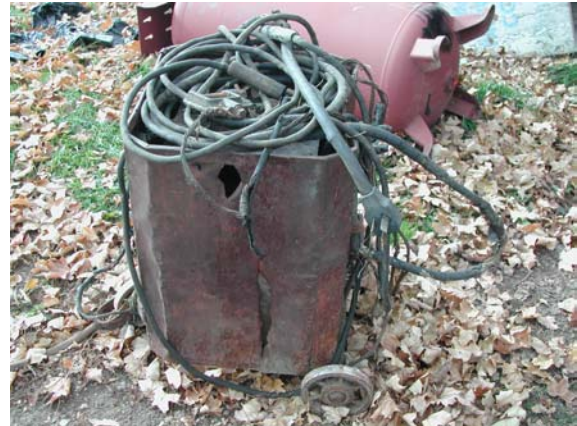
On July 9, 2002, a 43-year old male was welding to repair a rotary disc mower on his family's farm. The rotary disc mower had a broken disc and stone guard. The portable 240V plug-in-cord connected welder was in disrepair, both welder cables had exposed wiring, and the ground cable wiring was almost completely exposed. (See Figure 1) The ground cable was attached to a metal piece on the rotary disc mower. The victim's brother directed the victim as to the repairs needed on the mower, and went to do other work at the farm. The victim had completed the weld on the disc and appeared to be repositioning to repair the stone guard when his face touched the mower. The mower was energized, and the victim was electrocuted. Upon finishing his chores, the brother walked over to the mower to see the progress on the mower repair and found the victim lying motionless on the ground. He went to get help at the farmhouse. His mother came down to the area, touched the mower and received a shock. The dog also touched the mower and yelped, at which time the victim's brother then turned off the circuit breaker. Emergency response was called, and the victim was declared dead at the scene.

Figure 1- Overall Poor Welder Condition

- Equipment should be maintained in good operating condition

The brother of the victim indicated that they both knew about the condition of the “ground” cable insulation and the overall condition of the welder. They talked about repairing the welder, but never got around to it. Maintaining equipment is integral to safe operation of the equipment so that it can provide the protection it was designed to do.

The family has purchased another welding unit and has scrapped the unit that was involved in the death.

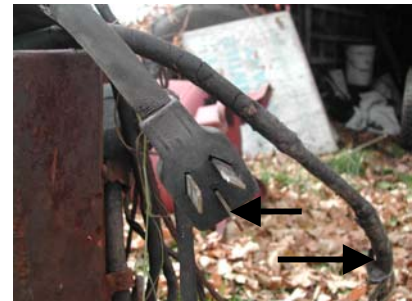
The welder was a portable, plug-in-cord Miller Electric 240V arc welder. The family bought the welder used in the 1960's. The welder was kept inside the farm shop, plugged in at an outlet. The welder's ground wire inside the plug was broken off; the ground tong could be easily moved by hand. The insulation was in poor condition on both the welding lead and the ground cable. (See Figure 2).

Figure 2-Ground prong loose and damaged insulation

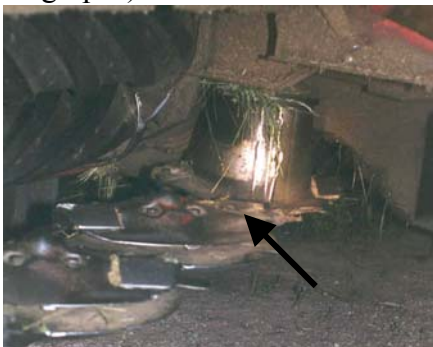
The rotary mower was a New Holland Discbine, Model 441. With use that year, part of the disc had broken and the stone guard also had to be fixed (See Figures 3 and 4 – state police photographs).

Figure 3 – Damaged Mower Disc

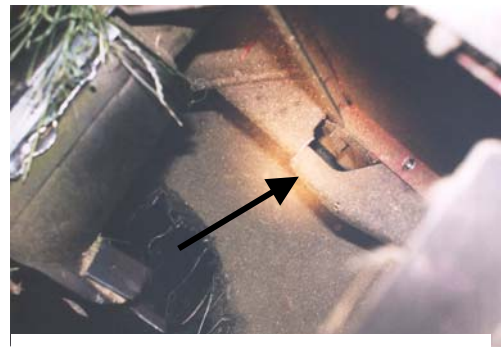
Figure 4 – Damaged Stone Guard

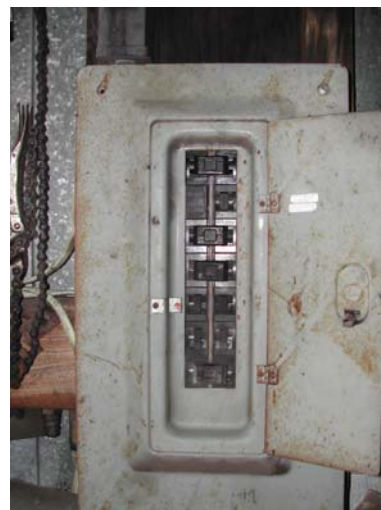
The circuit breaker in the machine shed did not have labels on the box (See Figure 7). It is recommended that labeling of all breakers be done to, not only identify the breaker and the system it is responsible for, but also to aid in an emergency situation so that individuals trying to turn off power to a system can quickly identify it.

Figure 7. Unlabeled circuit breaker box in shed

- All circuit breaker circuits should be labeled as to the outlets covered by each breaker.
