MIFACE INVESTIGATION: #02MI090

SUBJECT: Journeyman Pipefitter Killed When Struck in Head by Grooved End Cap under Pressure

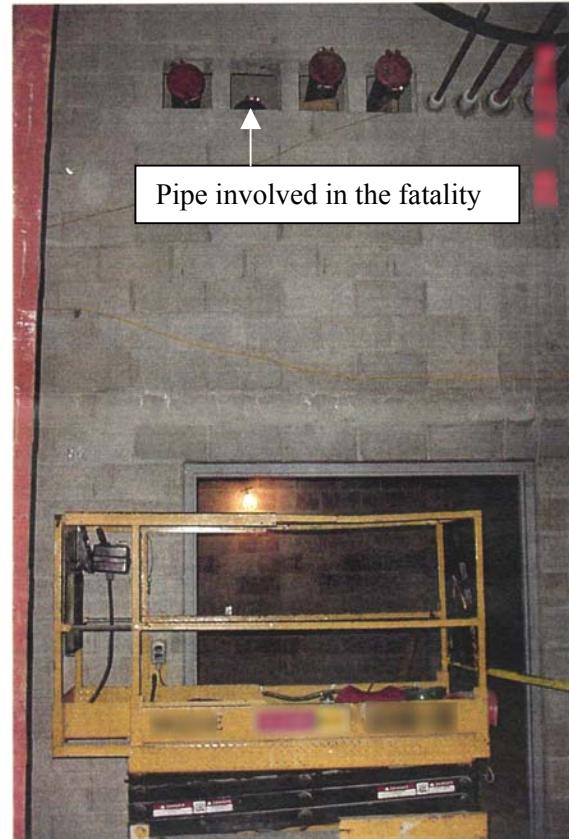
Figure 1 Pipes and Scissors Lift

Figure 1 is a photograph of the pipes on which the men were working with the scissors lift (shown in the retracted position) below. The second pipe from the left is the pipe involved in the fatality. It was recessed into the wall opening from the force of the end cap exploding off of it.

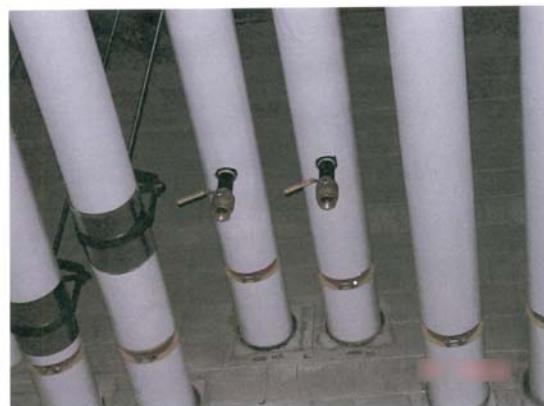
Figure 2 Closed Pressure Relief Valves

The pipes had been pressurized previously with air to 100 psi to test for leaks by the pipefitter. To pressurize the pipes, a test header apparatus was connected to a valve in each of the pipes. The apparatus consisted of a pressure gauge attached between lines connected to the valve on each pipe and a compressed air cylinder. The pipes were pressurized in a separate room approximately 50 feet from where the workers were working. After pressurizing the pipes to the desired psi, the valves were closed and the apparatus removed. Figure 2 shows the pipe valves in the closed position.

Attachment 1 of this report is an example of the type of standard operating procedure developed for this task. Apparently it is not unusual for an air test to be left on for several days. Because the air test apparatus was removed, it would have been appropriate to tag the lines as a reminder that they were pressurized. A red tag on the lines would have been a reminder to the crew that the lines were still under pressure.

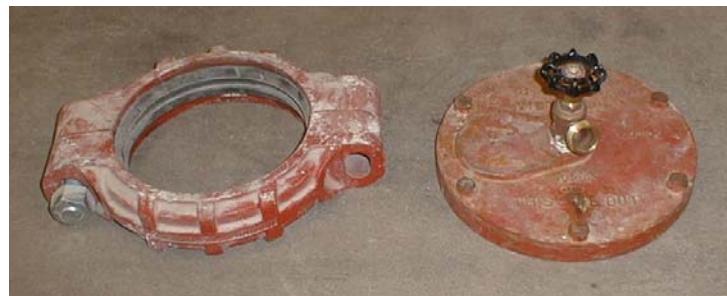
Figure 3 Coupling (left) and retrofitted grooved cap

The cap that was used to blank the pipes was referred to by several names. It was called a grooved cap, or Vic cap, or grooved plug. These names describe a method of blanking a pipe that consists of bolting a coupling with a gasket in which the cap or plug is seated onto the end of the pipe. The two pipes on the right in Figure 1 are shown with an end cap attached. Figure 3 shows a coupling and a grooved cap retrofitted with a pressure relieving valve. The caps used at the time of the incident did not have pressure relieving valves.

- All grooved caps were drilled, tapped and a pressure relieving valve was added in the center of each.
- Pressure piping testing procedures and lock out tag out procedures for the testing were written and distributed to company workers. They included an Inspection Test Report that must be signed off by the job superintendent and the mechanical inspector. The company's written procedures are included as Appendix 1.

The employer's retrofit of the grooved caps the company now uses was one way to ensure a cap would not be allowed to explode from the end of a pressurized pipe. There are other fittings such as blind flanges that can be purchased to blank a line that stay attached to the pipe until the pressure is bled off as they are being removed. Whichever method is used to guard against a cap exploding from the end of a pressurized line, the most important control is to make every effort and plan to ensure the line is depressurized first.
