MIFACE INVESTIGATION: #02MI060

SUBJECT: Millwright Dies from Fall Off Ladder

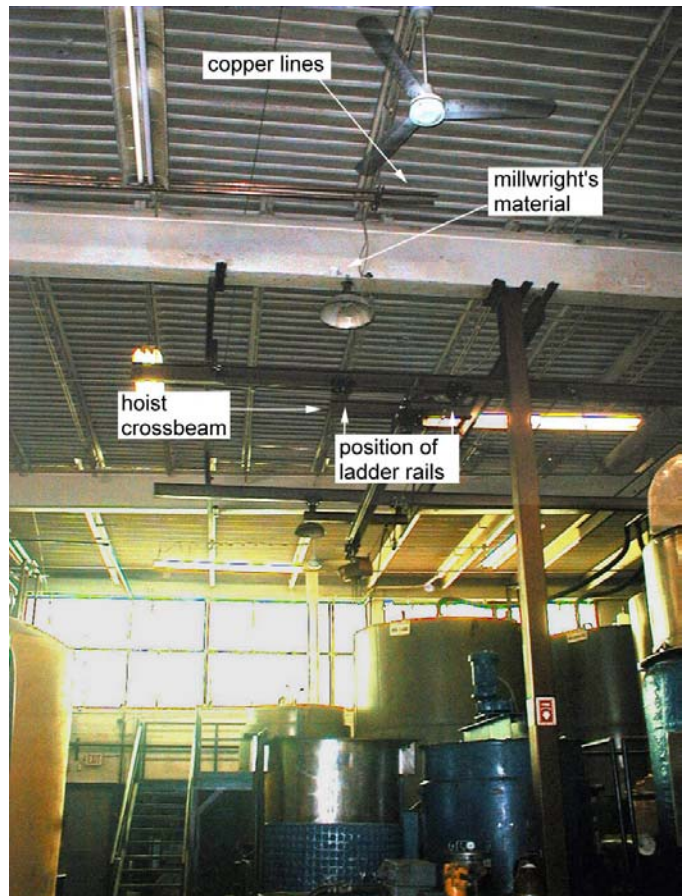
Figure 1

The victim started work at approximately 7:00 a.m. and had been working less than one hour when another employee working nearby heard a noise and went to investigate. He found the victim unconscious on the floor next to his ladder. The extension ladder was standing upright, leaning against a hoist crossbeam behind the area where the victim was working, not on the building I-beam closer to where he had placed his material. The container of material the victim had been using to connect the pipes was on the building I-beam (Figures 1 and 2).

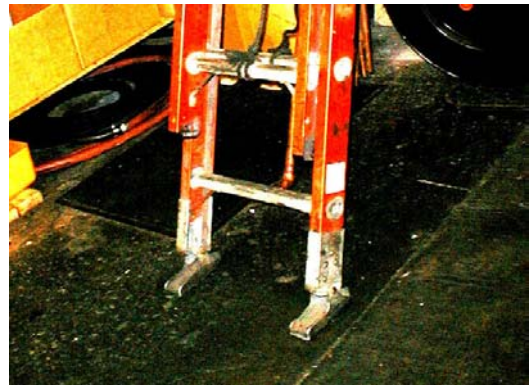
Figure 3

On the day of her visit, the MIFACE investigator was not able to examine the floor where the event occurred because containers were stored in the area. The extension ladder belonged to the victim and appeared to be in good condition (Figure 3). It was a fiberglass extension ladder with aluminum rungs. According to the Technical Director, the area around the ladder was clear at the time he was working there.

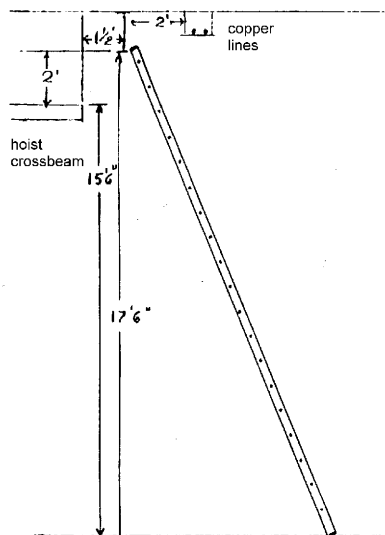
Diagram 1

Reconstruction of the probable scenario indicated that the ladder had been leaned against the I-beam and had slipped and fallen to the hoist crossbeam causing him to lose his balance and fall to the floor (Diagrams 1 & 2). Marks were apparent on the ladder that matched where it would have fallen to the hoist crossbeam in such a scenario.

- Securely fasten ladders to prevent them from slipping.

Ladders should be lashed or otherwise securely attached to ensure they will not slip. Slip resistant feet are not an acceptable substitute for holding a ladder in place that is used upon slippery surfaces.
