## MIFACE INVESTIGATION: #02MI040

### SUBJECT: Truck Driver Killed When Front-End Loader Secured by Chains on a Lowboy Trailer Broke Free and Rolled Onto Cab

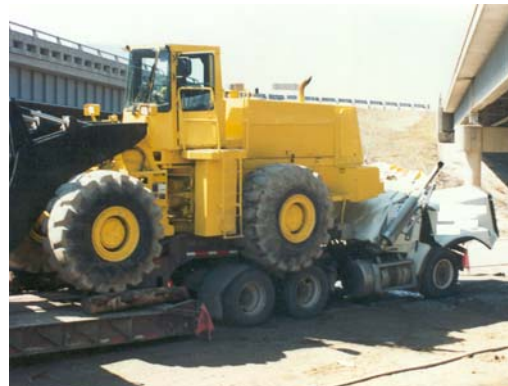
On April 10, 2002, a 56-year old truck driver with 22 years of experience died when a front-end loader weighing between 60,000 and 65,000 pounds that was being transported on a 50-ton lowboy trailer broke free from its securing chains and rolled onto the cab crushing him. The loader transmission was in neutral and the parking brake was set. The victim used at least four 3/8-inch chains rated at 6,600 pounds (the exact number is unknown) to secure the loader. Five binders were found at the scene. One chain appeared to be improperly attached to the loader's maintenance ladder, one chain appeared to be attached to an attachment point on the loader. The remaining chain attachments to the loader are unknown. If four chains were used, the load exceeded the aggregate working load limit of the chains. Also unknown is where each of the chain hooks and/or binder hooks were attached to the trailer. Based on the police report of the incident, at least one chain hook/binder was improperly attached to the trailer bed. One chain appeared to have an oversized hook. During transport, the driver stopped suddenly between two bridges. Skid marks from the truck were present on the roadway. It appears that a sudden stop caused sufficient force on the chains to break them. The loader rolled forward over the 5<sup>th</sup> wheel and onto the top of the truck cab. The cab was crushed, and the driver was declared dead at the scene.

Figure 1. Loader on truck cab

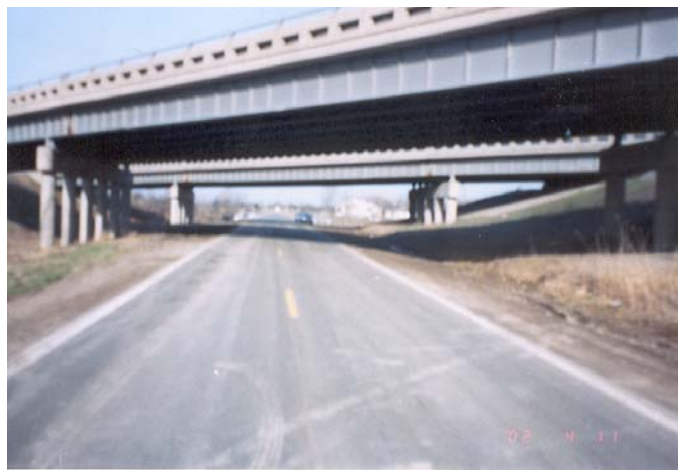
The loader was transported on a 2-lane paved, flat roadway that was in good condition. The speed limit was 55 mph. On the day of the incident the investigating police could not detect an obstacle that could have impaired the driver's vision. The overpass was measured at 17 feet 2 inches above the ground; the height of the truck with its load was 14 feet 1 inch.

Figure 2. Road where incident took place

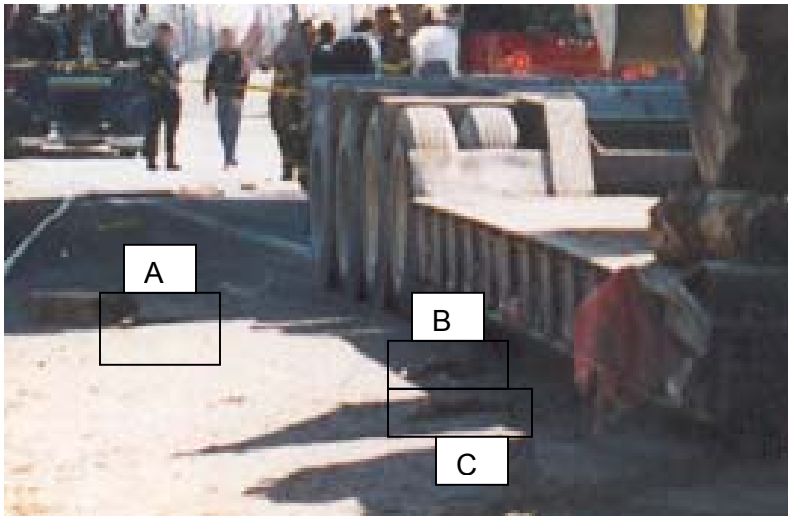
Police noted several chains and binders on the ground on each side of the trailer. The police located three ratchet binders and one chain on the passenger side of the truck's trailer. Figure 3 shows the chain and binder locations on the passenger side. One binder with a broken hook was found at the rear of the trailer (Box A). One binder/chain with a broken chain link were found at the middle of the trailer (Box B). One binder was located at the front of the trailer (Box C). Figures 4-5 show a close-up view of the binder with the broken hook noted in Figure 3, Box A.

Figure 3. Passenger side, Binders and chains marked in Boxes A-C

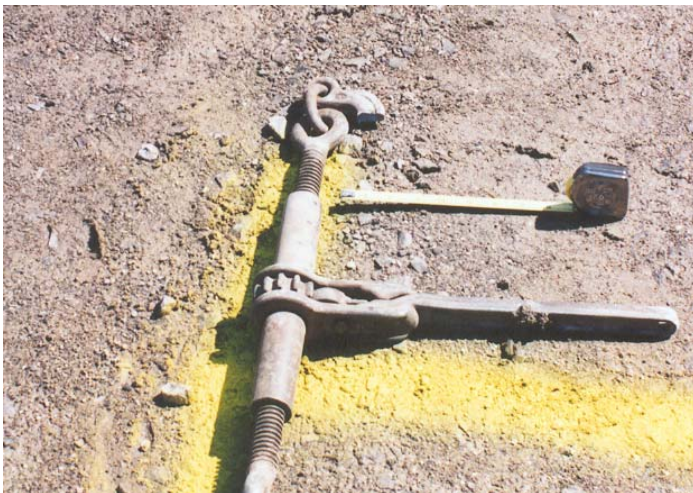
Figure 4. Broken binder hook, passenger side

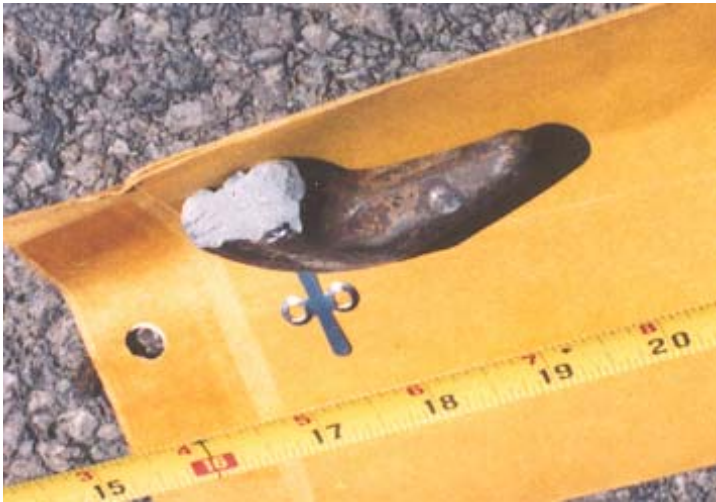
Figure 5. Broken hook, passenger side

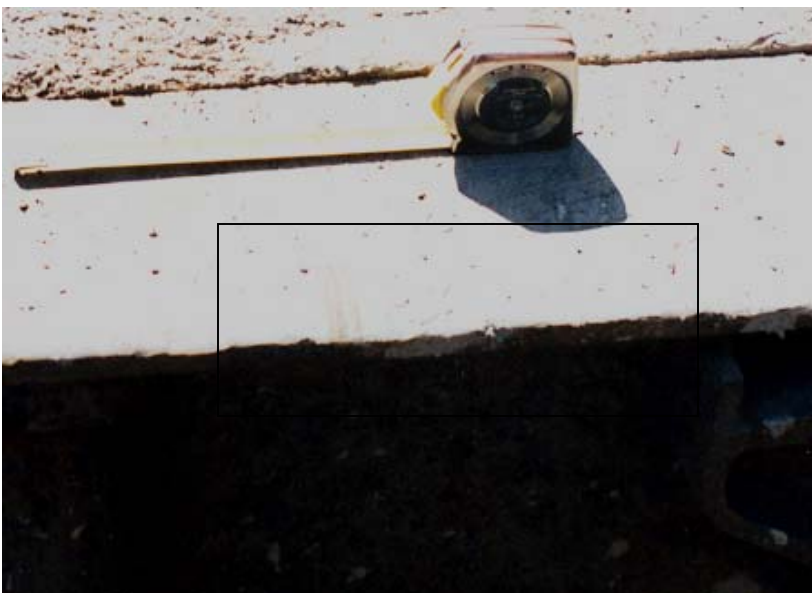
During their investigation, police found fresh scratches on the middle of the trailer decking. There were no fresh marks or scratches on the "D" rings. The box in Figure 6 outlines the chain or binder marks.

Figure 6. Chain or binder marks on trailer

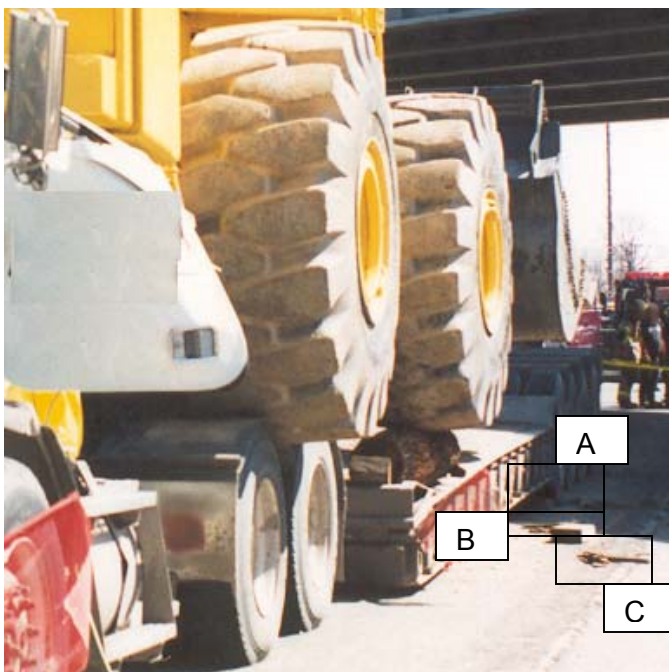
On the driver's side of the vehicle, Figure 7 shows the chains and binders found on the ground. One long chain was found at the rear of the trailer. (Box A and Figure 8) Another chain and binder were located at the middle of the trailer (Box B, and Figure 9). A binder was found toward the front of the trailer (Box C).

Figure 7. Driver's side view of chains and binders. Binders and chains marked in Boxes A-C

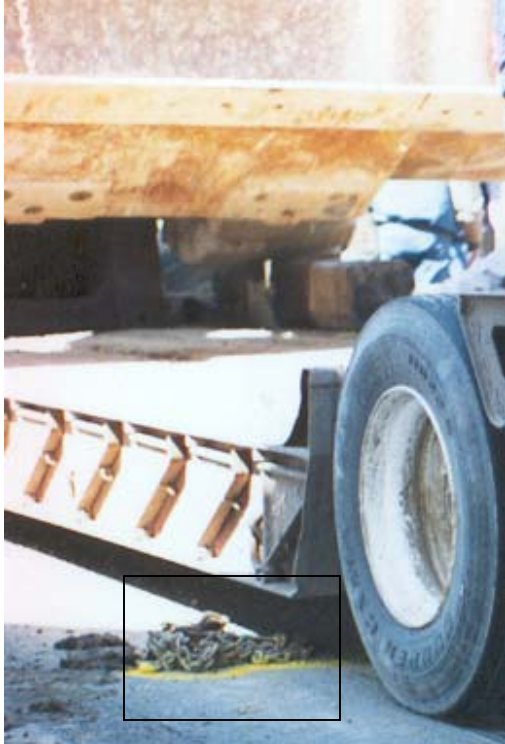
Figure 8. Long chain at trailer rear on driver's side

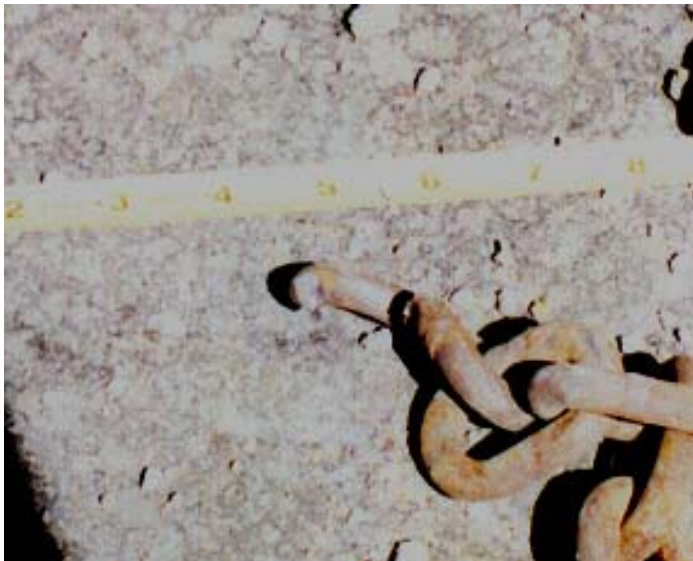
Figure 9. Broken chain, middle of trailer, driver's side

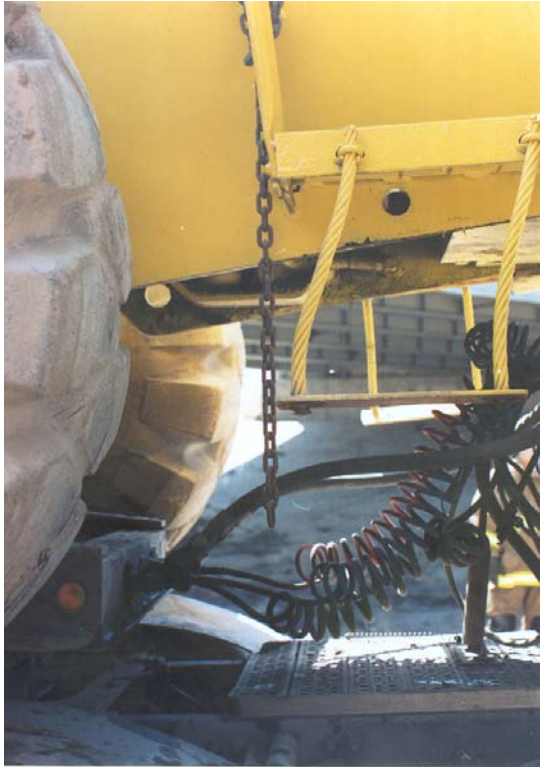
Broken chains were also attached to the loader. One chain appeared to be attached to the mechanic's ladder (See Figure 10) on the passenger side of the truck. Two chains were attached to the loader bucket (Figure 11). It is unknown if the chains on the bucket were

Figure 10. Chain on mechanic's ladder, passenger side.

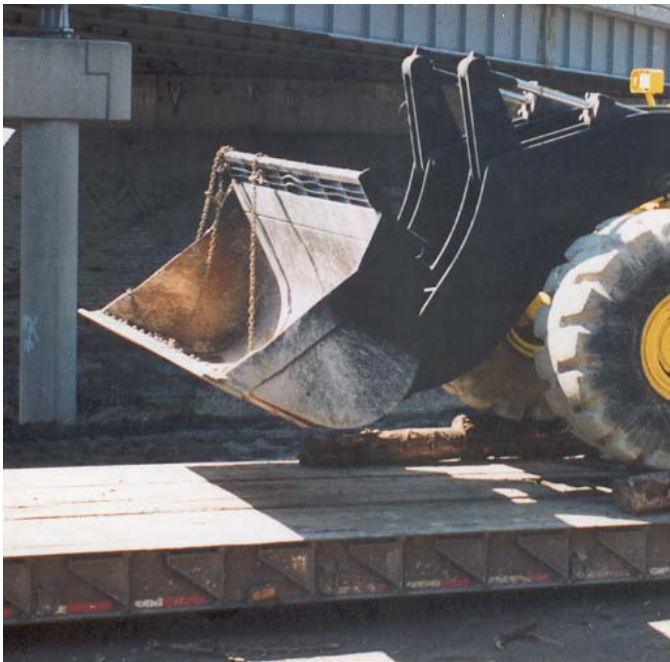
Figure 11. Two chains on loader's bucket

The victim did ensure that the loader's hydraulic bucket (accessory equipment) was completely lowered to the trailer bed. It is unknown if the chains on the bucket were intended to secure the bucket to the trailer and to prevent articulation in transit.

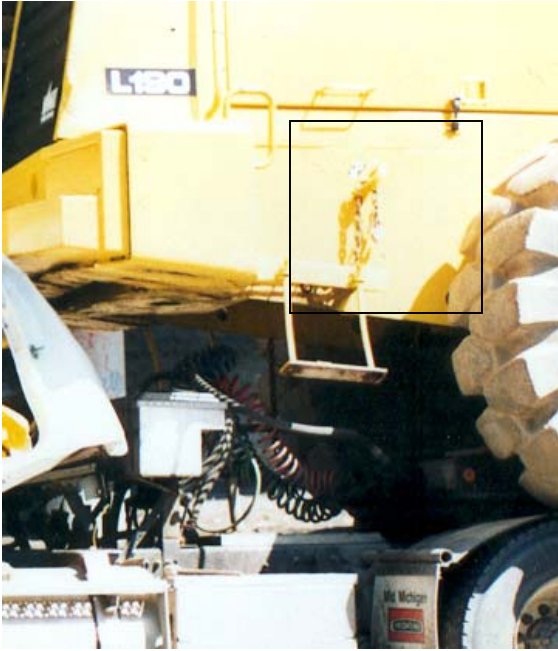
used for securing the loader or if they were used earlier and prior and were not taken off the loader prior to transport. One chain is attached to an attachment point on the loader (See Figure 12).

Figure 12. Chain located on loader, driver's side

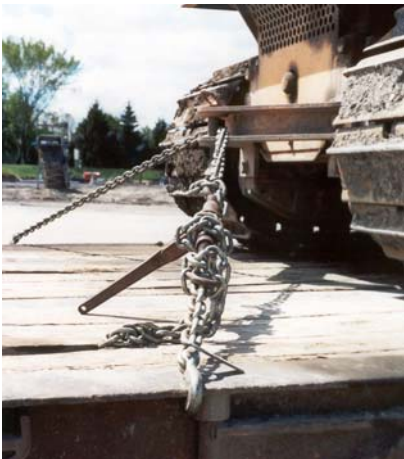
During the MIFACE visit, the company representative arranged for a lowboy trailer that was loaded with a piece of heavy machinery to be driven to the company headquarters so the MIFACE representative could see how a load should be secured. The loader blade was retracted and wedged against the trailer end. The individual who secured the load on the trailer stated he was trained by the victim and also by a trade association representative on proper load securement procedures. Figures 13 and 14 show that the loader was not properly secured on the trailer bed. Figures 13 and 14 were taken looking down the driver's side of the trailer. Figure 13 shows that one of the chains used to secure the load is improperly attached to the trailer bed. Figure 14 shows proper attachment to the "D" ring, but improper loader attachment.

Figure 13. Improper attachment of loader to trailer bed

The development of a “load securement” SOP and training associated with the SOP will assist individuals responsible to secure cargo being transported to properly assess the securement requirements of the load, including the number of tie down assemblies required and appropriate load attachment points. The SOP should prohibit the work practice of attaching chain hooks/binders directly to the truck trailer bed.

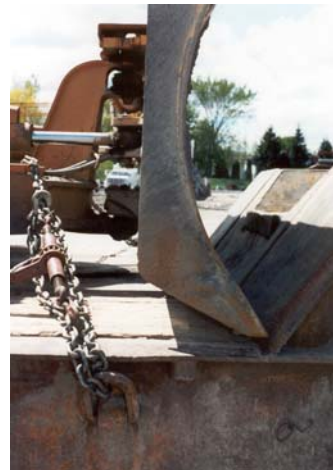
Figure 14. Proper attachment to "D" ring

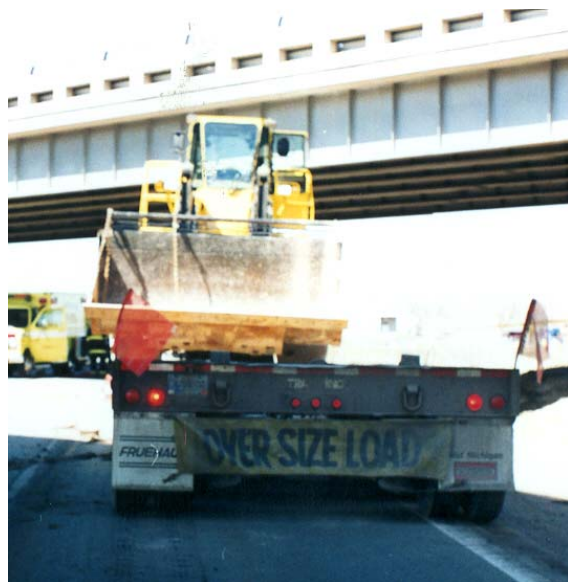
The load was not adequately secured against longitudinal (forward/rearward) and lateral movement. See Figure 15. Protecting against longitudinal movement insures the cargo remains on the vehicle and does not penetrate the vehicle's front-end structure. Protection against lateral movement insures the load does not shift sideways in transit.

Figure 15. Lateral movement of loader

- Companies should require and train employees to use manufacturer identified cargo attachment points and "D" rings on the trailer using the appropriate number of tiedown assemblies.

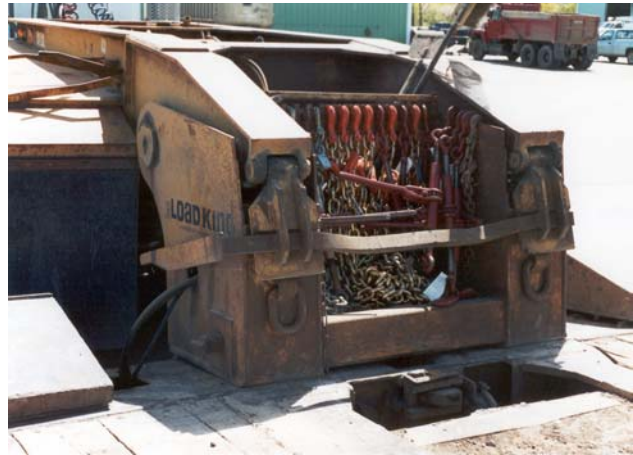
Figure 16. Storage area holding 1/2 inch chains

Company personnel indicated that the company has upgraded from 3/8-inch chains to 1/2-inch chains. See Figure 16. The entire tiedown assembly is only as strong as its weakest component. When upgrading, the company must take the next necessary step to ensure that the chain upgrade does not exceed the working load limit of any of the other components of the assembly, such as the hooks, tensioner, “D” rings, equipment attachment points, etc.

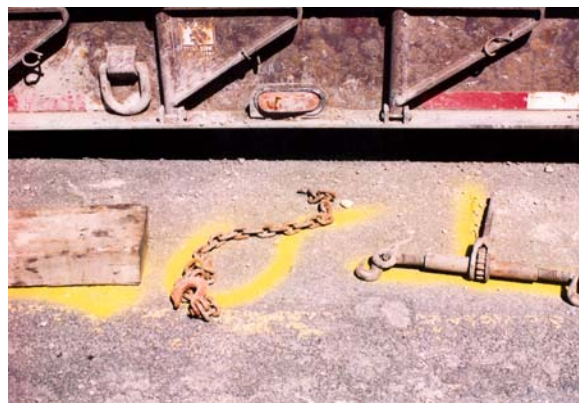
On the day of the incident, it appears that the victim used a grab hook with a throat too big for the 3/8-inch chain link. See Figure 17. The chain links would not fit securely inside of the throat and could possibly slip during transport.

Figure 17. Oversized hook, driver's side

- Companies should ensure all components of a tiedown assembly are inspected for defects and correlate in size while securing each load.

FMCSA Rule 393.104 states that all vehicle structures, systems, parts, and components including vehicle tiedown anchor points used to secure cargo must be in proper working order when used to perform that function with no damaged or weakened components that will adversely effect their performance for cargo securement purposes, including reducing the working load limit and must not have any cracks or cuts. Company personnel indicated that they routinely check the chains for stretched links by laying the chain out and measuring. According to a company worker, chains normally don't stretch; they break. The workers do not routinely check for damaged chain links, damaged transport vehicle anchor points, or damage to the anchor points on the load. MIFACE recommends that the company require drivers who transport loads to check all components of the tiedown assembly during securement to ensure all components are in proper working order.
