## MIFACE INVESTIGATION: #02MI016

### SUBJECT: Rig Hand Entangled In Rotating Drive Shaft While Hanging Light in Rig Substructure

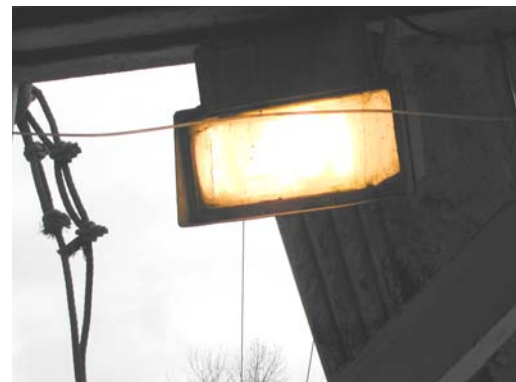
Figure 4

and a 6-8 foot flexible cord, which was to be plugged into a receptacle located on the doghouse side of the derrick. An example of the light the victim was hanging is shown in Figure 4. Another worker handed the light to the victim while he was in the substructure area, and walked away.

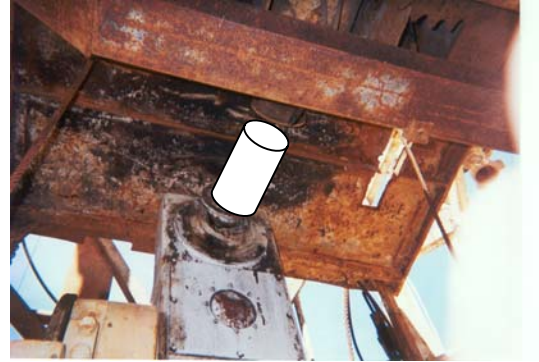
To mount the replacement light, the victim was looking to the south, and was attaching the light to the angle iron in the southwest corner of the substructure. The victim was instructed to place the light on the bottom of the beam approximately 12" below the rig floor. The victim did not use a ladder to climb up so he could hang the light; he climbed on the winches/steel mounting plates. When he climbed on the winches and/or steel plates, the drive shaft was located approximately 2-3 feet to his left and 2-3 feet above his head. Figure 5 shows the prior setup without the drive shaft attached. The white cylinder represents the drive shaft location when installed.
