# MIFACE INVESTIGATION: #01MI029

**SUBJECT:** Farmer Crushed between lift arms and frame of skid-steer loader

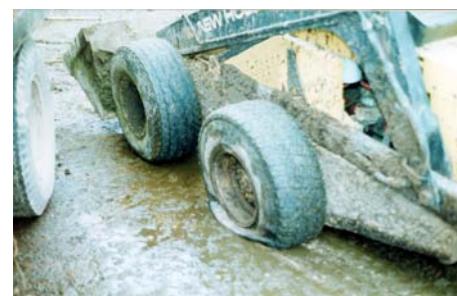
Figure 2

outside of the operator's compartment through the unguarded window opening to look at the flat tire. While he was leaning outside of the cab, he apparently activated the left foot pedal, causing the bucket to lower quickly, crushing his head between the frame and the lift arm. See Figure 2.

The skid-steer loader did not have side shields or a properly working seat hydraulic safety switch. The farm owner recognized the operating hazards of using the skid-steer loader without the side shields, as he had informed family members to keep their bodies within the cab. Skid-steer loader operators are seated in close proximity to the moving lift arms. The farm owner must have believed that he could safely operate the machine without the side screens in place, because he had used the skid-steer in the past without the side screens. The side screens on a skid-steer loader cab are mounted within the frame of the rollover protective structure (ROPS) by a force fit rubber gasket. The side screens and related hardware were damaged in a fire on at the previous owner's property. The gasket material and side screens were not replaced by the previous or current skid-steer owner.

When the left rear tire blew, the victim must have instinctively leaned outside the confines of the cab to look at the blown rear tire. This movement caused him to be inside the lifting arms plane of motion while the arms were in a raised position. Upon leaning to his left, he must have inadvertently stepped on the lift control pedal, lowering the lift arm. Had the side screens been in place, they would have protected the operator from being caught in a pinch point created by the moving lift arms by providing a physical barrier from the plane of motion of the lift arms. The victim would have been prevented from placing any part of his body in the lift arm plane of motion.

- Skid-steer loader owners should ensure that all safety devices and physical safeguards, such as side screens on equipment are in place and operating.
