MIFACE INVESTIGATION: #01MI025

SUBJECT: Delivery Man Struck by Vehicle While Stopped on Roadway to Change Delivery Van Flat Tire

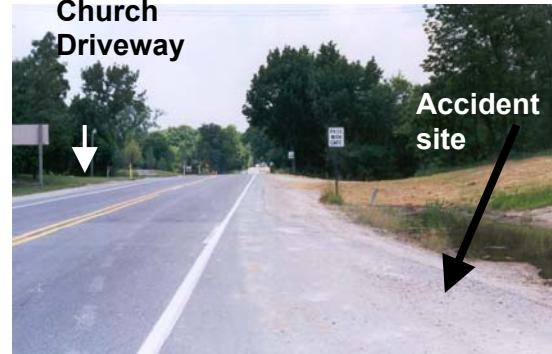
On February 13, 2001, a 49 -year old male died from injuries sustained when he was struck by another vehicle after pulling off a roadway to a paved shoulder to change a blown passenger side front tire. (See Figure 1). It is unknown where the driver experienced the blown passenger tire.

Figure 1
At corner of road/interchange, looking north

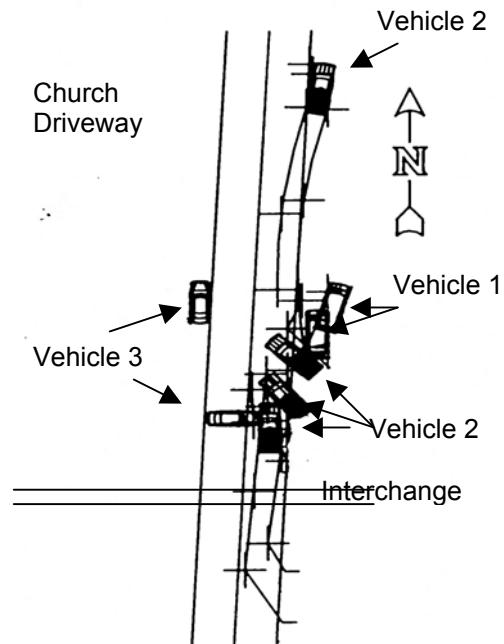
Figure 2

The police report and accident investigation was used to construct the sequence of incidence events. The police report provided the accident drawing, MIFACE labeled the vehicles. The accident drawing is labeled below as Figure 2.

Vehicle 2 was traveling northbound at approximately 54 mph. Vehicle 3 was traveling southbound, and had slowed to approximately 14 mph. Just south of where the delivery van was parked, Vehicle 3 appeared to make a u-turn to travel north. When Vehicle 2 saw Vehicle 3 begin to make the u-turn, Vehicle 2's driver slowed Vehicle 2's speed to

approximately 35 mph. Vehicle 2 was unable to avoid being struck by Vehicle 3. Vehicle 3, while making the u-turn, struck Vehicle 2's driver's side door. The collision caused Vehicle 2 to uncontrollably slide to the right, toward the delivery van. Vehicle 2's passenger side truck bed struck both the victim who was standing at the rear of the delivery van on the driver's side. Vehicle 2 continued to slide northbound for approximately 80 feet, coming to rest facing north on the shoulder of northbound lane. Vehicle 3 spun and came to rest facing north on the southbound lane shoulder. One of the drivers involved in the collision called 911, and emergency personnel arrived shortly thereafter. The victim was pronounced dead at the scene due to injuries sustained at the crash site.

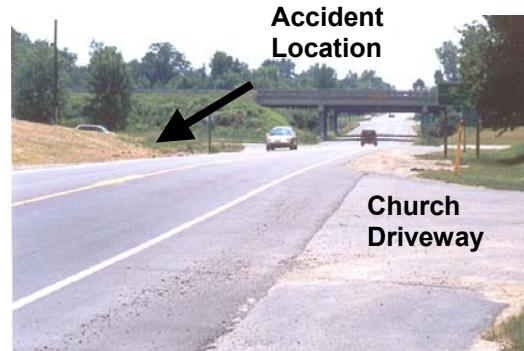
In this incident, the victim stopped on the wide, paved shoulder to change the tire just north of a busy intersection. Although the shoulder was a paved, even shoulder, there was a “safer” location to pull over to change the tire. Just north of his selected location, on the west side of the road, was a church. The driver should have turned into the church’s paved driveway and removed himself completely from the roadway. See Figure 3.

Figure 3
Looking south

- When changing a tire, choose a safe location out of the flow of traffic. To alert other drivers, use hazard warnings, such as emergency flashers and flares or reflectorized triangles.
