MIFACE INVESTIGATION: #01MI011

SUBJECT: Machinist Struck and Killed by Fragments from Ruptured Steam Turbine Housing

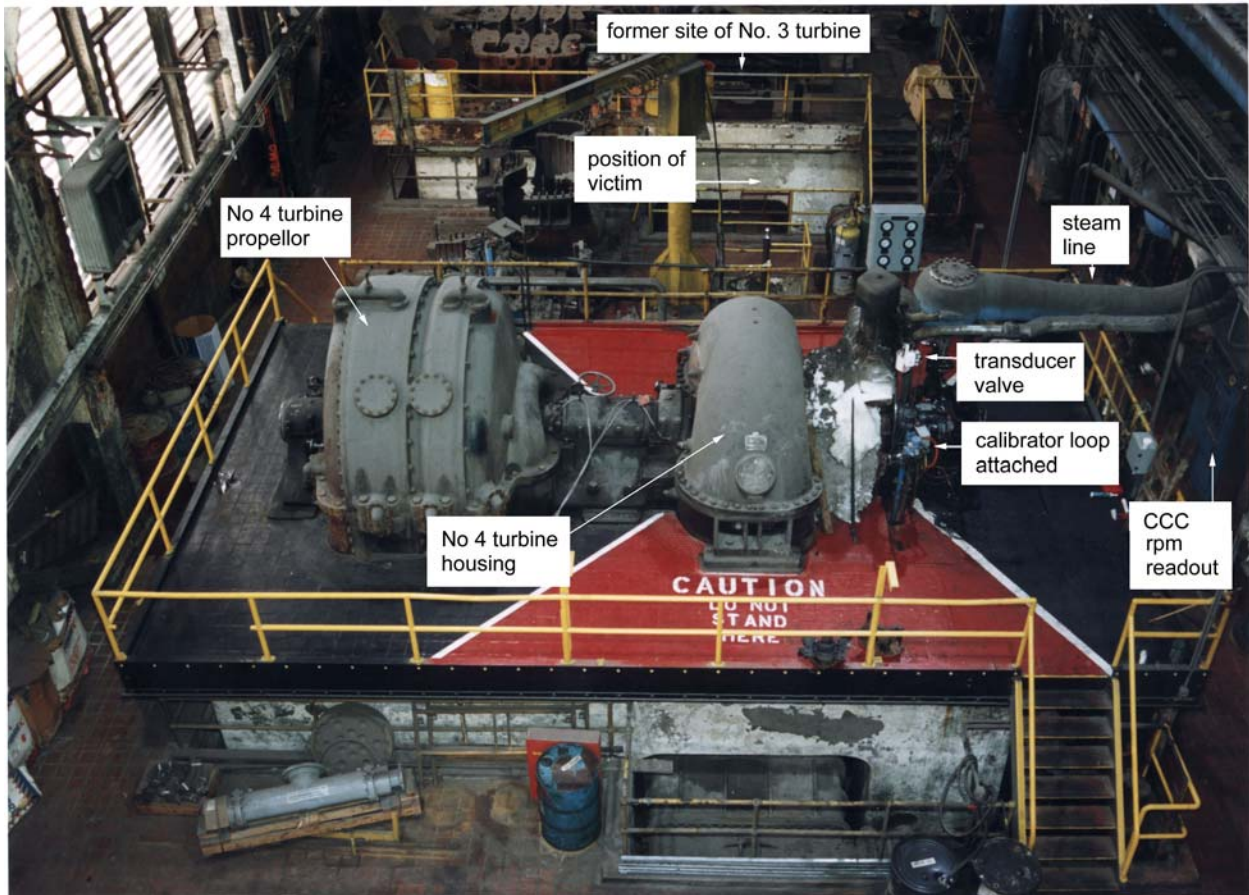
Although guardrails, barriers and signs cannot be the primary means to protect workers, they provide a useful visual reminder of existing hazards to supervisors and workers. The area identified as restricted surrounding No 4 turbine (Figure 1) would have encompassed the position where the victim was standing. A visual reminder should be sufficient in itself to warn a worker of a hazard. They also serve to underline the authority of a verbal reminder.

Figure 1
Plant Area Showing Former Site of Turbine No 3 and Site of Turbine No 4

- No one is allowed near the equipment during the test.
- Barricades, warning signs, and markings identify the restricted area. These warnings can be seen in Figure 1 as they were implemented for the No 4 steam turbine.

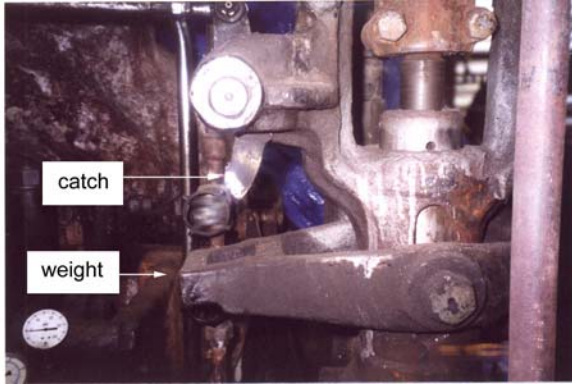
situation and signaled for the milliamp current that was controlling the transducer to be reduced, it was too late to stop the turbine from overspeeding. The mechanical shutoff device did not trip (Figure 2). The turbine buckets overran their safe speed causing a catastrophic failure of the turbine rotor. There were 12 rings on the turbine shaft (Figure 3). One hundred buckets broke away from one of the twelve rings on the shaft and pierced the two-inch thick turbine housing. The other eleven rings remained intact. The fragments resulting from the broken housing and turbine buckets struck the victim causing severe injuries and death.

The rpm gauge on the turbine was located at a critical position next to the mechanical trip device. Someone positioned at that location would have been able to immediately identify the overspeed condition and physically trip the device. The gauge was placed there for just that reason. Because it was unusable, the designed safety control of the proximate position of the two parts was overlooked. The safety redundancy was subsequently eliminated.

Figure 2
Mechanical Trip Device

- Redundant safety controls were established for conducting the overspeed trip test: the manual shutoff valve is the primary control, the person in the control booth conducting the test is located next to an emergency stop; the computer controlling the test is programmed to electronically shut down at a particular ceiling speed.

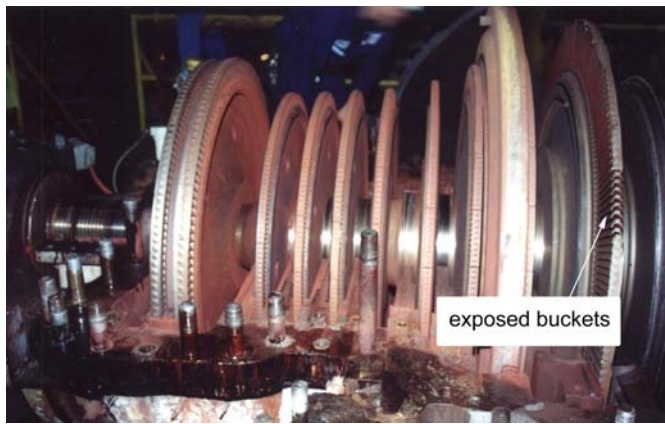
Figure 3
Turbine Shaft and Rings
