# MIFACE INVESTIGATION: #01MI008

## SUBJECT: Welder Struck By Falling Steel Frame

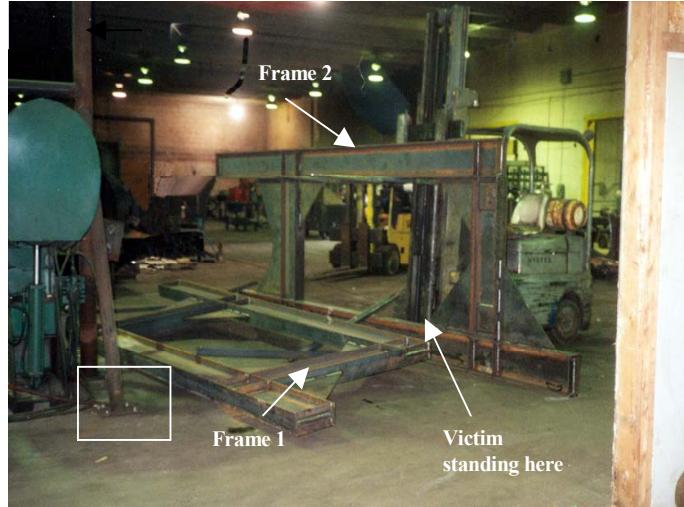
Figure 1

Frame 1 was moved to an upright, vertical position next to a hoist's vertical support pole, and left in an unrestrained, freestanding position. Two three-inch steel channel bars were tack-welded to the base of Frame 1. The channel bars were thought to provide upright support as well as a positioning aid for Frame 2. Frame 2 was moved into position by the forklift, and the channel bars from the base of Frame 1 were positioned on the top of the I-beam base of Frame 2. The forklift was supporting the top I-beam of Frame 2, and the victim was facing the forklift and standing between the unsecured Frame 1 and the forklift supported Frame 2. The victim was directing the forklift driver to properly position Frame 2. He was also helping with minor position adjustments of Frame 1. When Frame 2 was in the proper position, the victim was going to tack-weld the channel bars from Frame 1 to Frame 2's base I-beam. During the positioning of Frame 2, the forklift driver observed Frame 1 begin to fall. The driver yelled to the victim to get out of the way. The victim could not react quickly enough, and the top I-beam of Frame 1 struck the victim, and he fell against Frame 2. Fellow workers called 911 and lifted Frame 1 from the victim. Paramedics arrived and took the victim to the hospital where he died a short time later.

Frame 1 was the first section to be moved into position. A forklift moved frame 1 to an upright, vertical position next to a hoist's vertical support pole, in an unrestrained, freestanding position, standing approximately 6 feet in height. Two three-inch steel channel bars were tack-welded to the base of Frame 1 to provide both upright support and to act as a positioning aid for Frame 2. Frame 2 was moved into position by the forklift, and the channel bars from Frame 1 were positioned on the base of the I-beam of Frame 2. The forklift was supporting the top I-beam of Frame 2, and the victim was facing the forklift and standing between Frame 1 and Frame 2. He was directing the forklift driver to properly position side 2. He was also assisting in minor position adjustments of Frame 2. When Frame 2 was in the proper position, the victim was to tack-weld the channel bars from Frame 1 to the Frame 2's base I-beam. During the positioning of Frame 2, the forklift driver observed Frame 1 begin to fall. The driver yelled to the victim to get out of the way. The victim could not react quickly enough, and the top I-beam of Frame 1 struck the victim and he fell against Frame 2. Fellow workers called 911 and lifted Frame 1 from the victim. Paramedics arrived and took the victim to the hospital where he died a short time later.

- ◆ **TIE OFF:** Tie off any unsupported I-beams using a chain or "C" clamp to a secure mounting area. The secure mounting area should be properly secured at both top and bottom. Although not used, the hoist vertical support was properly secured and supported at ground level via a plate with bolts. (See Figure 1, white box). The type of support at the top of the hoist pole is unknown. Before using this method of securing a freestanding piece, ensure that the structure used for support is capable of supporting the additional weight of the structure being tied off.

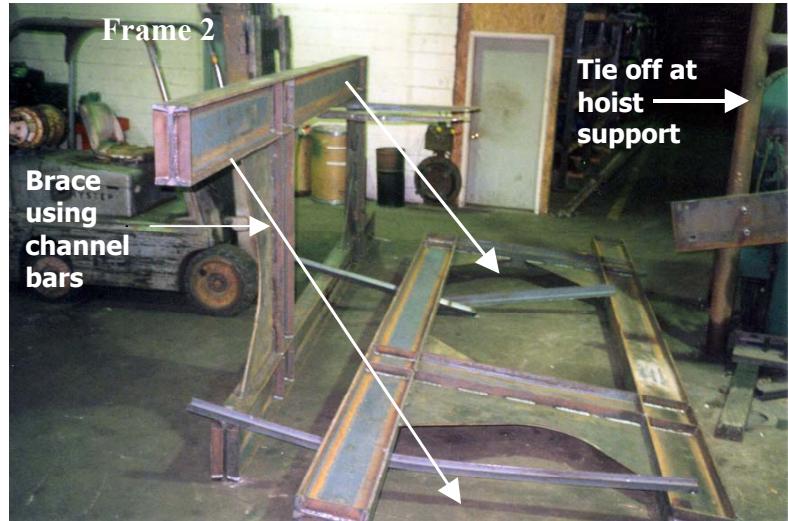
Figure 2

The unsupported, freestanding Frame 1 should have been supported to prevent its potential for movement, which could result in tipping and subsequently falling to the ground. Several methods could be used to support the freestanding frame. Below are two alternative suggestions:

- ◆ **BRACE:** Tack-weld at least a 3" channel brace (or "L" or "W" flange) at a 30-45 degree angle from each end of the top I-beam, and secure the brace to the floor via brackets, plates, etc. In Figure 2, this concept is demonstrated with Frame 2. The white arrows pointing to the floor represent the location of channel braces that should be tack welded to the top of the I-beam and appropriately secured to the floor.

The forklift was supporting Frame 2 during the incident. After properly positioning Frame 2, and tack welding the 3- inch channel sections from Frame 1, Frame 2 should not be left unsupported while retrieving Frame 3. The tack welded channel sections from Frame 1 should not be considered as an adequate support for Frame 2. Frame 2 should be supported as suggested above, either by bracing or tying off to a structure.
