MIFACE Investigation: #01MI006

SUBJECT: Pastor struck by falling roof ice dam, subsequently died from complications

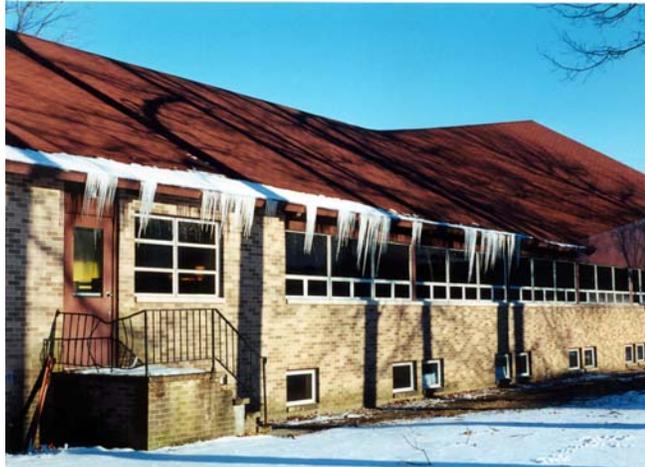
On January 28, 2001, a 48-year old male died of injuries he sustained approximately two weeks earlier when he was clearing icicles from the church roof at the church where he was pastor. The victim stood facing the church building and used a snow shovel to knock off icicles from the west side of the building roof. He began the roof clearing operation by clearing the small icicles from the roof first. After clearing the smaller icicles, he began work on the bigger icicles. Starting from the tip of the

icicle, he used the snow shovel to break the icicle into smaller portions. The victim apparently loosened an ice dam at the roof edge during the icicle clearing operations, and the icicle and the associated rooftop ice dam, estimated weight of one-half ton, fell on him. The icicle crushed his foot, and the ice dam hit his shoulder. He was rushed to the hospital, and due to the extent of the injury, his leg was amputated below his knee. The victim was treated and eventually released from the hospital to continue recuperating from the injury at home. Several weeks later, he began to feel ill, and had difficulty breathing. He was rushed to the hospital, where he died a short time later from a blood clot in his lung.

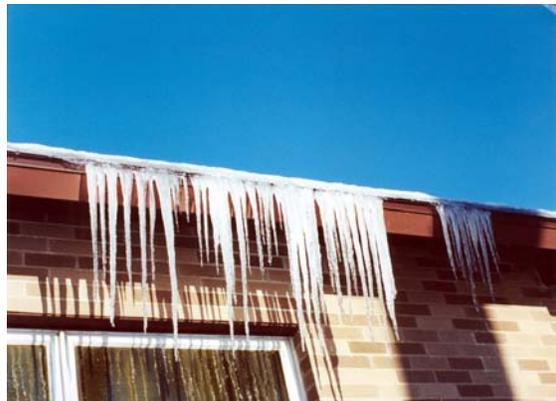
An ice dam is a barrier formed at the roof edge that prevents melt water from running off a roof. Ice dams can form when as little as 1 or 2 inches of snow accumulates on a roof - if the snowfall is followed by several days of sub-freezing temperatures. An ice dam develops when there is a temperature difference between different areas of a roof. In the winter, heated air enters the truss space, accumulating at the truss space's peak unless it is vented outside. Because warm air rises, the upper portion of the truss space is always the warmest. Lower areas of the roof, especially the area just above the eave, remain cold. The area near the eave may have a roof temperature that is not

much higher than the ambient outdoor temperature. Especially in an unvented truss space, heat high in the truss space raises the roof sheathing temperature and causes snow to melt near the roof peak. The water from the melting snow flows toward the eave area, where colder roof temperatures allow it to freeze. If conditions persist over several days, this refreezing of snowmelt can form an ice dam. Deeper snow and colder temperatures increase the likelihood and size of ice dams. Every inch of snow that accumulates on the roof's surface insulates the roof deck a little more, trapping more indoor heat beneath the roof deck. Frigid outdoor temperatures assure a fast and deep freeze at the eaves. So the worst ice dams usually occur when a deep snow is followed by very cold weather.

- Increase truss space ventilation to alleviate accumulation of warm air at the peak of the truss space and the subsequent melting of snow that refreezes at the eave edge.

The church does not have any truss space ventilation. Truss space ventilation can help to diminish the temperature differential between the roof peak and the eaves by allowing the heated air to escape from the truss space. The most effective way to eliminate heated air from a truss space area is to combine a ridge vent with soffit vents. A ridge vent is a continuous opening along the entire ridgeline of the roof. The soffit vents must be installed on opposite sides of a building to allow for effective truss space ventilation. With appropriate truss space ventilation, the heat is vented out of the truss space creating a colder roof surface and diminishes snowmelt from the roof surface to refreeze on the eave area, diminishing ice dam and icicle formation.

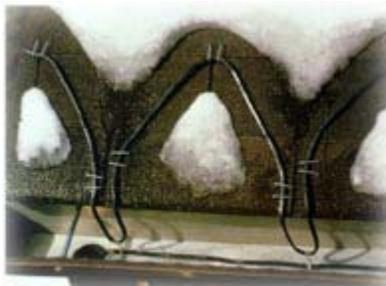
Heat Tapes

Heat tapes or roof de-icing cables can be used to help prevent ice dam formation on the eaves. Disadvantages to heat tapes or de-icing cables are that they are heated by electric power, are expensive to install and use, and can leak water through loose fasteners. At times, the electric cable creates an ice dam just above it. A qualified contractor is recommended for installation of heat tapes and/or roof de-icing cables.
