## MIFACE INVESTIGATION: #01MI003

**SUBJECT:** Operator Crushed Between a Rotating Barrel and Its Hoist Support Bar

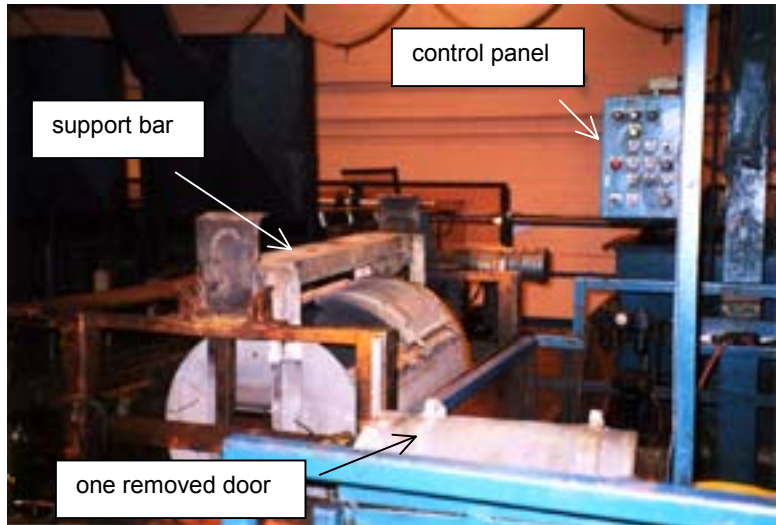
Figure 1  
Operator's Workstation

On January 20, 2001, an 18-year old male died from crushing head injuries sustained when he was pulled into the hoist support bar of a rotating barrel by the rotation of the barrel. He was the operator at the unload station of a barrel plating operation. The hoist supporting the barrel placed the barrel containing the plated parts onto a cart that transported the barrel from the last plating station to the unload station. Approaching the unload station from the right, a tab on the barrel contacted a wire on a limit switch that stopped the barrel rotation so that two doors on the barrel were facing the operator. He removed the two doors from the barrel and pushed two palm buttons on a control panel to the right of the station so the barrel continued, moving right to left, to a dump station.

Although no one saw the incident take place, it is presumed that the operator reached into the barrel to remove some parts that had not fallen out at the dump station as the barrel was returning to the operator's station. The barrel would have been rotating to find its position for the replacement of the doors. It is believed that his sweater became entangled on something inside the barrel, and he was not able to extricate himself. His sweater was torn on the left arm. Apparently the limit switch did not function to stop the barrel from rotating at the unload station. The left side of the victim's head was pulled into the hoist support bar and crushed between the bar and the rotating barrel. When the equipment was tested after the event, the limit switch did not stop the barrel rotation.

- A light curtain was installed, so that the equipment will shut down if anyone reaches through it into the path of the returning barrel.
- The rail guarding was extended so that an operator cannot reach into a barrel before it reaches the unload station.
- The position of the limit switch was moved further to the left of the unload station, so that the barrel stops rotating well before it reaches the unload station.
- An emergency stop was installed on the left side of the unload station within the reach of the operator standing at the unload station.

- Review the design characteristics of the barrel to ensure that parts tumble out freely when it is tilted.

Because of the possibility that the operator was trying to retrieve parts that had not fallen out of the barrel at the dump station, the barrel perforations and size of door opening should be reviewed to insure that the plated parts tumble out unimpeded.

- Guard moving parts at equipment point of operation

Guards must cover all moving parts in such a way that no part of the operator's body can come into contact with them. All rotating equipment parts have inherent dangers. Even slowly rotating equipment can grip material it contacts. Where there are protrusions, the potential for catching increases, and the travelling motion of a rotating piece of equipment is a cause for yet greater vigilance. This piece of equipment encompassed all three.
