INVESTIGATION REPORT

Fatality Assessment & Control Evaluation Project

FACE 03-NJ-086

Laborer Crushed Under Overturned Road Milling Machine

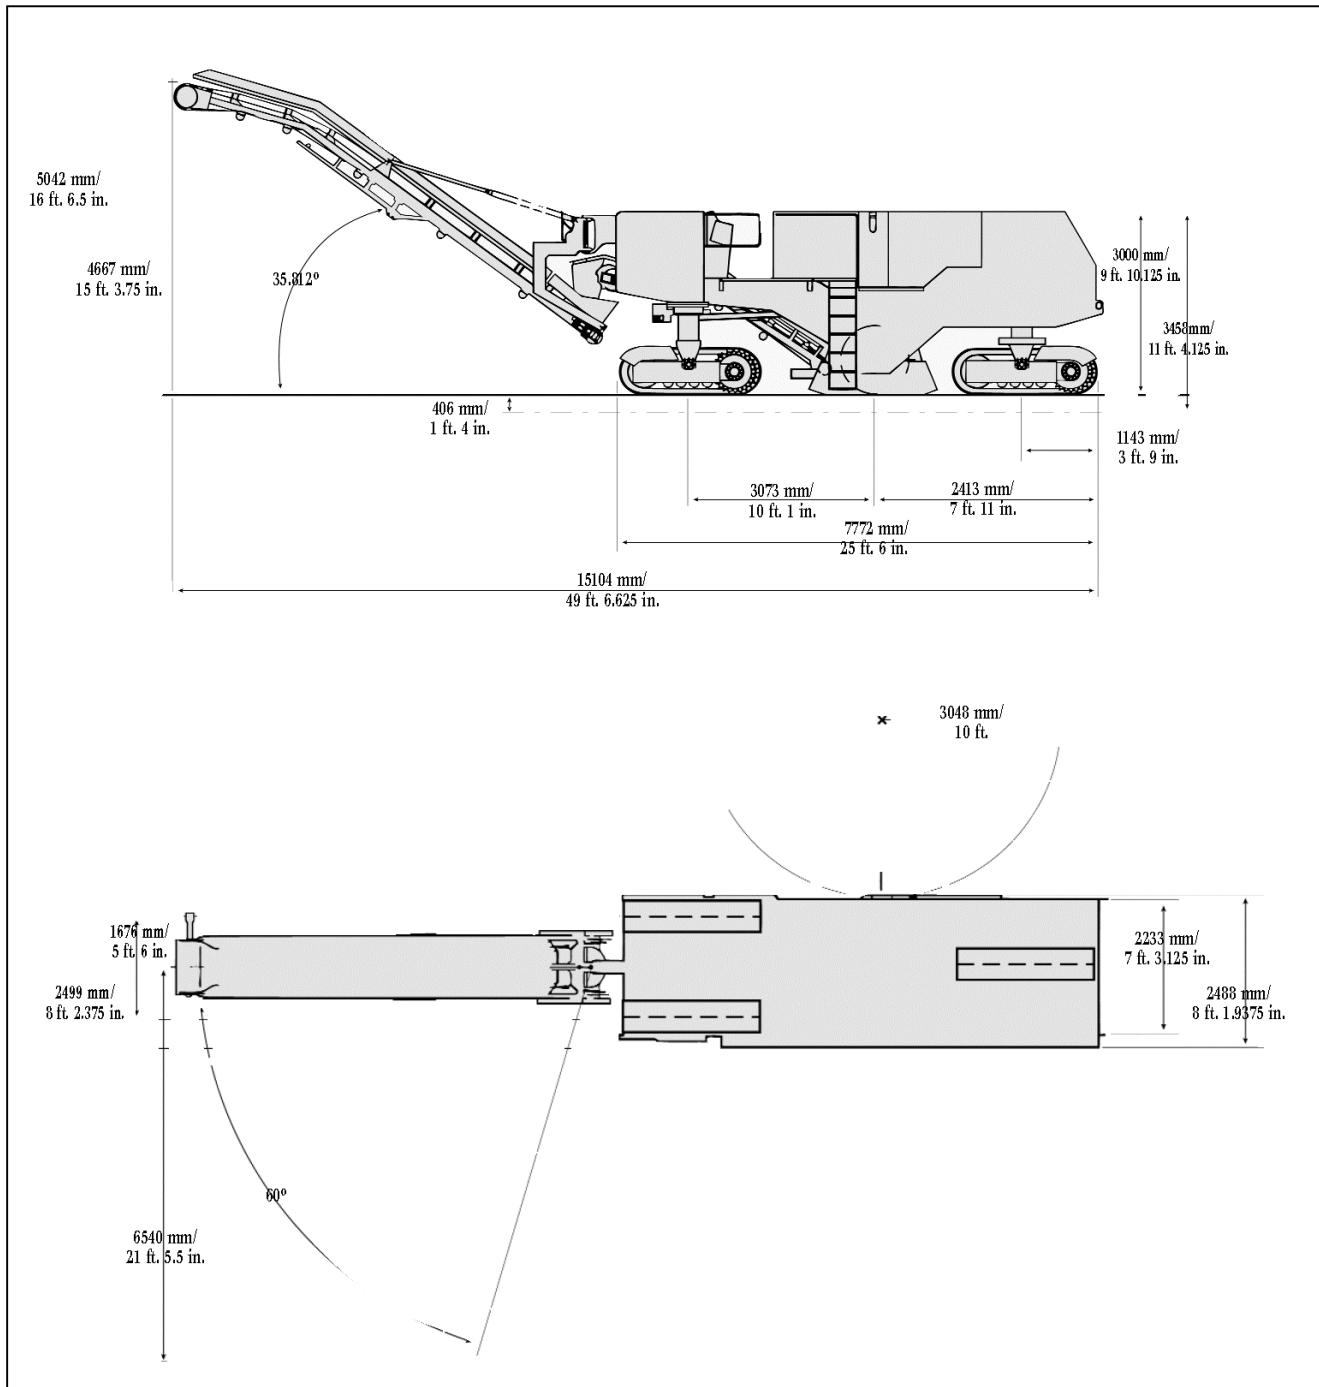
The machine involved in the incident had a specified weight of 80,760 pounds and was equipped with an 800 horsepower diesel engine. The manufacturer listed its operating dimensions as 10' wide, 9' 10" high, and 49' 6" long (see Figure 1). This machine ran on three caterpillar tracks, with two tracks in the front and a single, central track in the rear. All three tracks had listed measurements of 7' 9" long and were mounted on steering pivots. The front tracks were 14" wide, and the rear track was 18" wide. The machine could travel at an operating (milling) speed of up to 308 feet per minute and a traveling speed of up to 3.5 miles per hour. A 1,300-gallon water tank supplied water to the spray nozzles for the 176 bits on the cutting drum. The

Figure 1
Manufacturer's illustration of profiler/reclaimer

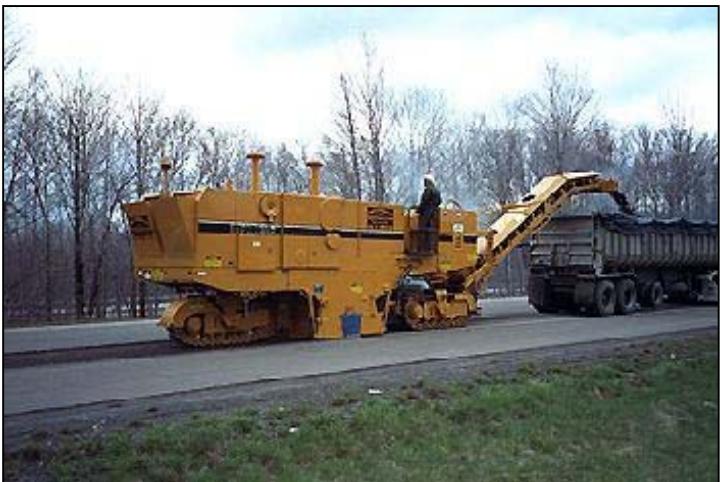
Photo 1
Manufacturer's photo of machine in use

material (see Photo 1). The cutting depth was set by adjusting the height of the tracks, each of which could be independently raised and lowered. This lifted the body of the machine off the ground, which set the height of the fixed cutting drum, located in the center of the machine. This feature allowed the machine to operate on uneven road surfaces, as one track could be set higher than the other to keep the cutting drum level. The cutting depth was maintained with an elevation sensor on each side of the machine. The sensor resembled a small outrigger, which swung away from the machine. Each sensor had a small wheel that followed the road surface and allowed the machine to correct itself. The sensors could be set to operate automatically, or in manual mode with a worker walking beside it to make the adjustments. Once set up, the operator moved the machine forward, causing the rotating cutting drum to mill and remove the road surface. Once the removal of a section (usually a long strip) was completed, the operator would back the machine to the starting point, position it for the next section, and resume milling.

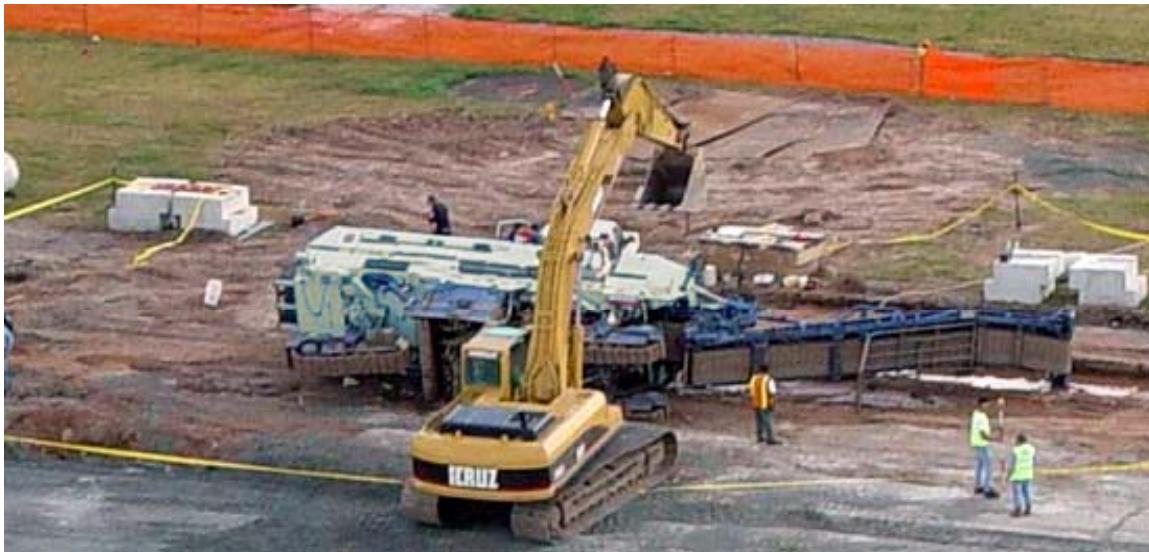
Photo 2
Photo of incident site showing excavator lifting machine
(Port Authority Police)

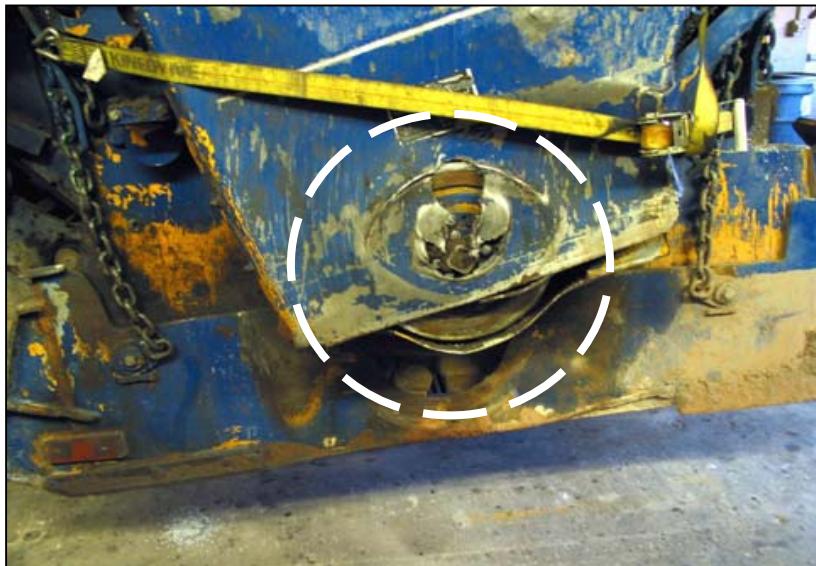
Discussion: During the examination of the machine, damage was noted that indicated that the cutting drum was rotating at the time of the incident (see Photo 3) when the machine was reportedly being backed into position. The operator's manual states that the cutting drum should not be engaged until a number of steps are completed, including adjusting the conveyor and elevation sensors. The manual also clearly warns that:

Photo 3
Damage caused by rotating drum bearing cutting through machine's sheet metal during tip-over

It is possible that the kick felt by the operator before the machine tipped was the rotating cutter contacting the uneven surface and/or debris. It is not known if this directly contributed to the incident, however the above warnings indicate that this could cause the machine to move backward uncontrollably.

Recommendation #2: Employers should ensure that machinery is operated in accordance with manufacturers directions.
