# Fatality Assessment and Control Evaluation Project

KY FACE #98KY072

20 January 1999

SUBJECT: Farmer Killed When Tractor Punctures Gas Line Causing an Explosion

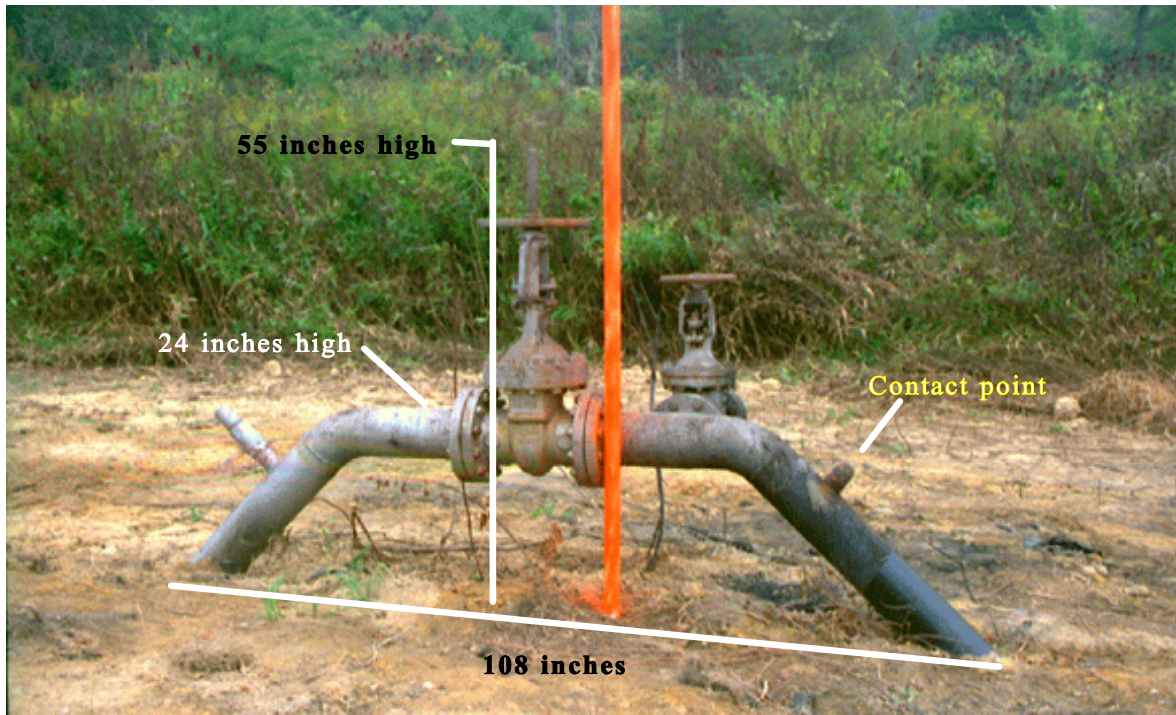
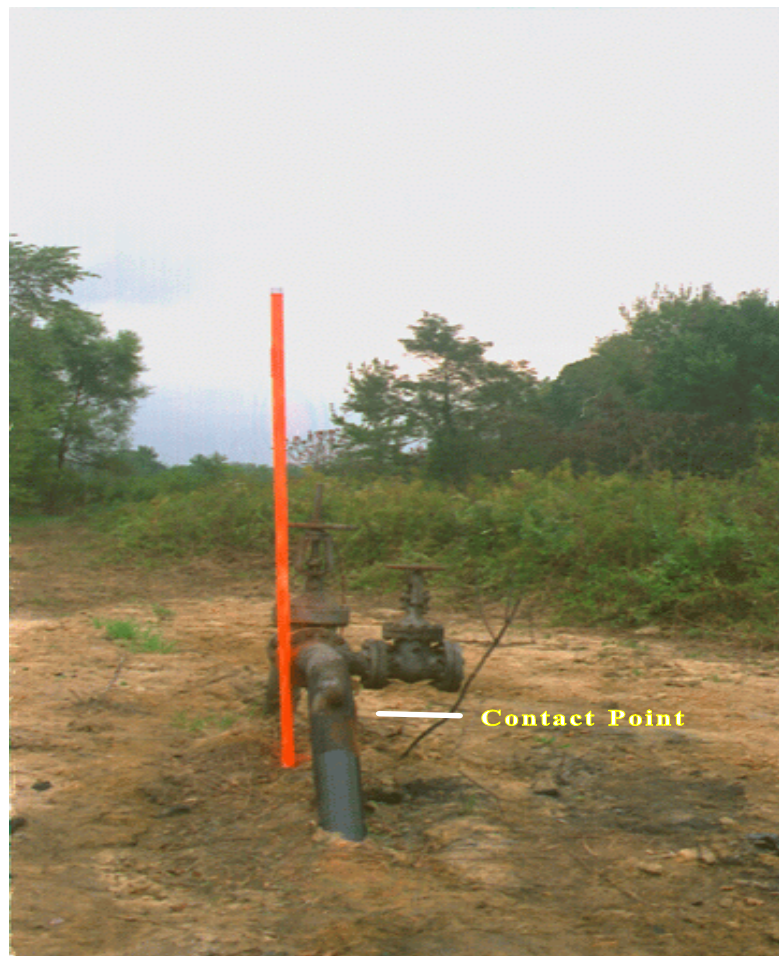
Photographs 1 and 2 show the aboveground valve that was struck in the fatal incident. (The tall pole present in the photographs was placed there after the incident occurred.) Measurements were taken at the site and are illustrated in Photograph 1: the highest point of the valve was 55 inches; the top of the straight section of pipe was 24 inches from the ground; and, the measurement along the ground at the outermost part of both ends of the pipe was 108 inches. Photographs 1 and 2 also illustrate where the tractor struck the valve.

at this point, a line marker had reportedly been placed at that location. This was a commonly used marker made of durable yellow plastic, approximately 4½ feet tall (above ground), 4 inches wide and located about 1 foot from the valve. This marker was not present at the time of the FACE investigator's visit; however, an orange pole approximately 7 feet tall had been placed there by the gas company after the incident occurred.

**Recommendation # 1:** Aboveground pipes and valves need to be clearly visible at all times, regardless of location, for safety and emergency purposes.

company needs to be able to find the aboveground valve quickly and easily, regardless of where the pipe is located. Identifying the aboveground portion with a marker or fence that is easily visible both in color and height would assist the gas company in locating the valve, as well as alert others to its existence to reduce the risk of accidental damage to the pipeline and to avoid injury. In this case, the marker was a dull yellow and it may not have been enough contrast from the surrounding weeds and brush to indicate the presence of the aboveground valve. Markers made in a bright neon color such as orange or pink would provide a starker contrast with the outside environment and be more visible. The victim in this case was unfamiliar with the land and it is likely that this fatal incident could have been avoided if a clearly visible marker had been there to alert him to stay clear of that area as he was mowing the field.

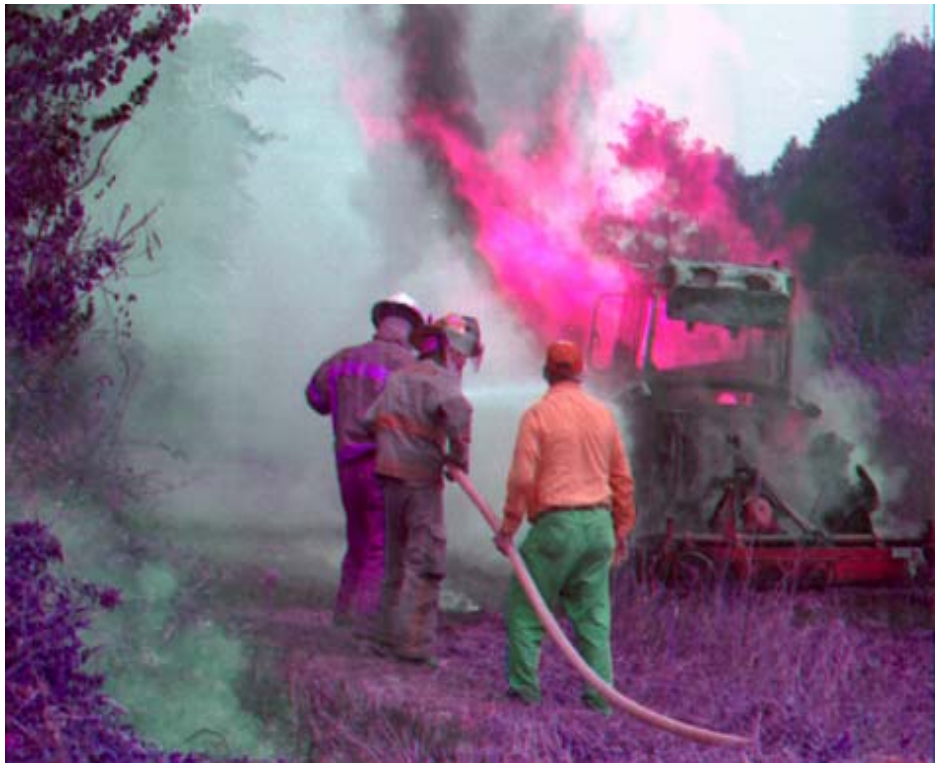
About 2 p.m. on a warm, clear afternoon, the victim began to clear the land for surveying using a Deutz tractor with an enclosed cab and a rotary mower attachment. He was working alone and the fatal incident was unwitnessed. The portion of the overgrown field that had been cleared during the incident indicated that he began mowing the section near the roadway and was likely on the third pass when the front of the tractor ran into the aboveground natural gas line (Photographs 1 and 2) that was likely obscured by the tall weeds and brush. As shown in Photograph 1, a 2-inch cap on the pipe is used to depressurize the line; the impact caused that cap to break off causing the release of natural gas at approximately 65 psig (pounds per square inch gauge). Apparently the gas was ignited by the tractor's engine causing an explosion that caught the tractor on fire and sent flames 40-50 feet in the air (see Photograph 3).

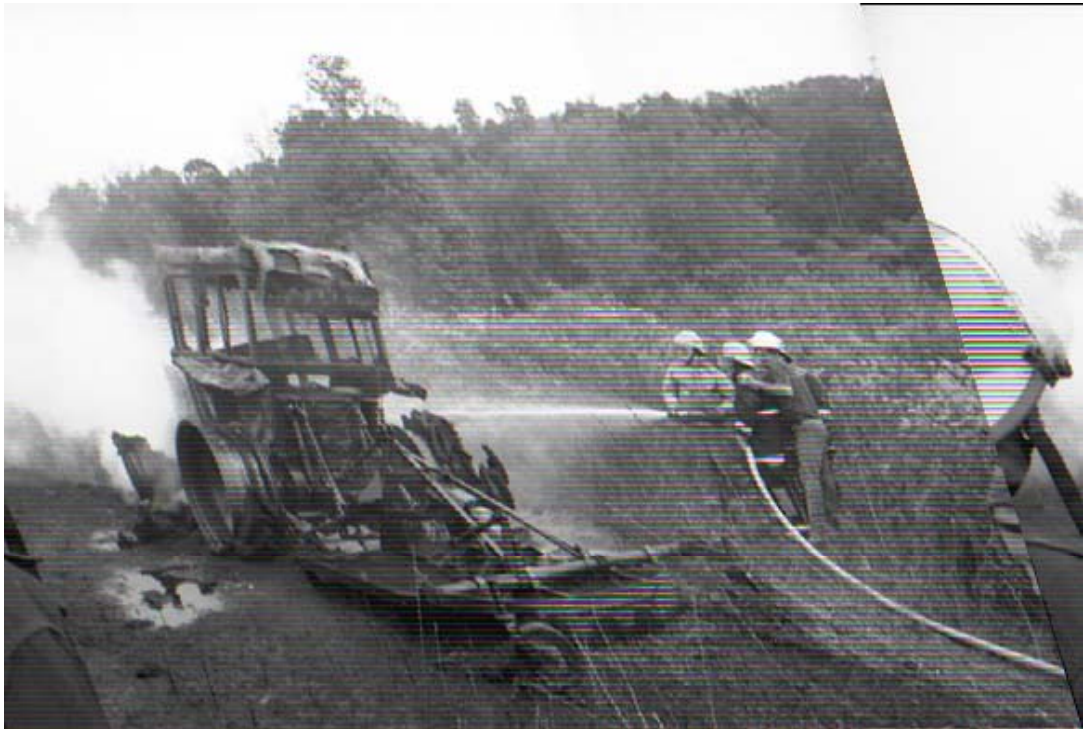
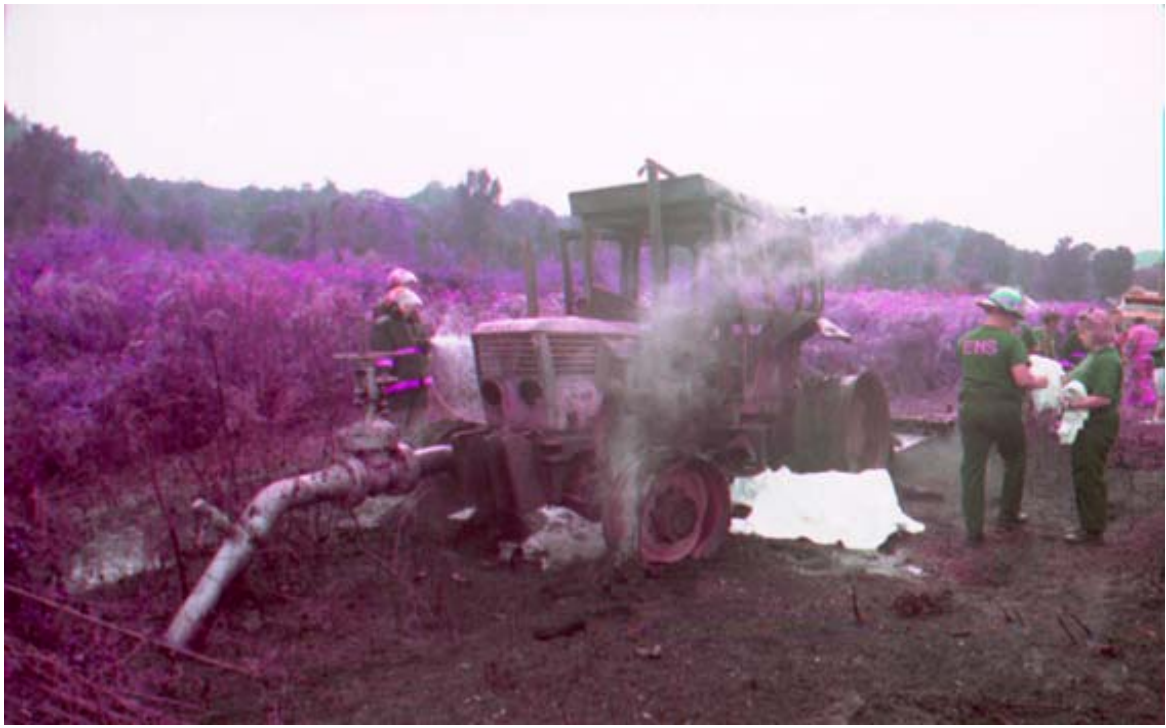
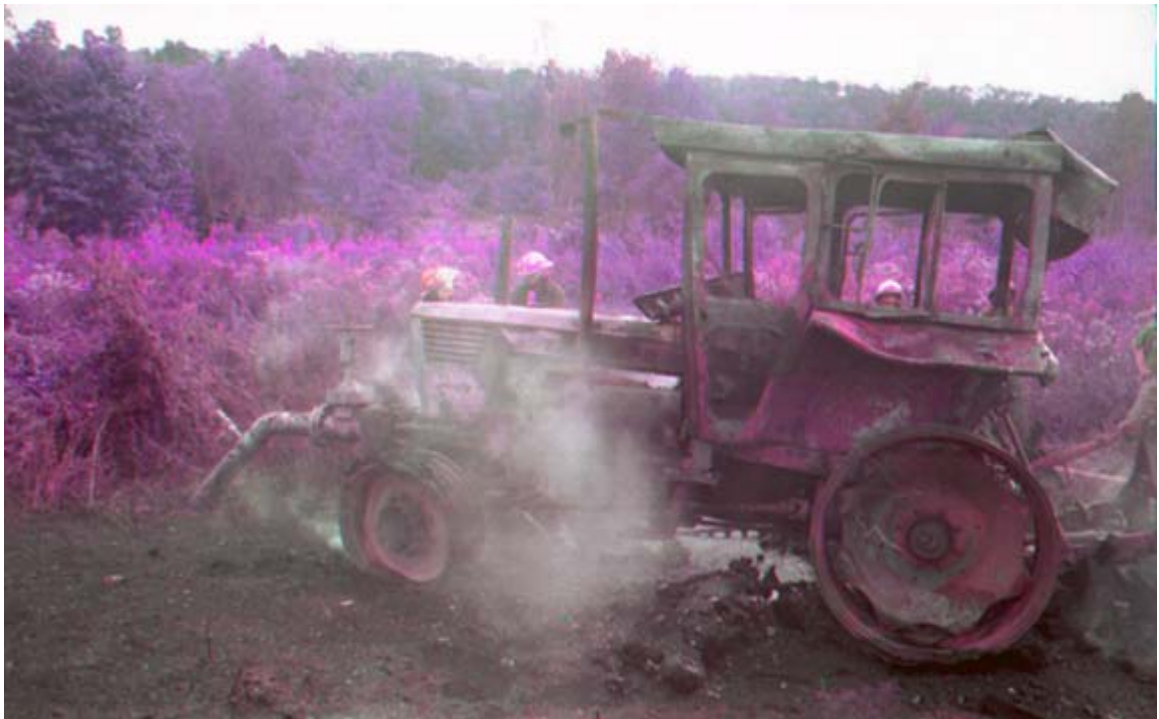
Rescue personnel were dispatched when the sheriff's department received a call about the explosion at 2:36 p.m. By the time the first firefighters arrived on the scene, the fire had burned the tractor and had cleared a 40-foot circle around it. Volunteer firefighters from four other departments arrived on the scene to assist. Gas company officials shut off the pipeline at about 3:20 which nearly extinguished the flames. The victim's body was found lying on the ground just in front of the melted left rear tire of the tractor, but rescue personnel could not approach him until the fire was contained almost an hour after the explosion. The coroner was called to the scene and pronounced the victim dead at 3:30 p.m. As shown in Photographs 4, 5 and 6, the tractor and rotary mower were destroyed by the fire.
