# **Metal Fabrication Shop Owner Dies When Crushed By Falling Steel Plate**

**Incident Number: 03KY124**

## **Kentucky Fatality Assessment and Control Evaluation (FACE) Program**

**Subject: Metal Fabrication Shop Owner Dies When  
Crushed by Falling Steel Plate**

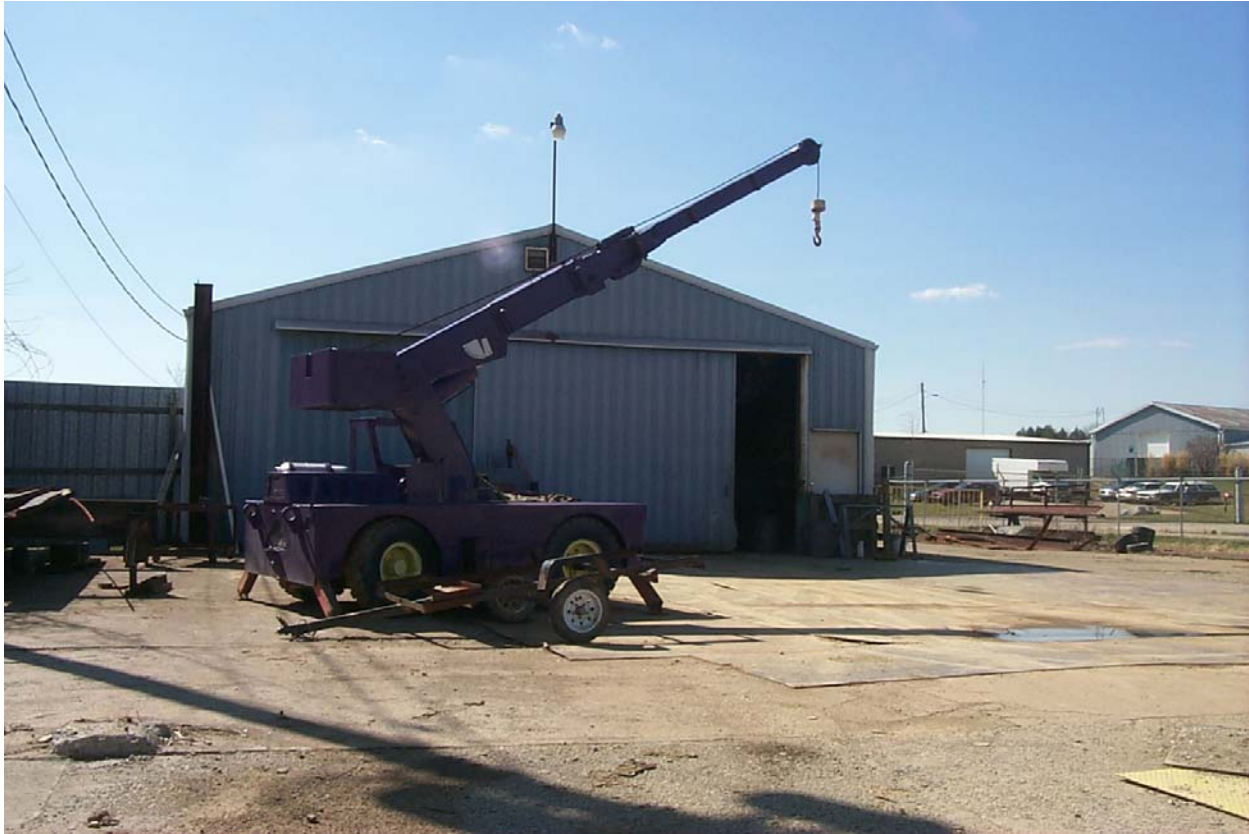
Back of shop where steel plate fell on business owner. The crane was used to load and unload materials.

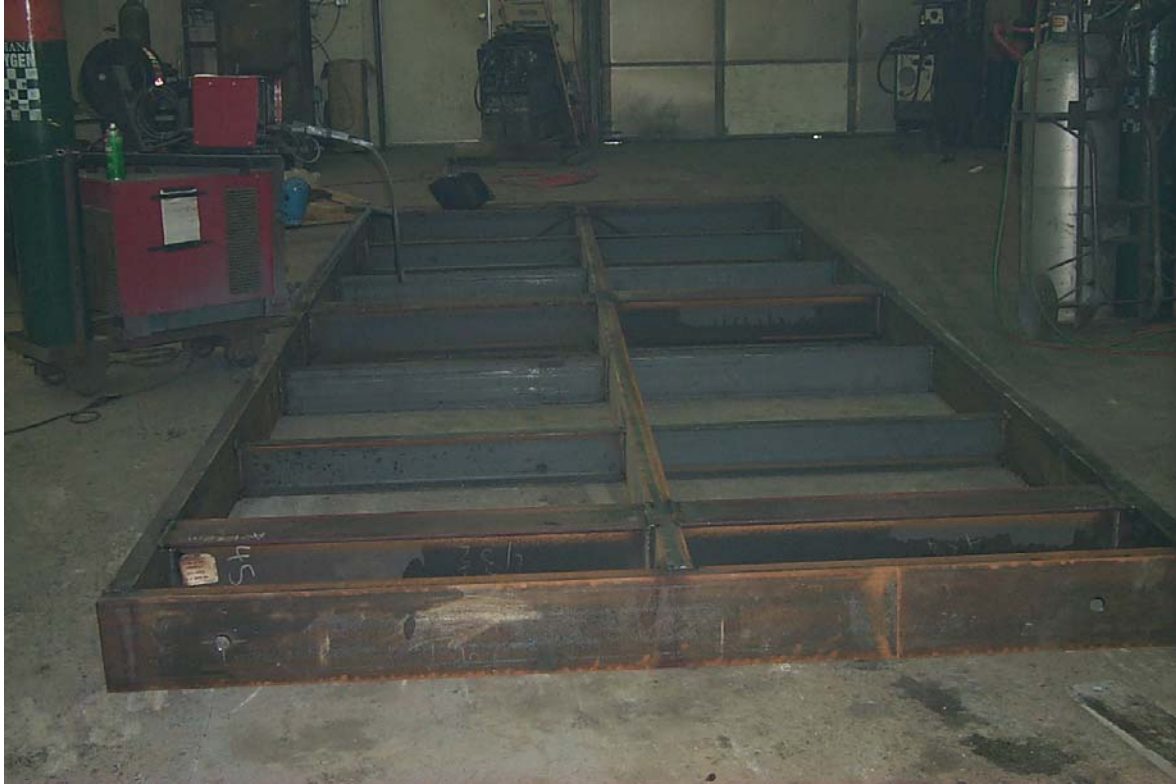
The victim in this incident owned a metal fabrication business that produced steel plate bases for large motors and pumps. Bases were made of steel and channel iron. Due to space limitations inside the facility, it was common practice to push the large plates outside with a fork truck, flip them over, then push the plates back inside so the other side could be worked on. This procedure was used when pieces required welding or painting.

Base plate inside shop before being pushed outside to be turned over. This plate is very similar in configuration to the one which fell on business owner.

An adequate beam and hoist mechanism for flipping over large plates and heavy pieces of metal should have been installed. By using a series of clamps and cables attached to an appropriate beam in the ceiling, the cables could be clamped on to the plates and by using tension on the cables, plates could be turned over or moved in a more controlled manner. Another alternative method for turning over cumbersome material would be to use an overhead crane. Either of these methods would allow for a safer way of handling and moving large pieces of steel and turning them over. Metal plates could be hoisted and turned over without positioning blocks underneath the 4,000 pound plate.

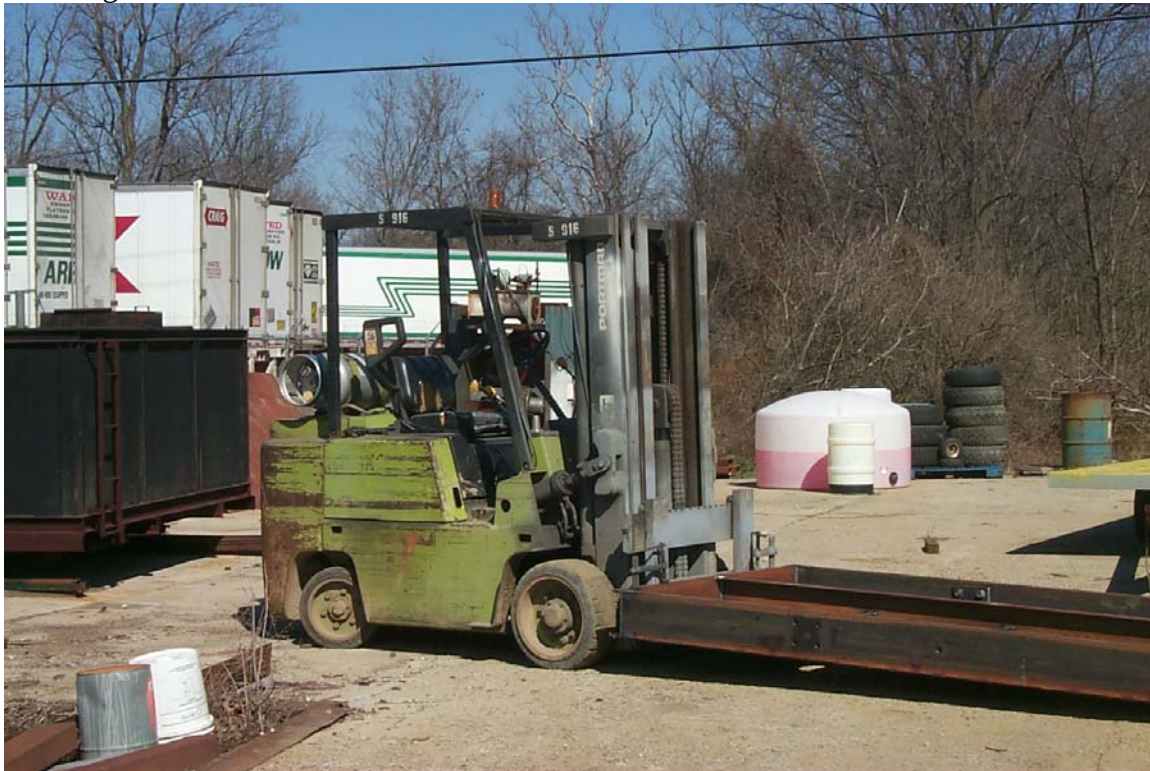
KY OSH 1910.178(o)(1) states, “only stable or safely arranged loads shall be handled. Caution shall be exercised when handling off-center loads which cannot be centered”. Lifting the edge of a 10’ x 20’ metal plate with forks of a forklift is a dangerous undertaking. This type of task, if necessary to perform, should be performed by an individual trained in the mechanics of picking up a typical heavy load such as this with a forklift.

An example of how the fork truck was used to lift the metal plate. This plate is similar to the one that fell on the business owner.

KY OSH 1910.178(m)(2) states that “No person shall be allowed to stand or pass under the elevated portion of any truck, whether loaded or empty”. This type of injury could be prevented by adhering to this standard.

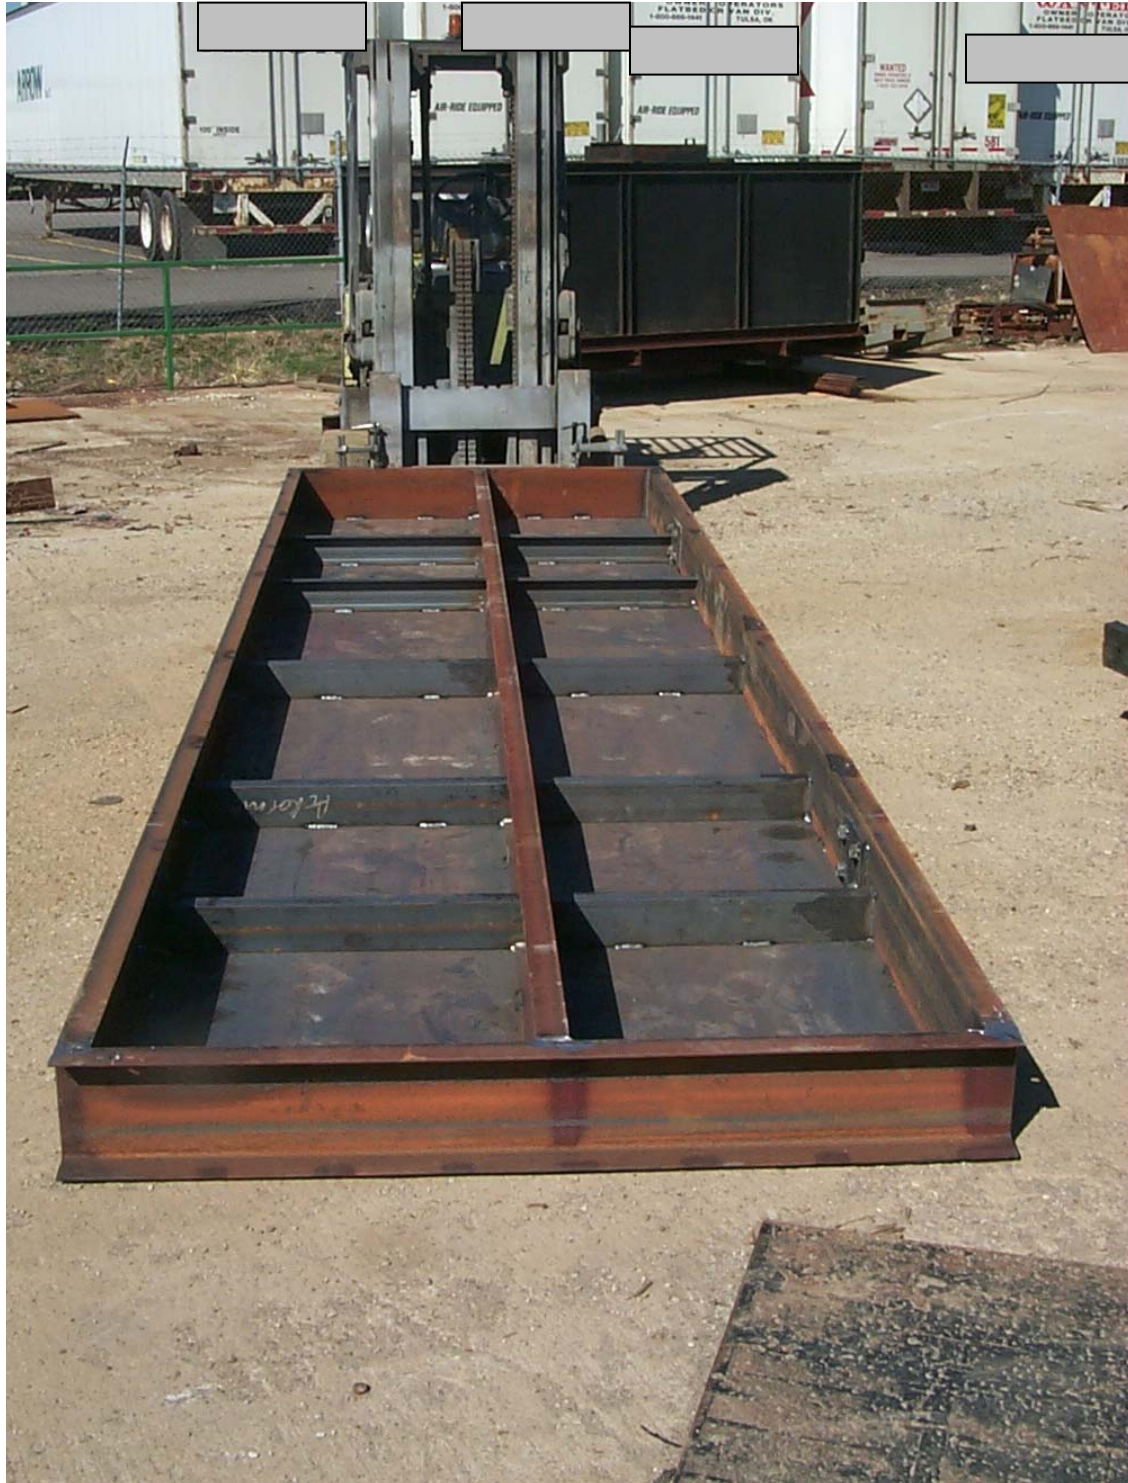
An example of the metal base plate which fell on business owner.
