38 Year-Old Construction Laborer Dies When Trench Walls Collapse

Incident Number: 03KY107

Kentucky Fatality Assessment and Control Evaluation (FACE) Program

Subject: 38 Year-Old Construction Laborer Dies When Trench Collapses

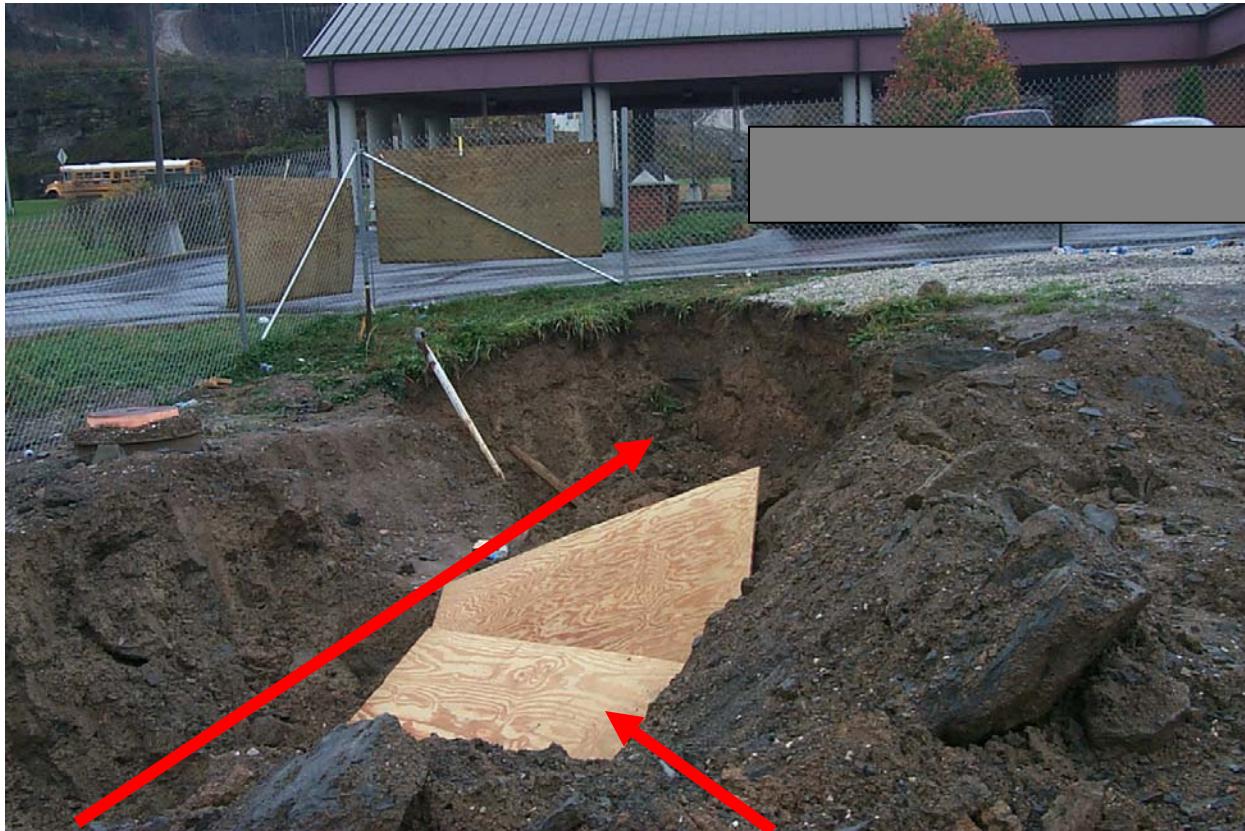
Location of victim in trench when sides collapsed. Plywood used by emergency response personnel.

At 11:15 am, the superintendent and the subcontractor's foreman were at the boundary line next to the trench where the work crew had worked in since Thursday. The two men determined the location where the old abandoned gas pipe was to be cut off at the boundary line. After this decision was made, the superintendent returned to the trailer and the foreman proceeded to operate a track hoe and excavate to dig a 6 foot wide x 8 foot deep x 16 foot long trench from the end of Thursday's trench to within 4 feet of the boundary line and fence. This trench was within 10 feet of the heavily trafficked driveway which served the two neighboring businesses. No sloping or benching methods or shoring equipment were used in the trench. Instead, the sides of the trench, sheared by the teeth of the track hoe, were straight down. After the trench was dug by the foreman, he moved the track hoe to the far end of Thursday's ditch (see Diagram). The victim jumped in the hole with a saw and proceeded to cut through the gas line and casing (making this cut should have only taken a minute). While the laborer was cutting through the gas line and casing the sides of the trench caved in, burying him.

Recommendation No. 1: Employers and employees should not take shortcuts.

Recommendation No. 2: Employers should train employees on safe work practices and how to recognize and avoid unsafe work conditions.

Recommendation No. 3: Employers should train employees working in excavations on use of appropriate protective equipment.

Employers are required by OSHA Standard 29 CFR 1926.652(a)(1) to protect employees from cave-ins while performing excavation work. This regulation also stipulates configurations for sloping sides of trenches and appropriate materials to be used in shoring walls of excavation sites. Any trench 5 feet or more in depth must have an adequate protection system before being used by employees.

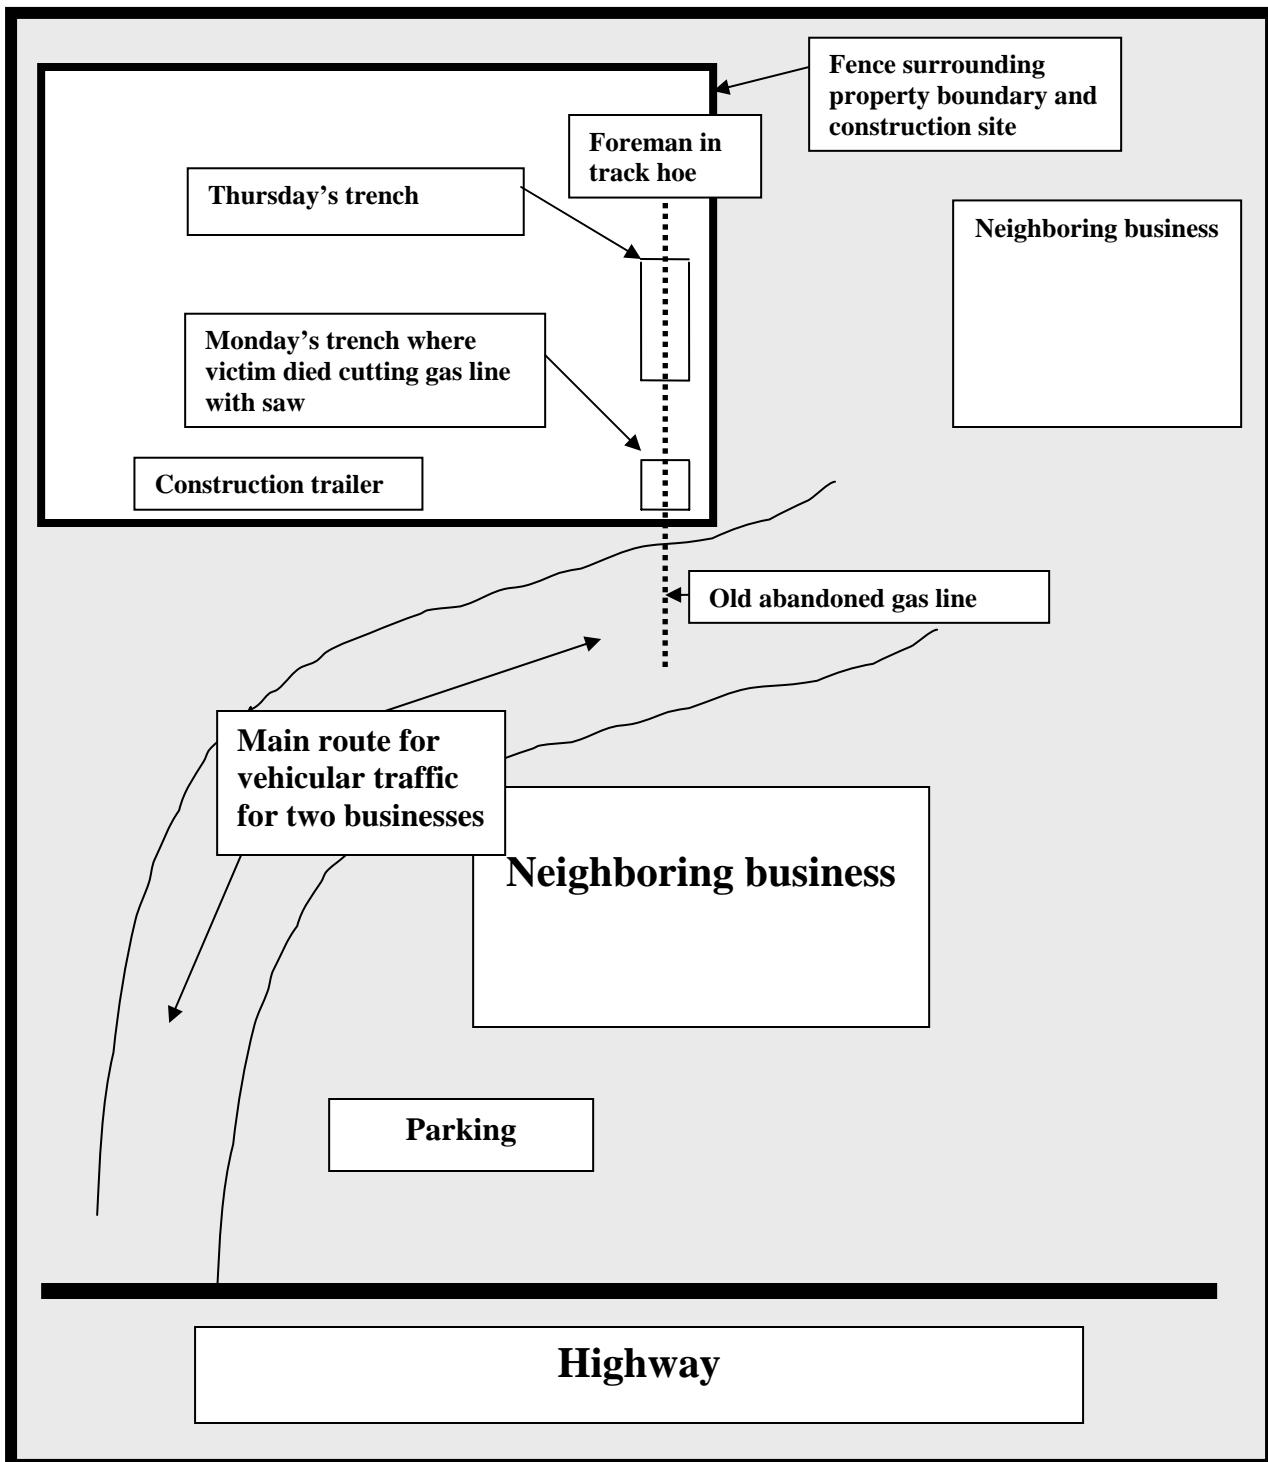
The job site was in a commercial area located behind and to the left of existing businesses (see diagram) and was surrounded by chain link fencing. The work was to be performed in a corner where the three properties came together. The two existing businesses shared a driveway which passed from the highway between the business in front and the construction site, around the corner and to the other existing parking lot. Heavy traffic traveled in front of the work site to and from the existing businesses and within 10 feet of the trench where the fatality occurred.

Diagram of construction site and neighboring businesses, driveway and parking lots
