Laborer Dies When Caught in Arms of a Skidsteer Loader

Incident Number: 03KY087

Kentucky Fatality Assessment and Control Evaluation (FACE) Program

Subject: **Laborer Dies When Caught in Arms of a Skidsteer Loader**

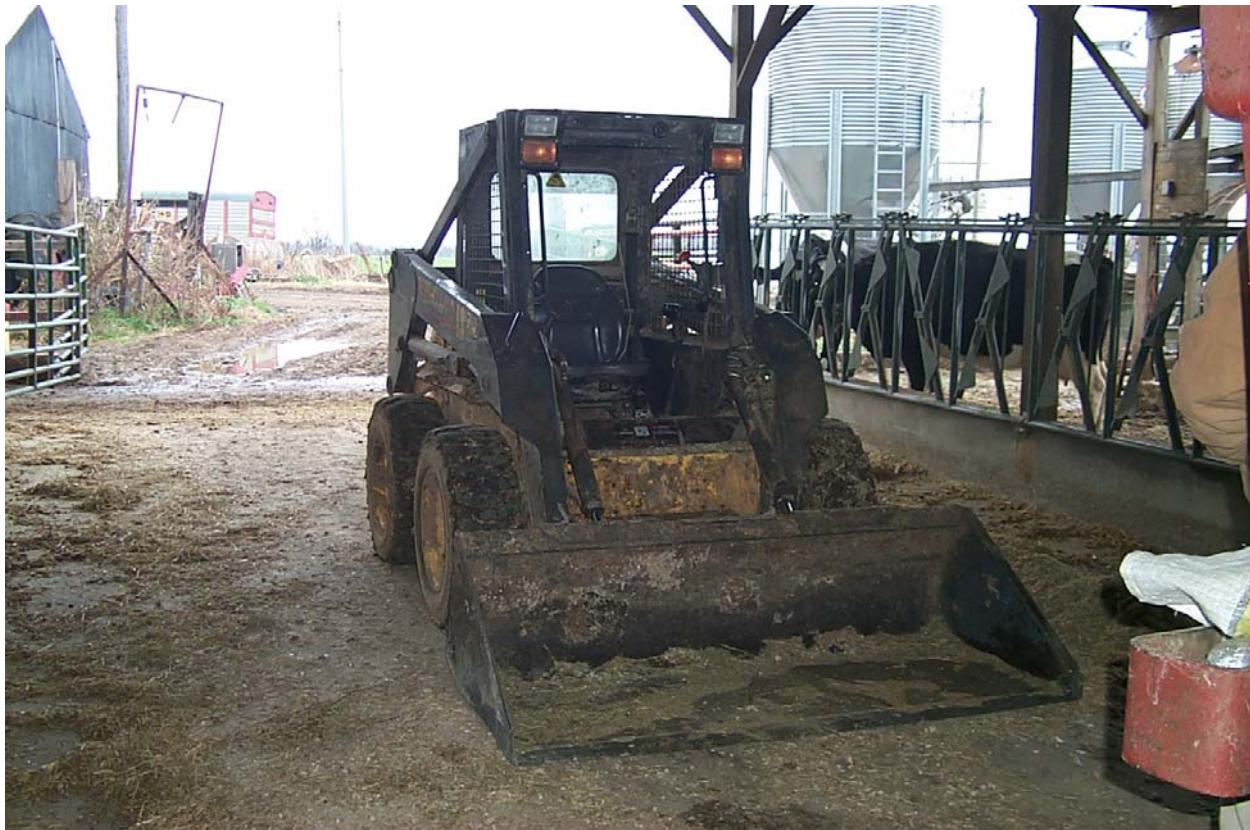
Borrowed skidsteer involved in fatality.
