# **Chinese Immigrant Restaurant Owner Electrocuted**

**Incident Number: 02KY131**  
**Date of Incident: August 12, 2002**  
**Report Release Date: August 14, 2003**

## **Kentucky Fatality Assessment and Control Evaluation (FACE) Program**

**Subject:** Chinese Immigrant Restaurant Owner Electrocuted

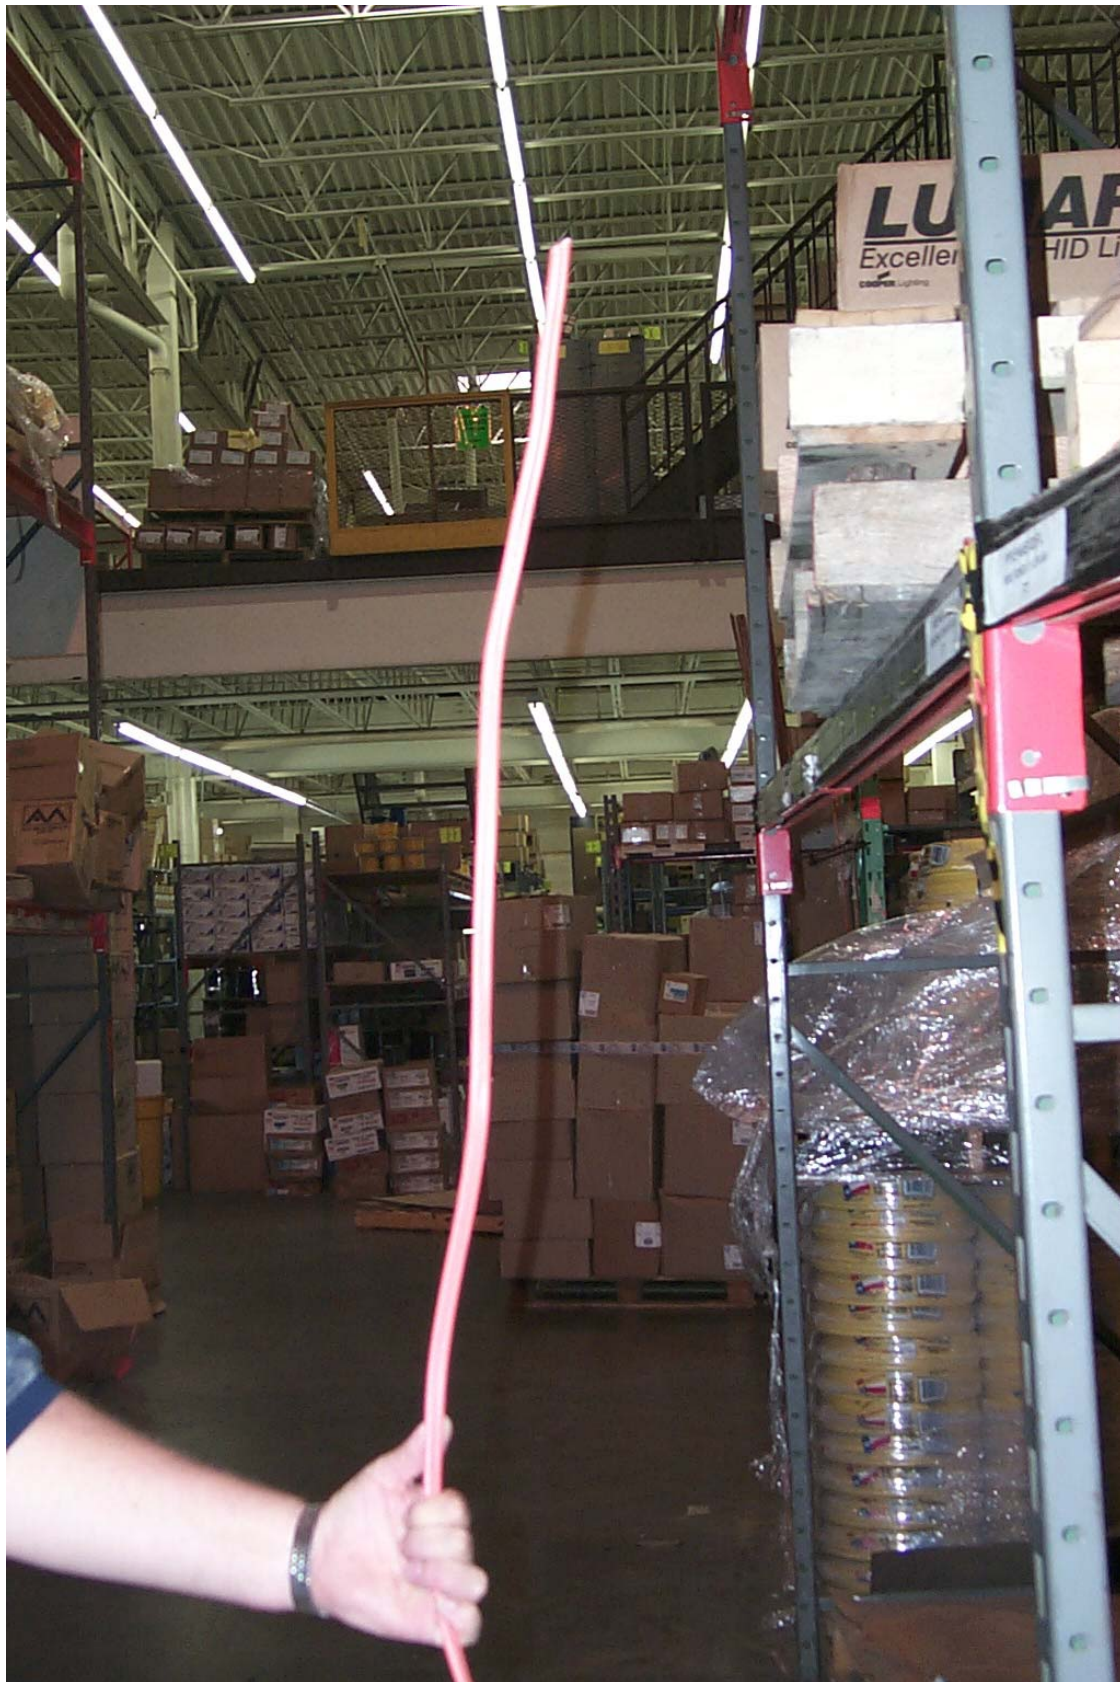
The local electrical codes inspector went to the scene and investigated this incident. During the interview, he said the wiring connections to the unit and the splices were made correctly but the restaurant owner had used inappropriate material to fabricate the extension cord. The 10/2 wire was too rigid for the application the decedent used it for.

The wire the decedent chose to use to fabricate the extension cord is very rigid and does not allow flexibility in movement. The stiffness of the wire caused the connection to fail and the

wire to become loose and touch the metal frame of the cooler. It is unknown why he chose 10/2 wire instead of a more flexible wire to fabricate the extension cord. Also unknown is why the decedent chose not to plug the existing cord into an approved extension cord to lengthen the existing cord.

An example of 10/2 wire. Notice how rigid it is.

**Only persons properly trained in electrical procedures should perform electrical services.**

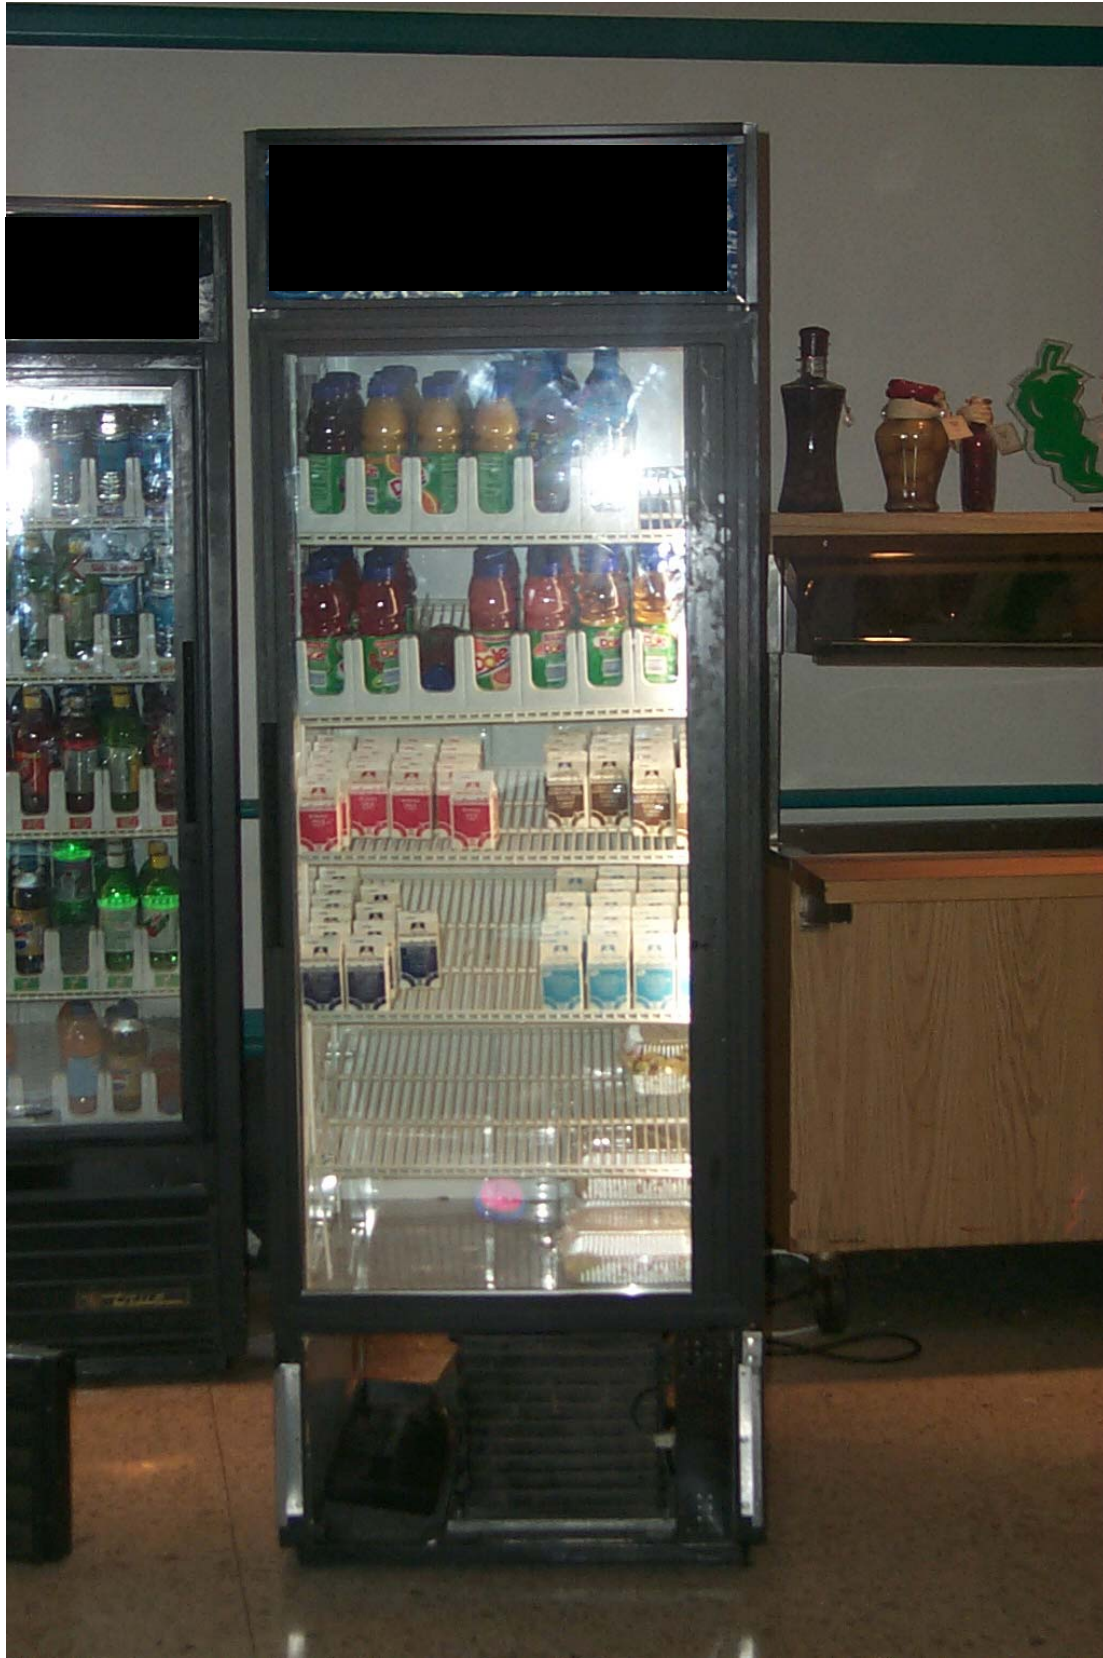
around the kitchen to keep it out of the way as they cleaned. The electrical cord to the cooler was not long enough to allow much mobility of the cooler and have it remain plugged into the wall. In order to increase the distance the cooler could be moved and still remain plugged into the wall, the restaurant owner replaced the electrical cord of the unit with a self-fabricated extension cord composed of a 10 foot length of 10/2 wire and a one foot length of extension cord. The decedent wired the 10/2 wire to the electrical panel in the back of the cooler and spliced the other end into one foot of extension cord. He wrapped the spliced area with electrical tape then plugged the unit into the wall receptacle. During the course of the day, the man and his wife moved the cooler to different locations around the kitchen. The first time the cooler was moved, it felt normal to the touch. However, subsequent to the initial move, each person moving the cooler felt a slight tingling to their hands when they touched the metal frame. The ground wire had detached from its connection to the electrical panel inside the cooler. The exposed ground came into contact with the metal side of the cooler. This energized the outside of the cooler.

By evening, the unit had been moved approximately eight to twelve inches cattycorner to a gas cook stove. The restaurant owner who was hot, sweaty and shirtless bent down between the cook stove and the cooler. As he did so, his chest touched the outside aluminum casing of the cooler and his back touched the metal stove. He was electrocuted as the electric current traveled from the cooler through him to ground through the stove.

Cooler similar to the one in the restaurant.
