# Kentucky

## **Fatality Assessment and Control Evaluation Project**

**KY FACE # 02KY025**

**SUBJECT: Backhoe Operator Dies After Backhoe Tips Over**

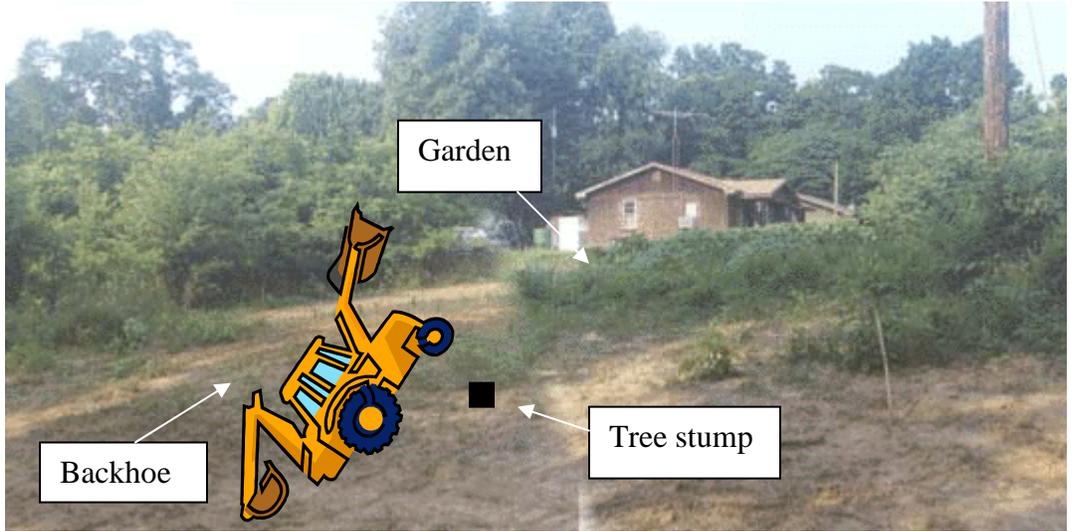
Discussion No. 2: The land had been cleared to install utilities. Tree stumps, limbs, bushes and brush had been bulldozed to the sides of the work area. The tree stump was visible and should have been avoided by the operator. Time should be taken for a thorough hazard assessment of the work site before work begins. An assessment of the area probably would have revealed the tree stump sticking up and the operator, had he known about the stump, would have been able to avoid it.

View from pipeline ditch toward the garden egress. The area where the tree stump was had been graded by the time the FACE investigation took place.

Recommendation No. 2: Before starting, work sites should be inventoried for hazards and ways to avoid hazards should be communicated to employees.
