Fatality Assessment and Control Evaluation Project

KY FACE #97KY044

26 June 1997

SUBJECT: Tractor/Baler Operator Killed in Entanglement

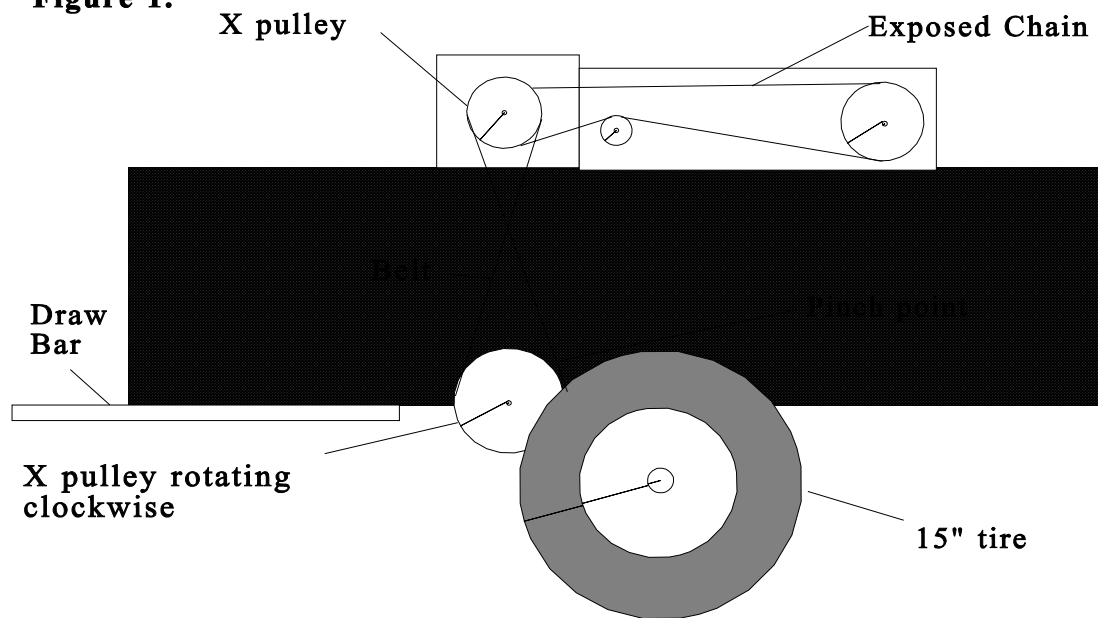
Figure 1.

The baler being used in this case was a 1970 Ford Model 530 square baler. It was purchased by the victim new from a dealer who had used it as a demonstration model. A pulley guard had been included in the sale with the baler; however, it was never installed and so was not on at the time of the incident nor at the time of the site visit. According to an equipment dealer, the tractor and the baler were compatible with respect to horsepower and weight of the baler. Although the farmer had a round baler, he still used the square baler two or three times a year. At the time of the incident, the round baler was being repaired. On the left side of the baler (see Figure 1) were two exposed pulleys, one above the other, just forward of the rubber tire. A belt between the pulleys drove the pick-up tines and the feeder teeth. The lower pulley measured 13" across; its lowest part was 9" from the ground. The distance between the rubber wheel and the pulley was 2".

At about 5:00 pm the victim was nearly finished with the task. As he began to turn downhill and to the right, evidence at the scene suggests he ran over a bale or partial bale that became lodged under the baler. He then depressed the clutch part way, taking the tractor out of gear. Next he set the parking brake on the left wheel. He dismounted the tractor and walked to the side of the baler with the exposed pulleys. He knelt down just forward of the wheel and with his left hand reached under the baler to clear it out. In doing so, part of his clothing became entangled in the exposed pulley, drawing him in tight against the wheel and the pulley. His clothing wrapped so tight it cut off his airway.

Recommendation #2: Machines should be examined to ensure that all moving components are properly guarded. If better shielding is needed an authorized equipment dealer should be contacted to determine if safety modifications have been engineered or made available.

Discussion #2: The guard for the baler came with the unit when it was sold. However, it was never attached to the baler. The shield would have prevented the clothing from being caught. The distance between the wheel and the lower pulley was 2", leaving little room for a guard; however, the guard would have prevented any clothing from being "taken up" the pulley. Safety guards should not be removed or modified. Guards should not interfere with the tasks nor create additional sharp edges or protruding parts.
