Public Health  
Kentucky FACE #95KY07301  
Date: 5 September 1995

Subject: Logger Killed in Endloader Rollover

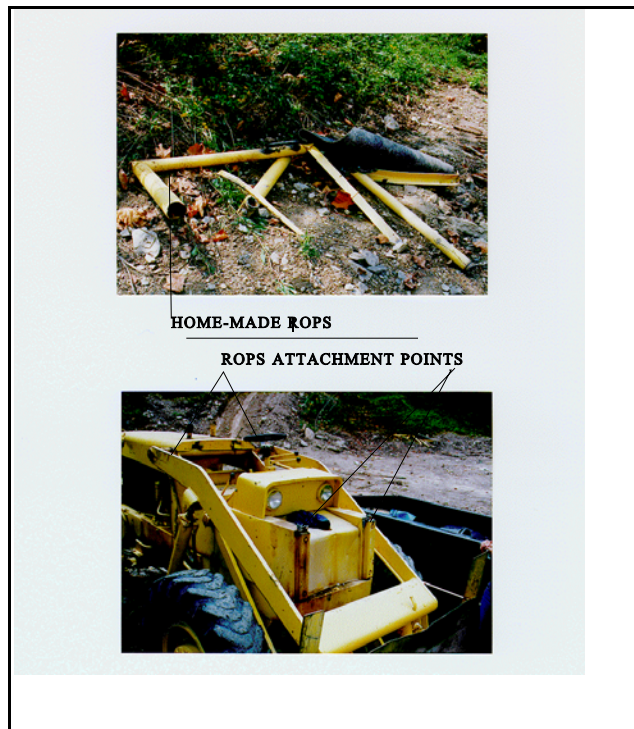
At the time of the incident, the victim was operating a Michigan endloader, model #55-AG, manufactured in 1960, with four-wheel drive and rear wheel steering, and a total weight of approximately 13,000 pounds. This machinery was used to load logs onto a truck; however the victim was not transporting logs at that time. Although the vehicle was equipped with a rollbar-like structure, the device was not issued by the manufacturer and it is not known if it was installed for protection purposes or possibly for shade and/or a guard against low-hanging tree branches. (According to a Michigan dealer, a ROPS kit is not readily available for this endloader.) The rollbar on the machine had been made from angle iron and steel pipe, with a rubber roof, and had been welded to the endloader. However, during the rollover the welding gave way; the rollbar came off the machine and was crushed by its weight. (See photos below.) The endloader also was not equipped with a seatbelt. The air-filled tires were 3 feet 11 inches high with a width of 12 inches; treads were worn and smooth.

he was transporting logs to be loaded onto the truck. As he traveled downhill, the vehicle apparently began to slide, leaving tire marks in the mud about 10 feet long. Indentations in the mud indicated that the right front tire apparently struck the embankment, causing the vehicle to veer toward the left side of the road and then roll over the edge. The victim was thrown from the vehicle as it overturned several times before coming to rest on its left side at the bottom of the hill. The victim was found lying facedown about 15 feet from the edge of the road, while the endloader was 37 feet 9 inches from it.

**Recommendation #1:** All mobile equipment should be equipped with adequate rollover protective structures (ROPS) and operator restraint systems.

**Discussion:** Although in this case it is not known if the steel pipe structure was welded onto the endloader to serve as protection in a rollover or as a shield from sun and tree branches, an appropriate dealer-installed ROPS and restraint system could have kept the operator in the protected zone during the rollover, decreasing the risk of injury. If the device was intended for safety purposes, it was inadequate to handle the weight of the machine when it rolled over. It came completely off the machine and was mangled and crushed in the rollover. Additionally, there was no seatbelt on this piece of equipment, so the operator fell out of the driver's seat before the machine rolled over on him.

**Recommendation #3:** Equipment should be maintained in good working condition.

**Discussion:** The tires on this endloader were almost worn out. The tread was worn down

so that good traction could not be maintained. Also, the tires contained no fluid, which might have provided greater stability and traction. These problems compounded the problems discussed in #2 above (steep slope; muddy conditions).
