Indiana FACE 96IN12301

SUBJECT: Laborer falls 48 feet to his death while painting inside of empty storage silo

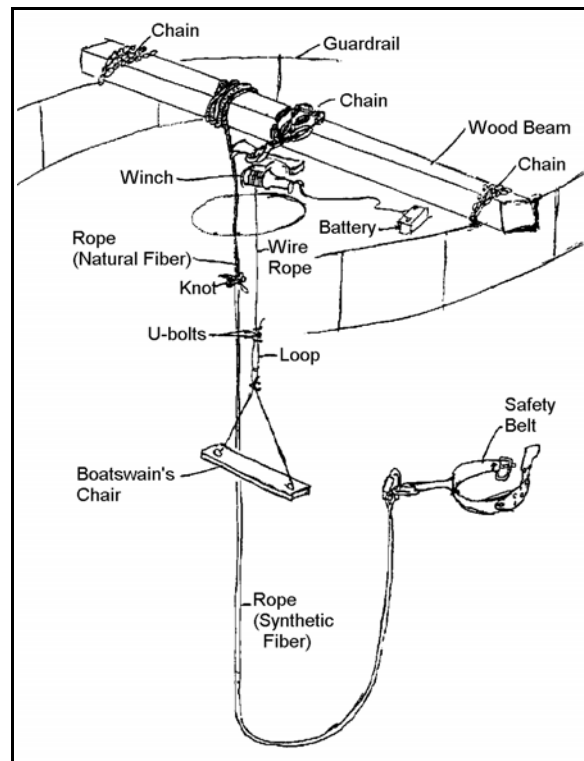
The victim worked for a three-employee construction company which was sub-contracted to paint the inside of the silo. On September 20, 1996, all three began work on this job at about 8:30 A.M. First they mixed two different kinds of epoxy paint in a five-gallon bucket to get the right texture required for the inside of the silo. A co-worker then hauled the 5 gallon bucket to the top of the storage silo by means of a rope. This co-worker remained outside on top of the silo. The victim entered the 20" opening and sat in a makeshift boatswain's chair. (See Figure 1.) The chair was a substandard 21" x 5 1/2" in size and was supported by a 3/8"

DISCUSSION: In this incident the boatswain's chair seat was less than the minimum dimensions of 12" x 24" x 1" thick and was not reinforced with cleats to prevent the board from splitting. Furthermore, the "U"- bolts used to secure the loop in the wire rope which was supporting the boatswain's chair were installed backwards such that they were not contacting the dead end of the wire rope. This improper arrangement allowed the dead end to slip out causing the boatswain's chair to fall.

RECOMMENDATION #1: Ensure the boatswain's chair seat used to sit on while painting the inside of the storage silo is of at least minimum dimensions, reinforced by cleats, and properly suspended.

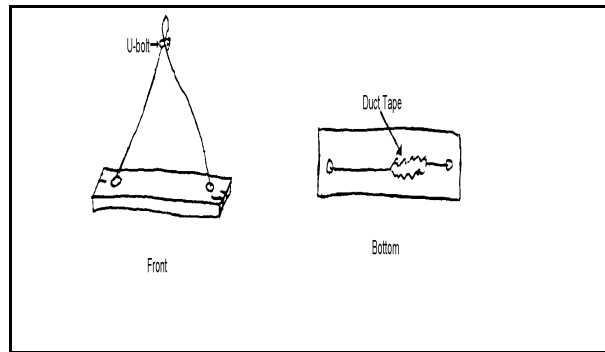
plastic coated cable (Figure 2). The working end of the plastic coated cable was

attached to the boatswain's chair support cable by two U-bolts and duct tape. The chair was lowered and raised by an electric winch powered by a large battery and a portable generator. Vise grips were used to connect the power cables to the battery.

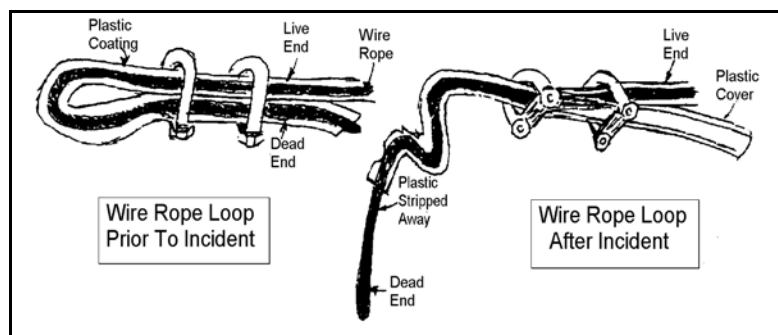
The co-worker on top of the storage silo stated that around 2:00 p.m., when they were ending their day, he started the winch to bring the victim up to the 20" opening in the top of the tank. The victim was near the top of the silo when the co-worker heard something snap but was not sure what it was. The next thing the co-worker knew, the victim and safety rope were plummeting 48 feet to the bottom of the silo. Investigation after the event revealed that the end of the winch line secured to the boatswain's chair had pulled out of the improperly positioned U-bolts (Figure 3) allowing the victim to fall.
