Lineman Killed After Being Struck by a Car in Washington State

Investigation: #00WA04001
Release Date: December 30, 2003

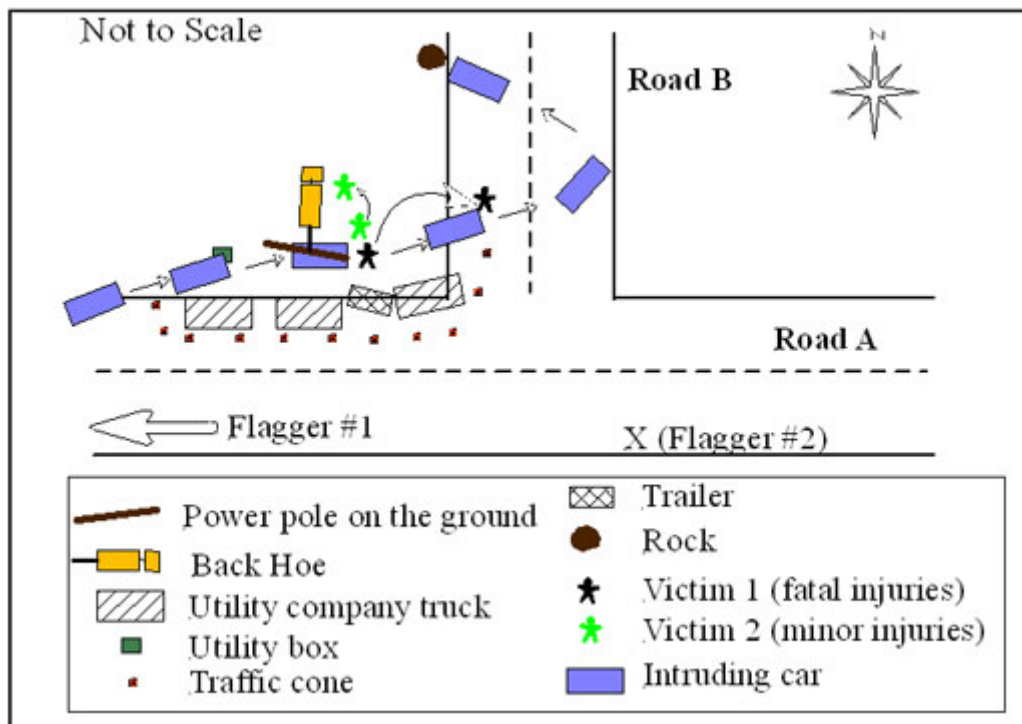
The incident site was located at the “T” intersection of two rural county roads ([Figure 1](#) roads A and B). Both roads were two-lane asphalt-surfaced arterials with moderate traffic flow. [Figure 1](#) shows the road layout with respect to the work zone, the incident site, and the travel path of the intruding vehicle. Flaggers were located west (flagger #1) and east (flagger #2) of the work site along road A. Flagger #2 was positioned along road A and would help direct traffic that would be traveling north and south on road B. Both flaggers were certified, as required by the state. All the utility vehicles had their flashing warning beacons on. A backhoe was also being used in the work area to help in the installation, set up, and positioning of the power pole.

Figure 1. Layout of the incident.

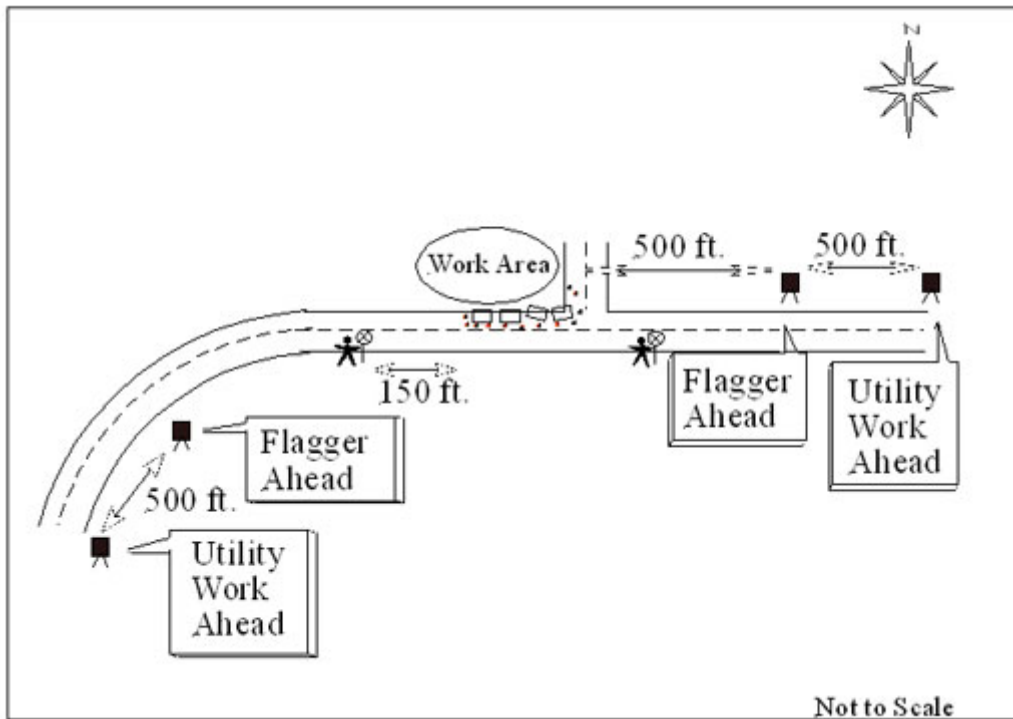
At the incident site, it was identified by WISHA and the Sheriff's Department that construction work signs and other traffic control devices had been set up to meet Manual on Uniform Traffic Control Devices (MUTCD)¹ guidelines as well as the Washington State Department of Transportation guidelines². The site layout is shown in [Figures 1](#) and [2](#).

Discussion: At the time of the incident, a new WISHA rule required the work zone to have at least 3 signs prior to the physical location of the flagger. The former requirement was for 2 warning signs (see [Figure 2](#)), as used in this work zone. In Washington State, if the Washington Administrative Codes (WAC) have more stringent rules for work zones than the MUTCD, then the WAC requirements take precedence over MUTCD guidelines.

Figure 2. Layout of the work zone.

Because of the level of hazards and exposures associated with highway work zones, extra effort needs be taken to ensure the safety of those in the work zone and the traveling public. “Typical Applications” # 10 and # 22, from the MUTCD,¹ should have been used for reference in designing traffic control for this work zone.

The signage for the work zone could have been improved by having the following four signs:

- Utility work ahead,
- One lane ahead,
- Flagger ahead, and
- Prepare to stop.

Also more traffic cones or barrels in the down stream and shifting taper could have been used. This would have made the work zone more visible to eastbound traffic. The employer could also have set up “lane separating” channeling devices around the work zone to give the work zone more definition and make it more visible to drivers along the restricted area of the roadway

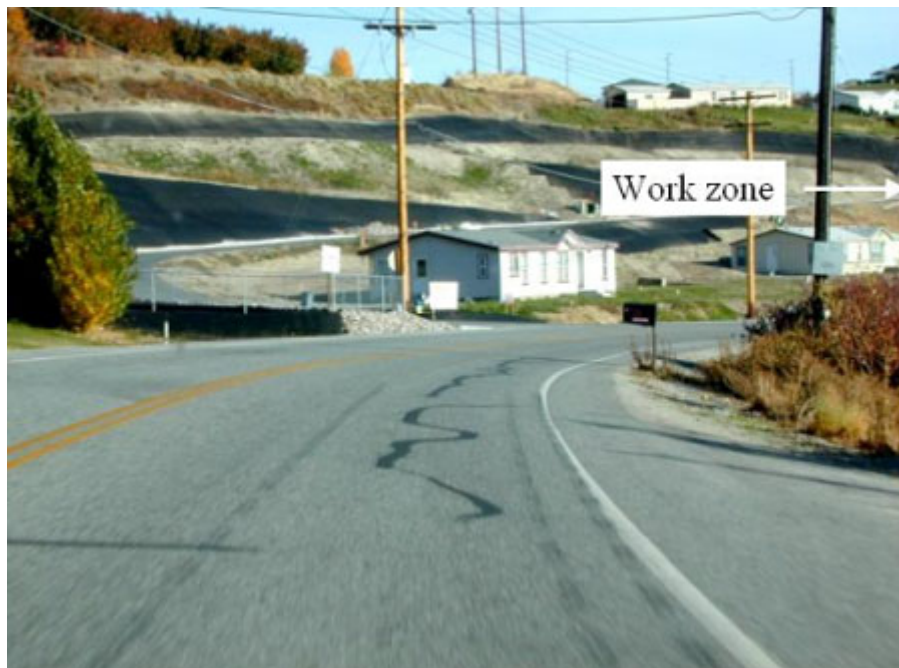
Photograph 1. View approaching the work zone from the south (direction from which the intruding vehicle approached).

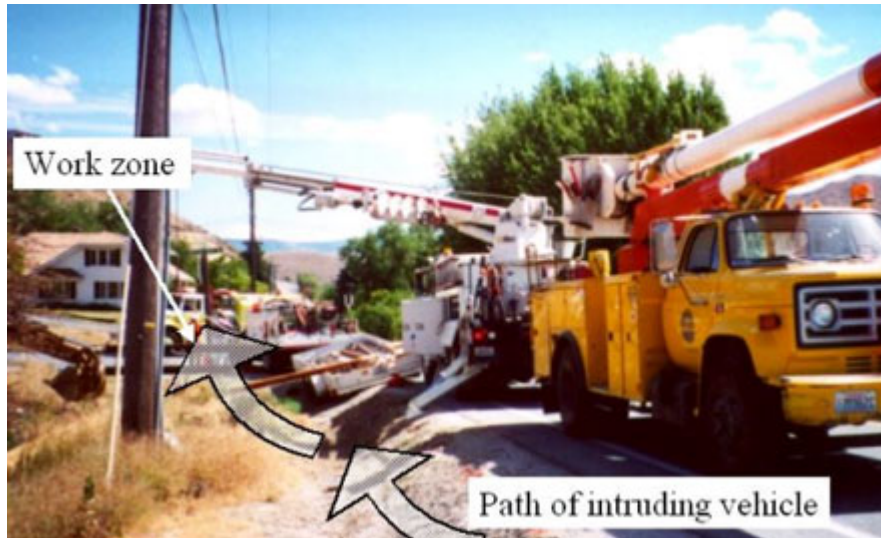
The driver still did not stop or slow down. After passing the flagger's station, the driver swerved his vehicle into the opposing lane, left the roadway just in front of a utility truck, crossed a 2 ft deep drainage ditch and entered the work area off of the roadway ([Photographs 2](#) and [3](#)). He then struck and crushed a telephone box and part of the new telephone pole that was being prepared for installation. The pole was suspended from one end by a backhoe and was in the process of having its frame attached by the victims. The vehicle struck the pole at a slight angle, drove under the elevated section of the pole, struck a portion of the frame that was being installed and continued without a reduction of speed (per witnesses) toward the victims. One flagger had yelled "CAR!, CAR!" and the other yelled, "LOOK OUT!" to try to warn the linemen, but neither warning were effective.

Photograph 2. The work zone.

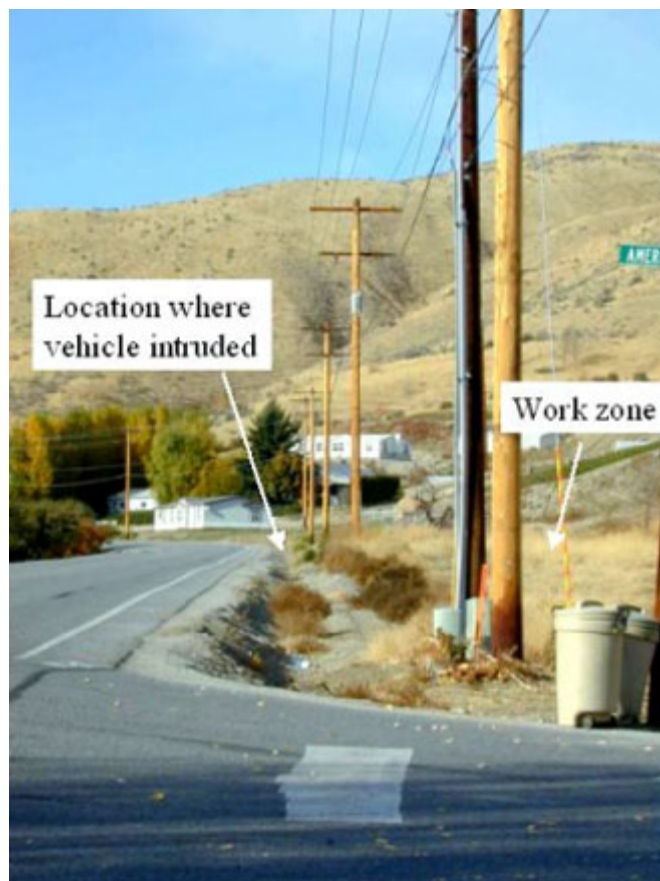
Photograph 3. The location of the work zone, after the incident.
