Logger Killed when Struck by Top of Falling Tree, which was Felled by an Adjacent Cutter, in Washington State

Investigation: #98WA07601
Release Date: April 30, 1999

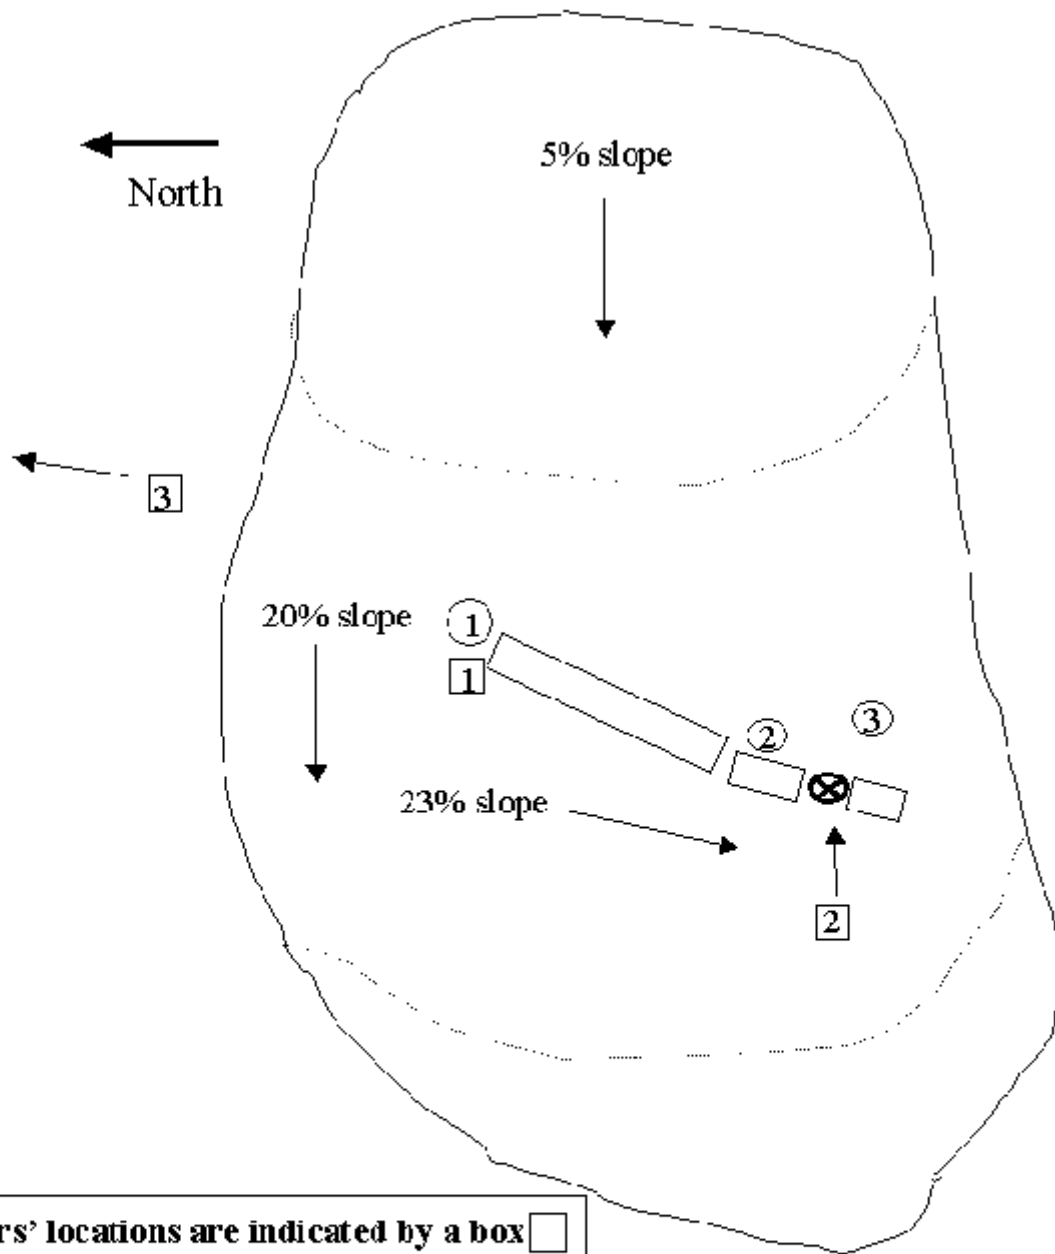
Figure 1. Schematic of the scene of the incident.

logging team was cutting and advancing along the slope, in a northwesterly direction (see figures [1](#) and [2](#)).

Discussion: The investigation of this fatality showed that the victim and the cutter who felled the tree, were working too close. It was estimated that the felled tree was 115-125 feet in height. The distance from tree faller #1 to the victim was 110 feet.

Workers' locations are indicated by a box

Worker #1 - tree feller who cut tree #1

Worker #2 - decedent working on tree #3

Worker #3 - tree feller working off of the ridge

Tree stump locations are indicated by shaded circles

Tree #1 - ~115 foot Douglas Fir, 2 ft, 4 in. diameter

Tree #2 - 2 ft, 4 in. diameter

Tree #3 - 2 ft, 5 in. diameter

Recommendation #1: All tree cutting operations should adhere to the principle that a distance of at least two tree lengths should separate adjacent occupied work areas.

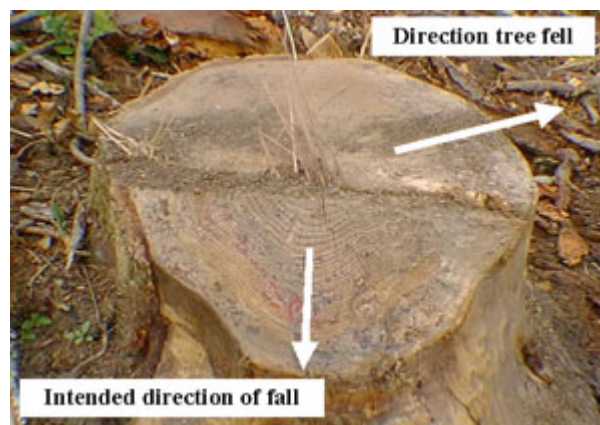
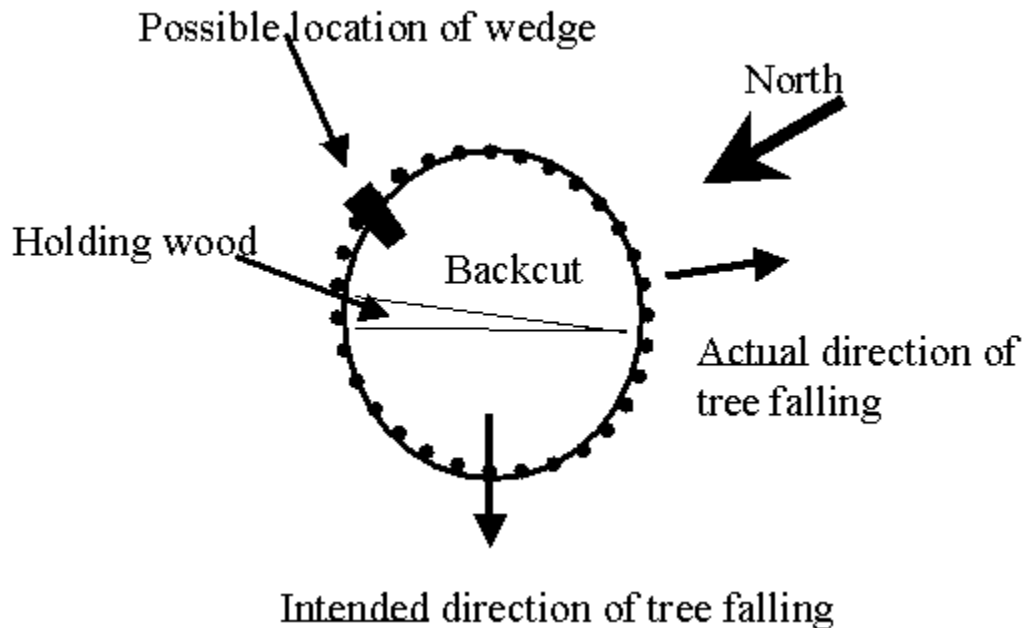
Figure 3. Photograph and schematic of stump of the tree that struck the logger.

At approximately 10:55 AM, the cutter (tree faller #1) working the middle of the slope, had just completed a cut on a Douglas Fir, estimated to be about 115-125 feet tall. Instead of falling in a northwesterly direction as intended, the tree fell in a south/southwesterly direction, toward the location of the lower positioned tree faller #2 (the victim) (see [figure 3](#)).

Discussion: In examining the stump of the felled tree (see [figure 3](#)) it was found that the tree fell approximately 90 degrees from the intended direction, toward the victim working on the lower slope. The WISHA representative (who has direct logging experience) determined that the under-cut and back-cut were poorly done and there was an attempt to cut a dutchman [***](#). A dutchman is a cut to counteract the natural lean of the tree and help maneuver the fall of a tree in the desired direction.^{3,4} There was also insufficient hinge wood (or holding wood) thickness, which would have helped control the direction of the tree's fall.

The investigation also indicates that a wedge was used in an attempt to direct the fall of the tree. However the impression the wedge made on the stump of the tree, suggests that it may have helped the tree fall in the wrong direction. The wedge was slightly off-center and positioned on the up-slope side of the tree which would have helped the tree to fall in the down-slope direction.

Recommendation #5: The felling of the cut tree should be controlled by a proper under-cut and back-cut, leaving hinge wood of sufficient strength to guide the tree during its fall.
