Sawmill Unscrambler Operator Killed when Struck by a Board Ejected by Trim Saw in Washington State

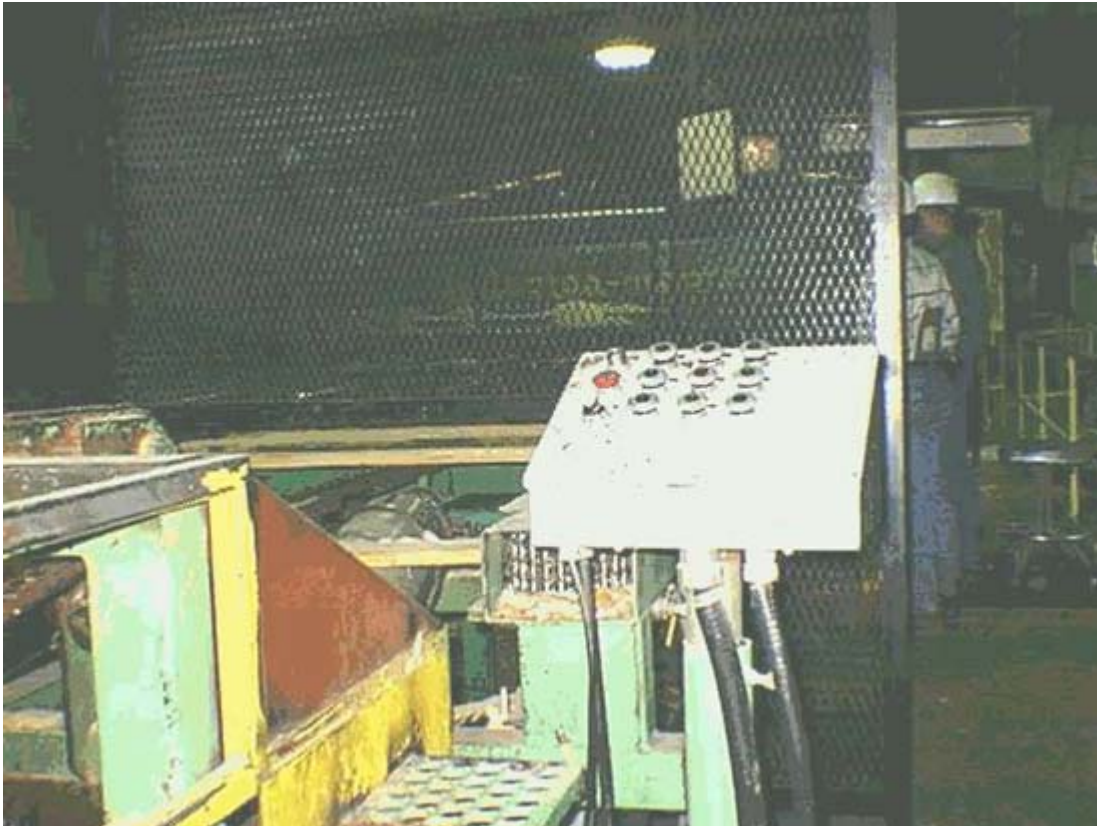
Photo #1. "Unscrambler" operator's workstation - facing "trimsaw" operators work station and trimsaw system. New guarding in place.

Since the incident and prior to the FACE investigation, the employer had added guarding to the trim saw and to the two operator workstations.

- The employer fabricated expanded metal guards situated at both sides of the trim system extending the length of the saws. There is still space below the trim system guards to allow for production flow.
- The employer also set up expanded metal guards at the trim saw and unscrambler operator's stations. These guards act as a second layer of defense in the event a board gets by the trim system guards. WISHA had made the operator station guarding recommendation. (see photos [#1](#) and [#2](#))
- The employer "aged" the working platform ends of the trim system to prevent material being ejected or thrown from that direction into the workspace. These guards also prevent personnel from direct access into the trim saw system from the working platform.

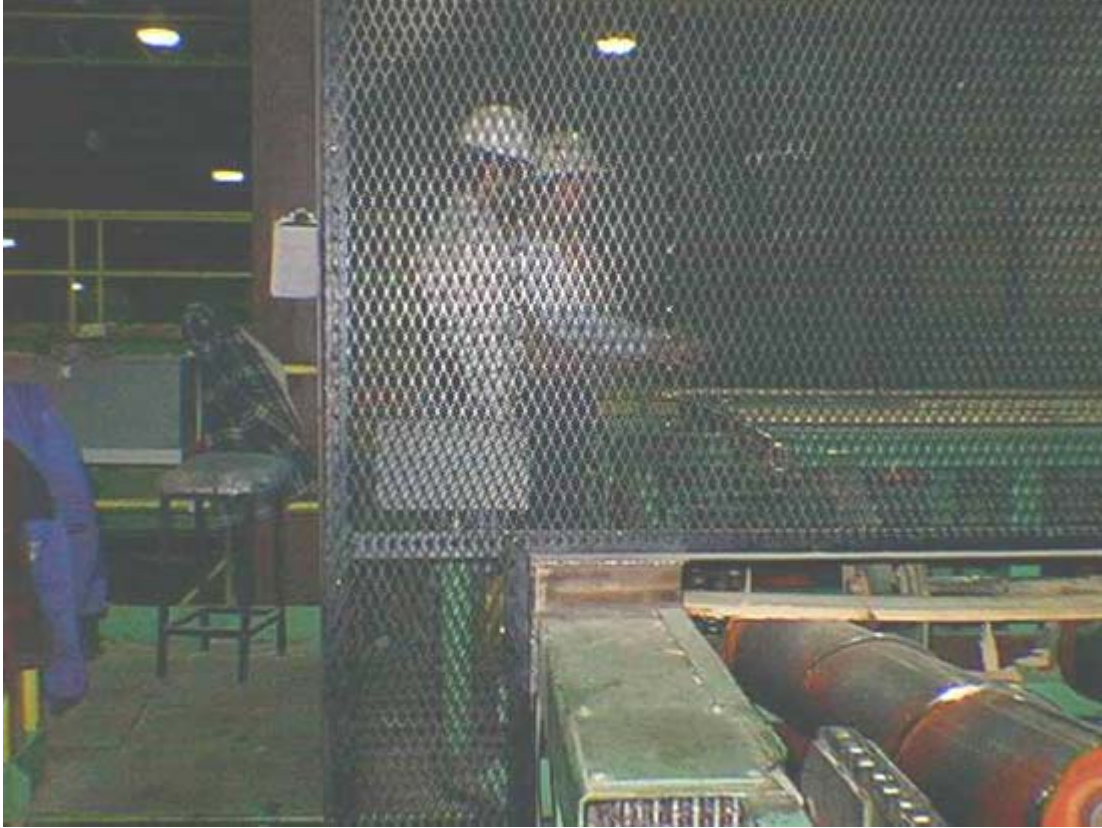
Photo #2. "Unscrambler" operator's station viewed from "trimsaw" operators work station. New Guarding in place.

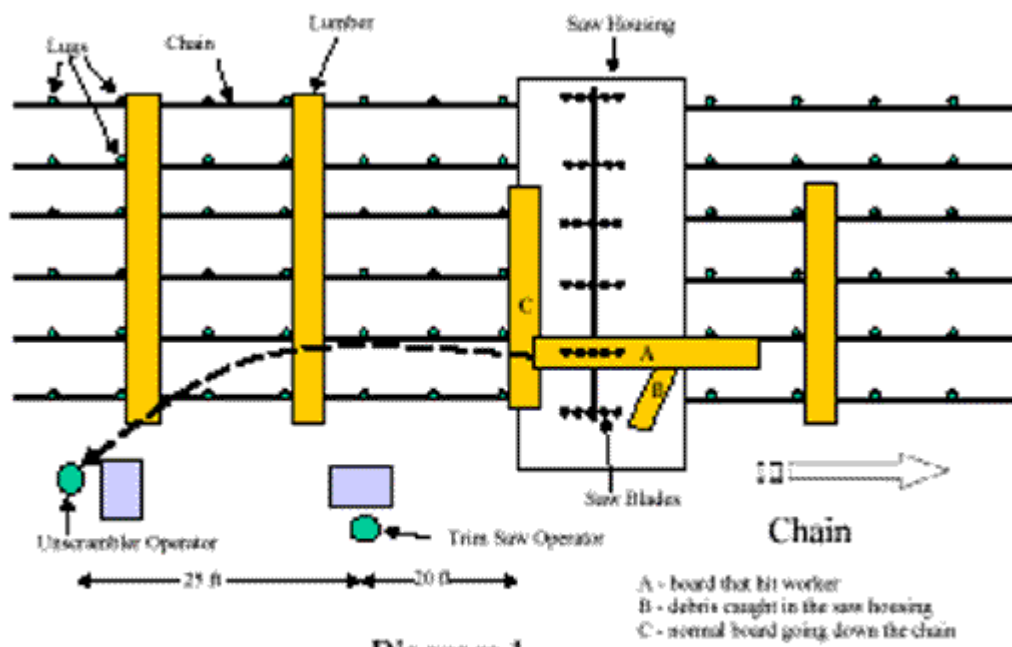
Diagram 1

The unscrambler operator worked with a trimsaw operator on the rough lumber line. The unscrambler operator's workstation was approximately 45' on the "upstream" side of the trimsaw system. The trimsaw operator's workstation was centered between the trimsaw and the unscrambler's workstation (see [diagram 1](#)).

The hypothesis of how this occurred, was that a piece, or pieces of material and/or other debris (depicted as [B] in [diagram 1](#)) might have caused the board (A) to "hang up" after exiting the trimsaw system, rotate 90 degrees, get caught by one of the saw blades and then be ejected from the system, while riding on top of board (C) (see diagrams [1](#) and [2](#)).
