Fatality Investigation Report

OR 2003-18-1

Auto salvage worker killed by unsecured car on transporter

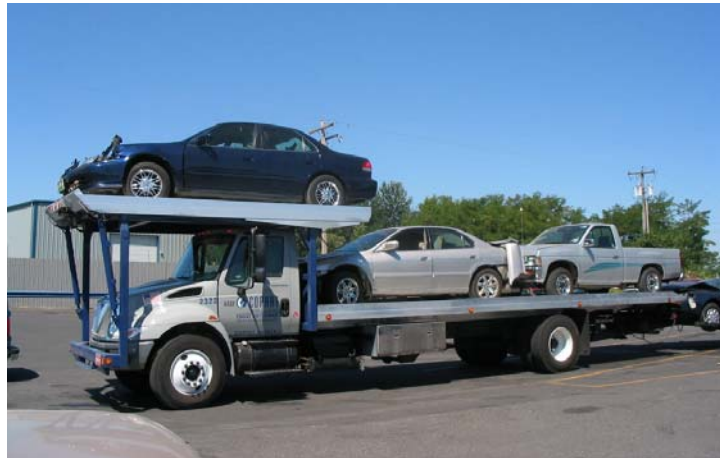
Typical vehicle hauling setup on a transporter.
OR FACE Photo
